# Home Inspection Report

807, 809 Detroit St.  
Sheboygan Falls, WI 53085

Inspected by:  
Ryan Eigenfeld  
National Property Inspections  
Inspection Date: 5/5/2025

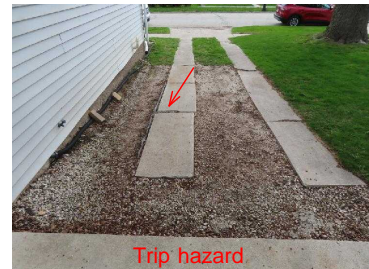
There are cracks with uneven settling and trip hazards present. Recommend a qualified contractor inspect and repair/ replace as needed.

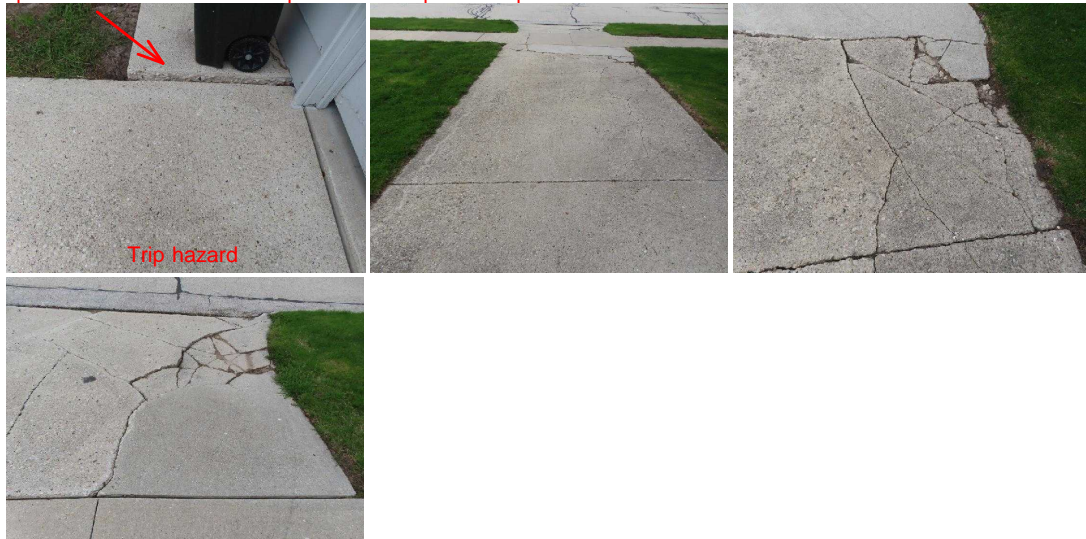
North Driveway: Concrete

There are cracks with uneven settling and trip hazards present. The driveway has settled towards the front of the Garage causing a trip hazard. Recommend a qualified contractor inspect and repair/ replace as needed.

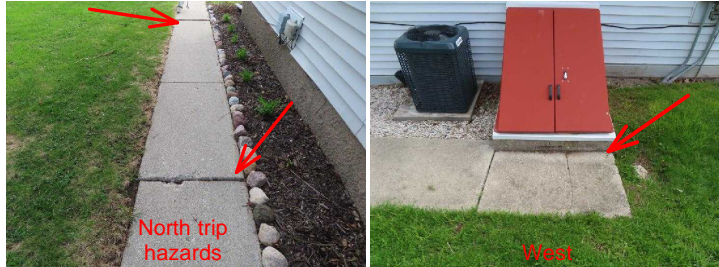
There is uneven settling with trip hazards present. The walk slopes towards the Bilco door opening. Recommend a qualified contractor inspect and repair/ replace as needed.

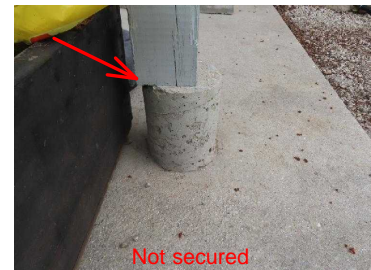
South Porch: Wood, Wood columns

The wood Porch post connection to the concrete footing is missing a proper bracket. There are typical cracks. Recommend a qualified contractor inspect and repair/ replace as needed.

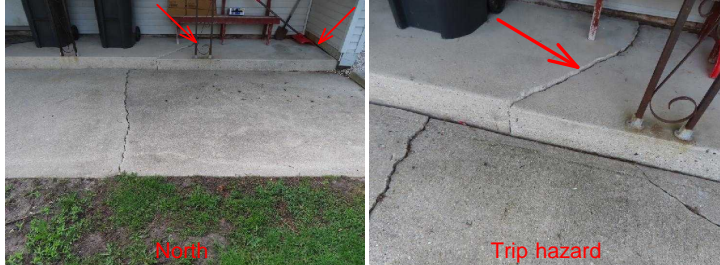
**Beams:** Wood were visible, Steel I-Beam      There is an exposed wood beam on the North side where the concrete Porch has settled that has dry rot present. There are several visible wood beams present with dry rot in the Basement at the West wall, South bearing wall and the mid bearing wall. There are home made metal joist hangers holding floor joists with previous repairs. There are lag bolt fasteners present. No evaluation could be made to verify proper repairs. Recommend a Structural Engineer and qualified Contractor to inspect and repair/ replace as needed.

The North concrete porch is cracked with settlement towards the foundation. There is a trip hazard. A main structural beam is exposed with dry rot present. The West metal post is loose. Recommend a qualified contractor inspect and repair/ replace as needed.

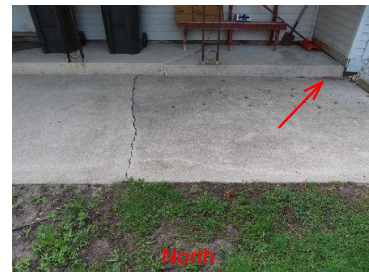
Patio: Concrete

The patio slopes towards the foundation of the building. Recommend repair to slope away from the building for proper water runoff. There is uneven settling with trip hazards present.

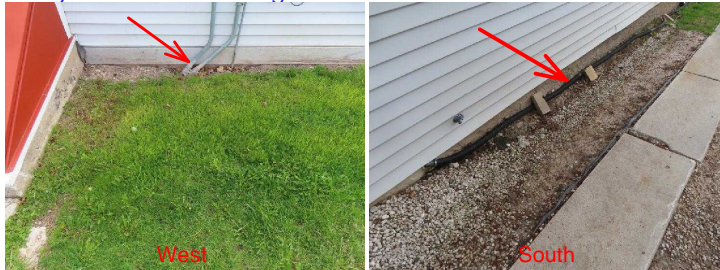
Recommend add more dirt as needed to provide proper drainage

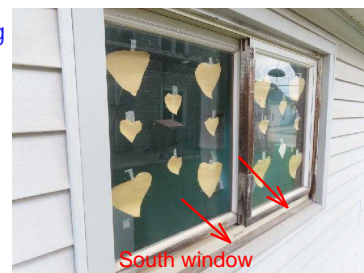
The South window trim is missing

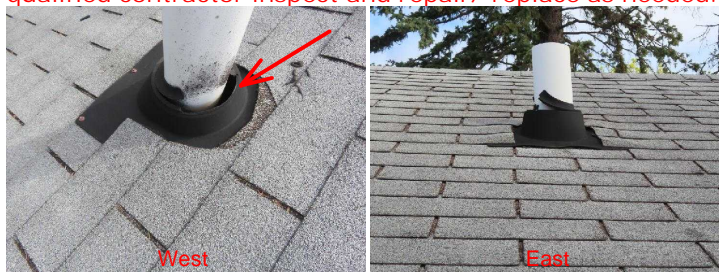
The rubber boots are torn at the plumbing stacks. Recommend a qualified contractor inspect and repair/ replace as needed.

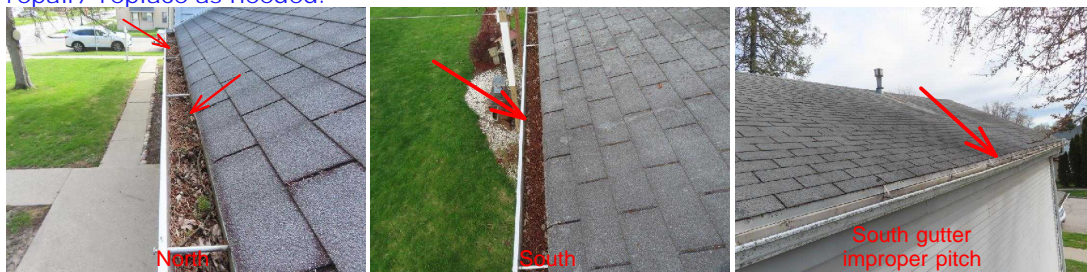
The South upper gutter has an improper pitch. The gutter corners appear to be leaking. Recommend clean debris out of gutters. Recommend a qualified contractor inspect and repair/ replace as needed.

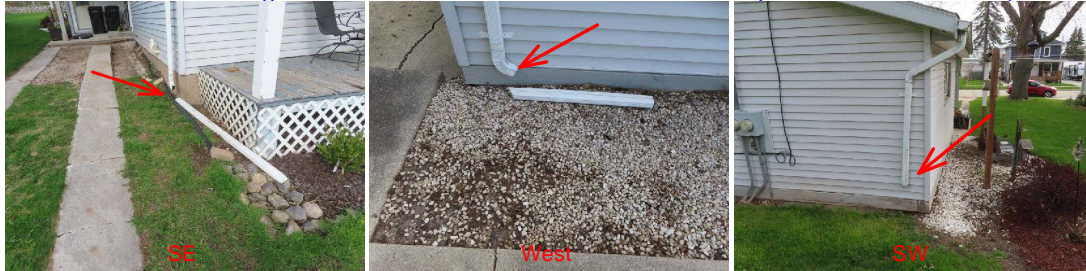
Recommend properly attach and add proper aluminum leaders where missing and ensure all leaders extend 6 feet beyond the foundation perimeter.

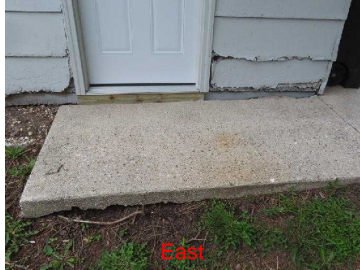
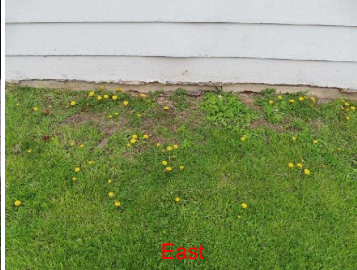
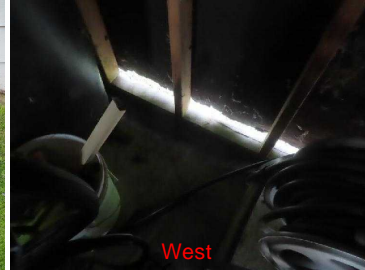
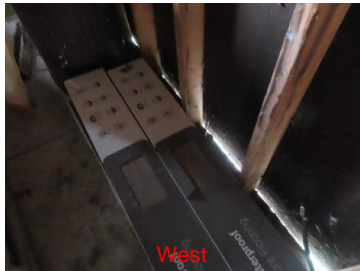
The siding is weathered/ damaged being maintained by paint.

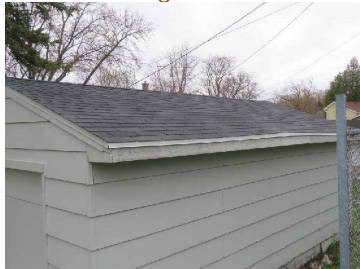
There is typical granular loss and/ or staining observed. The roof appears to be functional at time of inspection. Continued typical seasonal maintenance will be required as the roof ages.

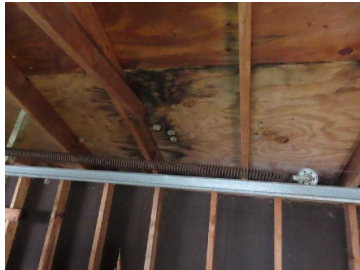
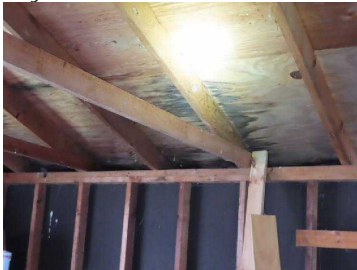
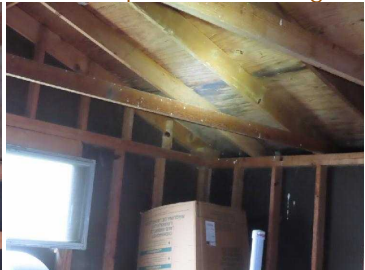
There is evidence of previous leaking.

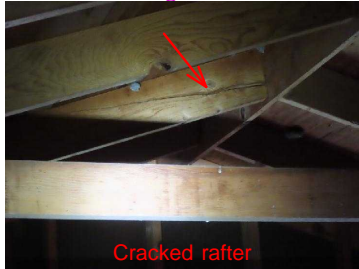
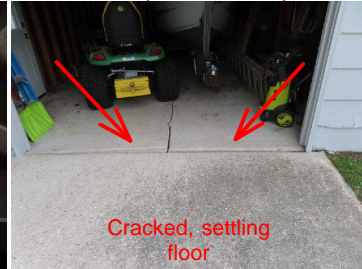
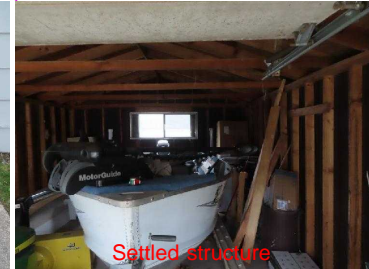
14. Functional Windows: Fixed
15. Further Evaluation Floor/Foundation: Concrete
- The concrete floor is cracked and settled. The settling is allowing the Garage structure to move. There is a cracked rafter present. Recommend a qualified Structural Engineer and Contractor to inspect and repair/ replace as needed.

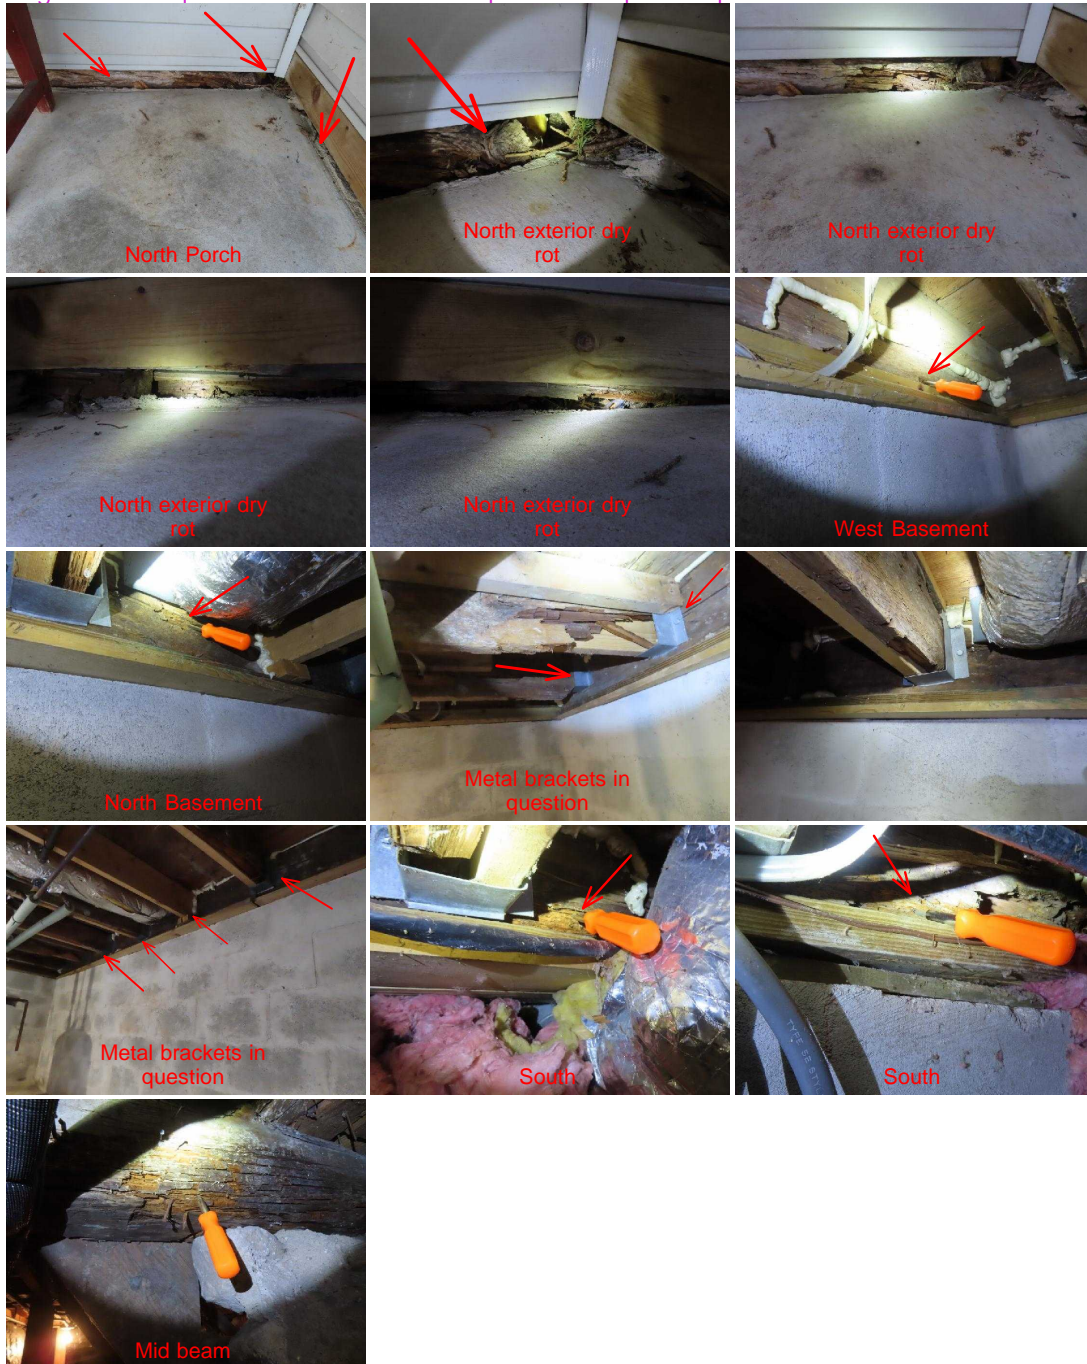
4. Further Evaluation Beams: Wood were visible, Steel I-Beam where the concrete Porch has settled that has dry rot present. There are several visible wood beams present with dry rot in the Basement at the West wall, South bearing wall and the mid bearing wall. There are home made metal joist hangers holding floor joists with previous repairs. There are lag bolt fasteners present. No evaluation could be made to verify proper repairs. Recommend a Structural Engineer and qualified Contractor to inspect and repair/ replace as needed.

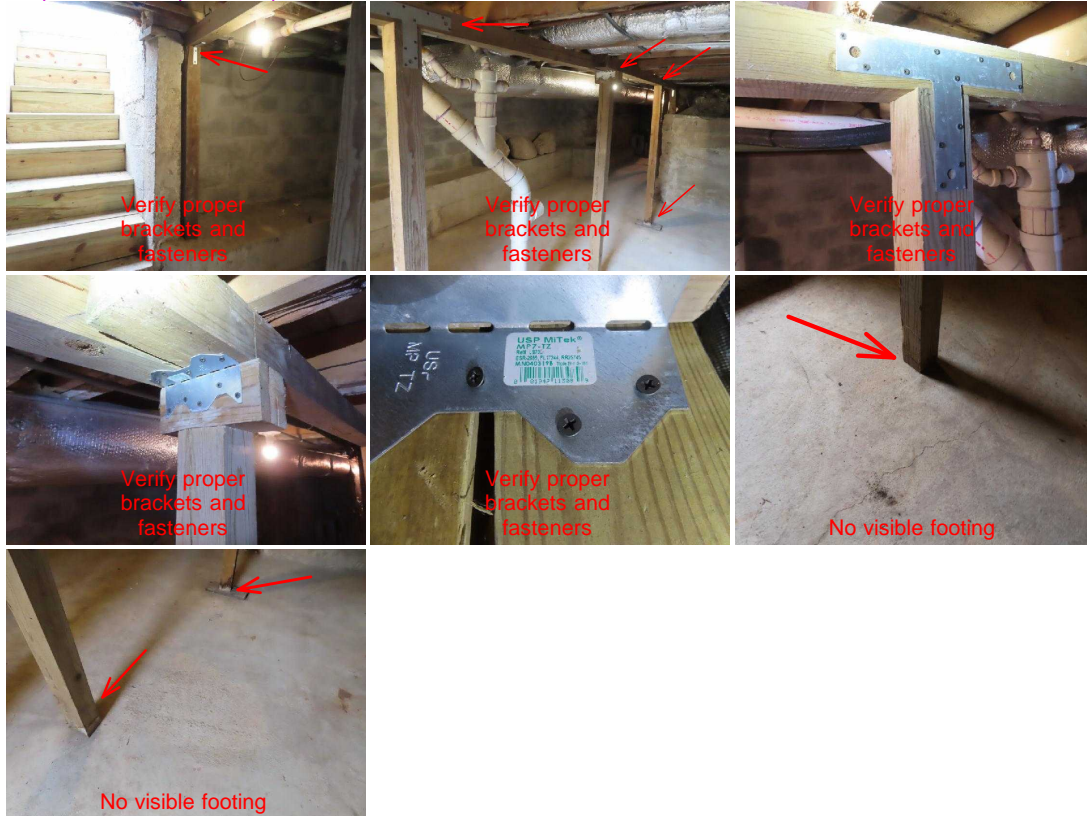
The vertical wood posts has metal brackets which appear to have improper fasteners with improper attachment to the Structure. There are no visible footings. The posts are water stained at the floor. Recommend a Structural Engineer and qualified Contractor to inspect and repair/ replace as needed.

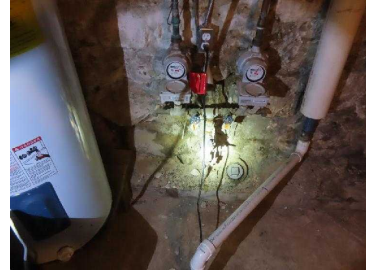
The main water supply line to the home is lead material. Lead water lines are common to the period the home was built. This material may allow lead to leach into the drinking water and cause safety concerns. Consider contacting the local municipality to see if updating to current material standards is an option.

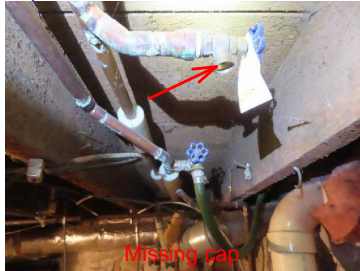
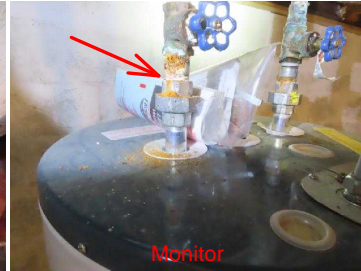
There is evidence of past/ present water leaks, dry at time of inspection, monitor for leaks, may need replacement in near future.

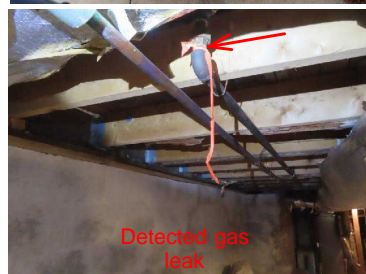
Gas Service Lines: Black pipe

There is one gas leak observed at time of inspection, see orange tag. Recommend a qualified, licensed plumbing contractor inspect and repair/ replace as needed.

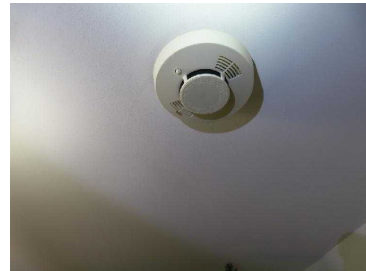
Co/ Smoke Detectors: Battery operated  
Recommend remove old yellow detectors and add new Smoke and CO detectors per NFPA and manufacture recommended locations.

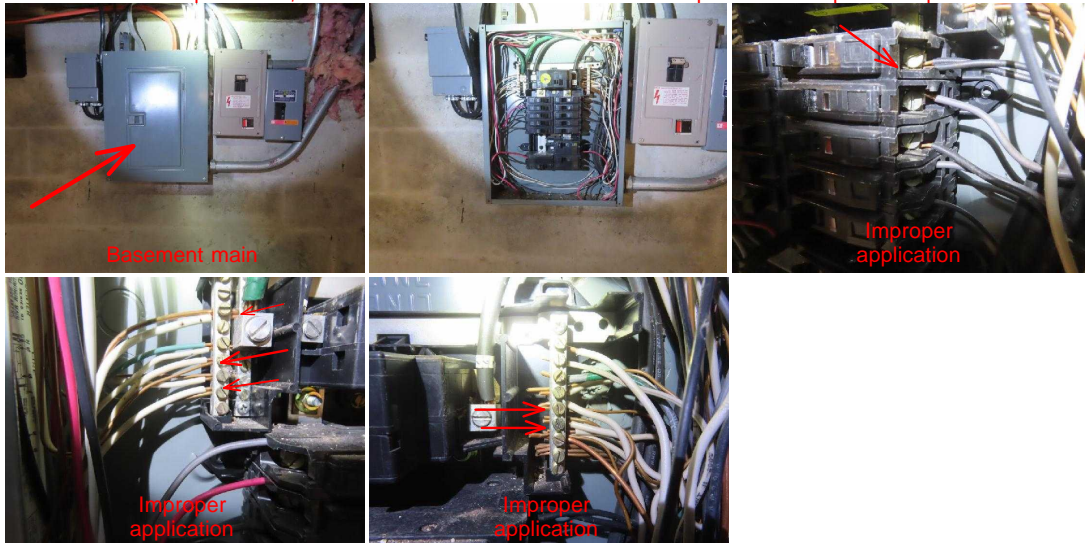
Basement - Main Electric Panel

There is an improper double tap present. There are neutral conductor(s) sharing a common screw on the bus bar with ground wire(s). This application is improper. Recommend a qualified, licensed electrical contractor inspect and repair/ replace as needed.

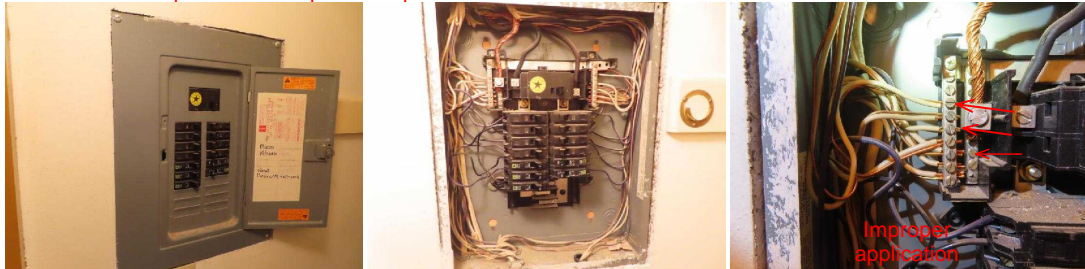
37. Defective Manufacturer: Square D There are neutral conductor(s) sharing a common screw on the bus bar with ground wire(s). This application is improper. Recommend a qualified, licensed electrical contractor inspect and repair/ replace as needed.

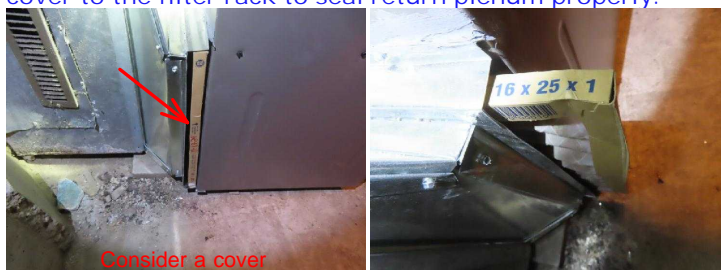
The filter is dirty, recommend replacement. Recommend add filter cover to the filter rack to seal return plenum properly.

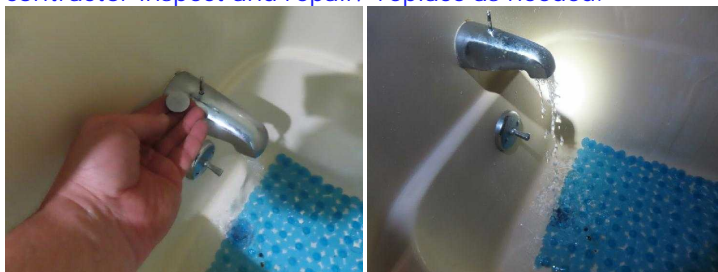
| 4. Needs Repair | Tub/Shower/Surround: Fiberglass tub and surround | The shower diverter is not functioning properly, all water is not flowing to showerhead. The pull is loose. Recommend a qualified contractor inspect and repair/ replace as needed. |

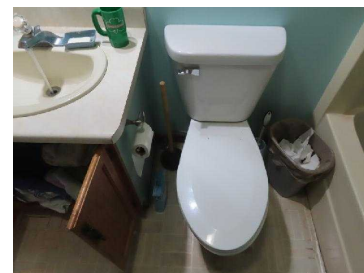
| 5. Defective | Toilets: Standard | The toilet is loose at the floor. Recommend a qualified, licensed plumbing contractor inspect and repair/ replace as needed. |

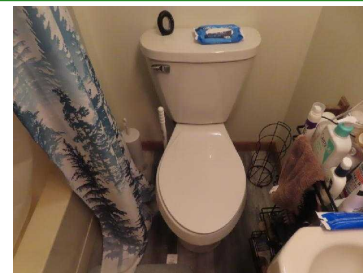
The toilet is loose at the floor. Recommend a qualified, licensed plumbing contractor inspect and repair/ replace as needed.

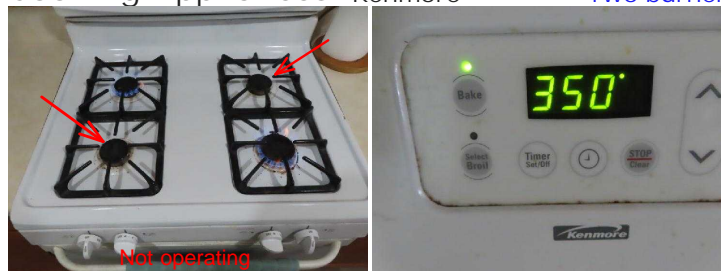
Two burners are inoperative.

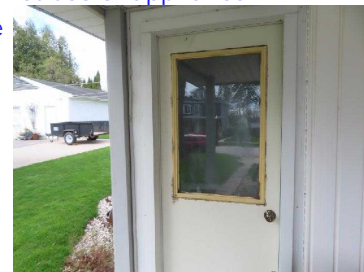
| 6. Maintenance | Doors: Metal | There is an broken insulated glass unit seal at the door. |

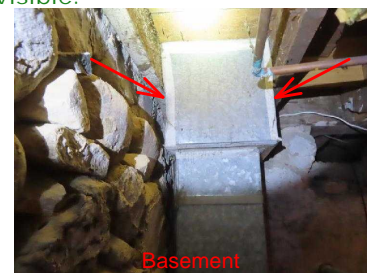
| 2. Defective | Suspected Asbestos: HVAC duct joints | Suspect asbestos observed on duct joints. Not tested at time of inspection. Lab testing of suspected asbestos containing materials are required to determine the presence of asbestos. Recommend a qualified asbestos contractor inspect and repair/ replace as needed. |

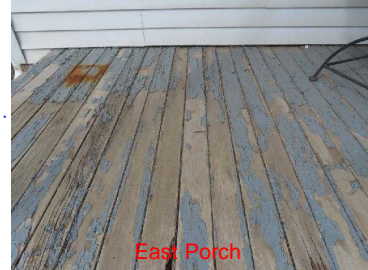
**Peeling Paint: Exterior Components** There is peeling paint present. Paint and caulk maintenance is required. Buildings built prior to 1978 may contain lead-based paint hazards. Testing of suspected lead-based paint is required to determine the presence of lead-based paint. Recommend a qualified contractor inspect and repair/ replace as needed.

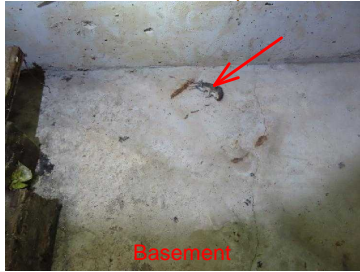
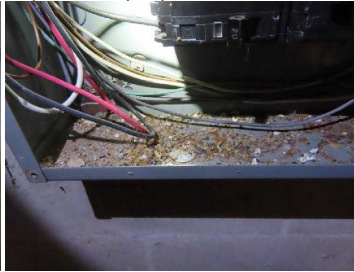
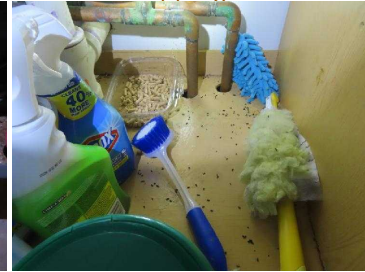
**Pests: Dead rodent, Rodent droppings, Rodent traps** There is past/present evidence of rodents. There are preventative pest traps present. There are rodent droppings observed.
