# Your Inspection Report

117 Judge Dr  
Saukville, WI 53080

INSPECTION DATE:  
Friday, September 12, 2025

Report No. 7402

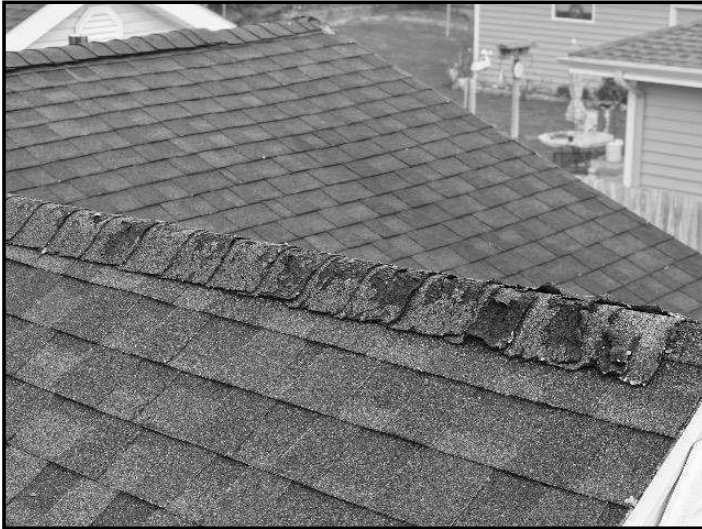
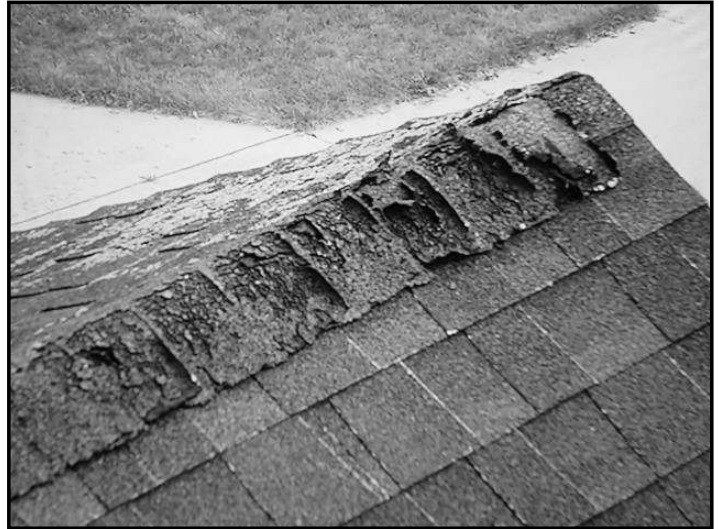
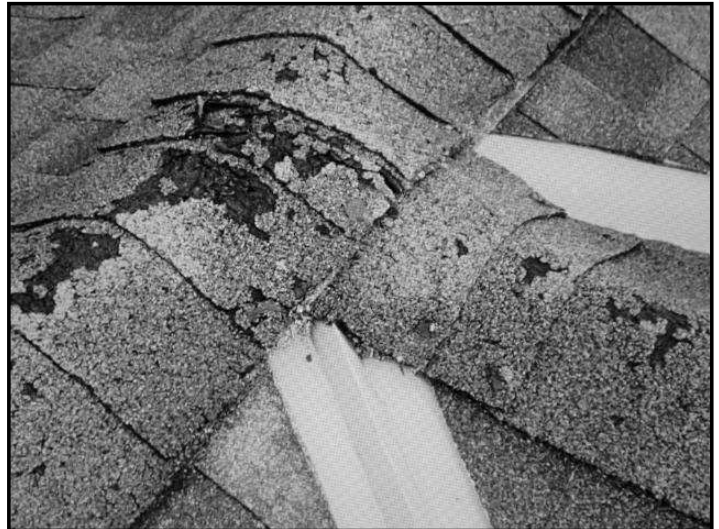
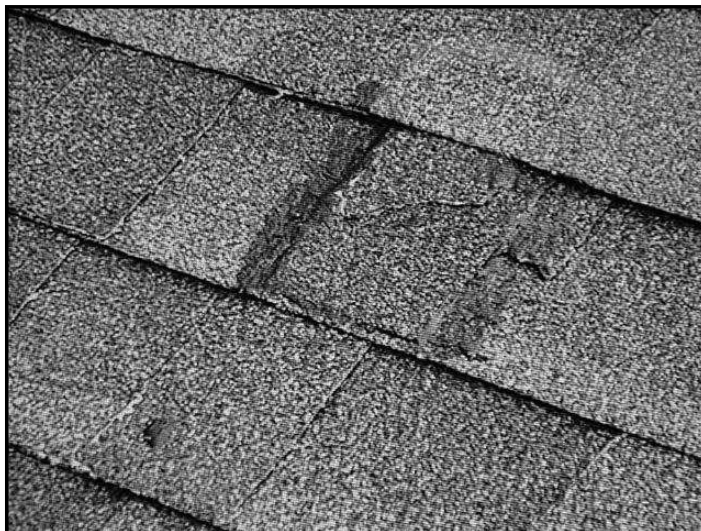
**Condition:** • Cupping, curling, clawing

**DEFECT** - There are a number of roof repairs that need to be made. There was no visible evidence of active leaking at the time of the inspection. The roof needs to be evaluated and repaired/replaced as deemed necessary by a qualified roofing contractor.

1. Cupping, curling, clawing

2. Cupping, curling, clawing

3. Cupping, curling, clawing

4. Cupping, curling, clawing

5. Cupping, curling, clawing

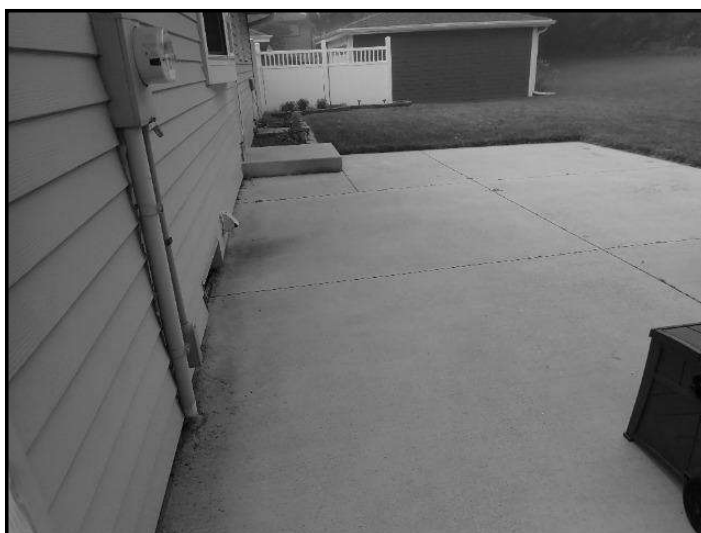
**DEFECT** - The rear patio has a poor slope and needs to be corrected to move water away from the home not towards it.

6. Improper slope or drainage

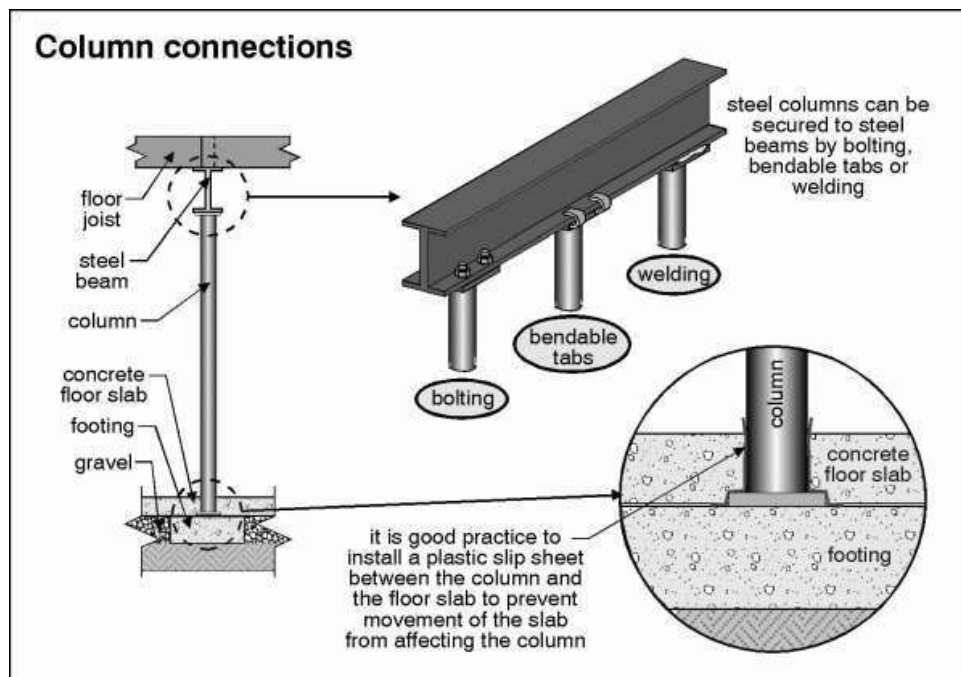
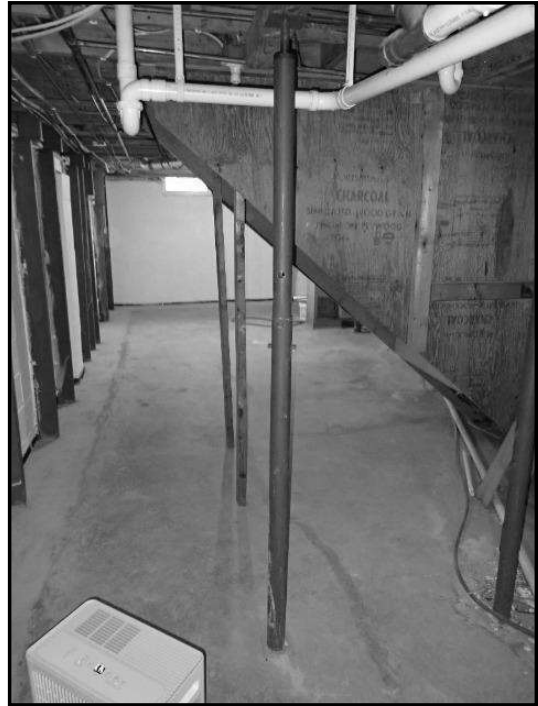
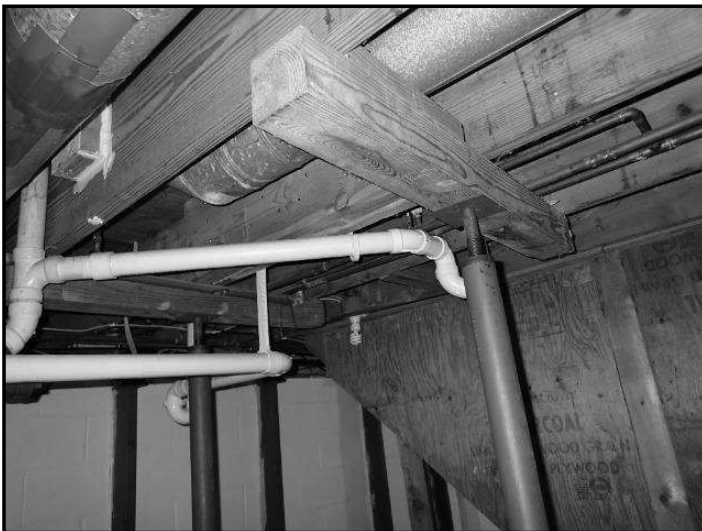
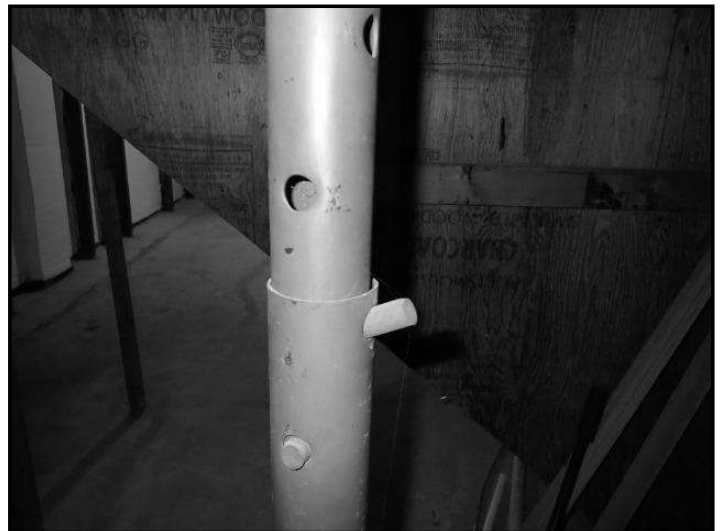
**DEFECT** - The temporary supports used in the basement are not proper permanent structural columns and need to be improved/corrected. There also needs to be a proper footing under each. The columns also need to be secured at the top and bottom.

7. Poorly secured at top or bottom

8. Poorly secured at top or bottom

9. Poorly secured at top or bottom

10. Poorly secured at top or bottom

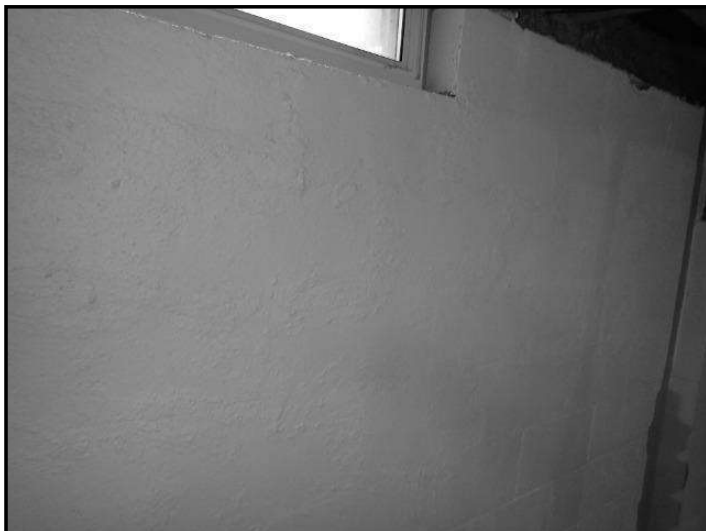
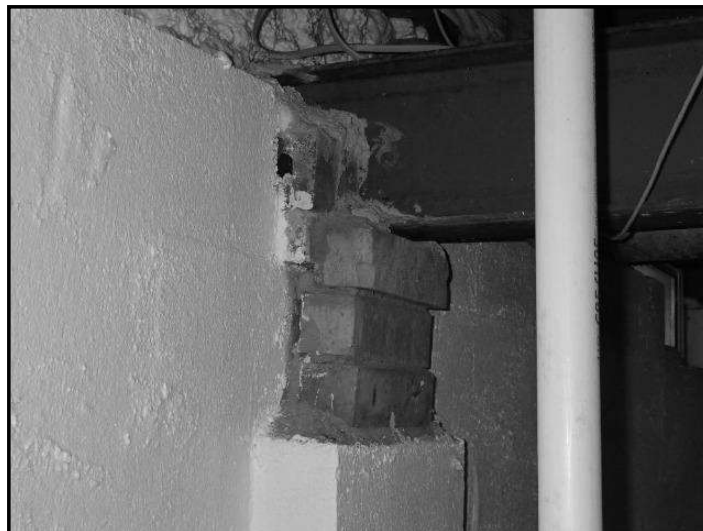
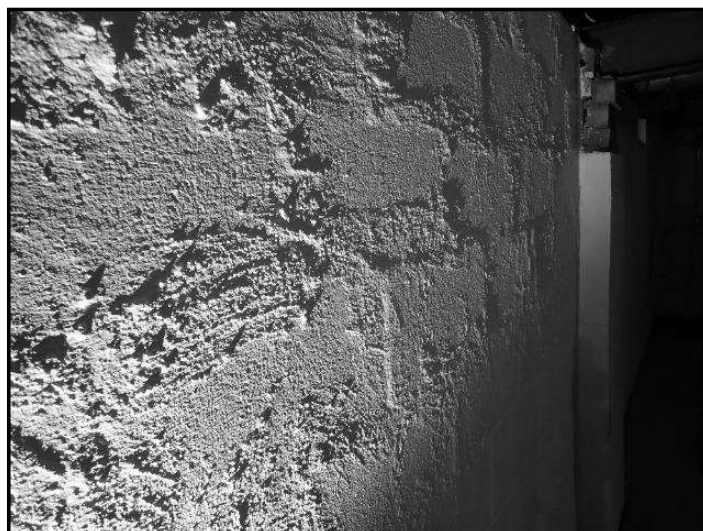
**DEFECT-** The foundation walls of the home should be evaluated as there was horizontal/vertical cracking and the walls were out of plumb by greater than 1/2". The foundation and drain tile should be evaluated by a foundation specialist or structural engineer to determine proper repairs that are necessary.

11. Bowed, bulging or leaning

12. Bowed, bulging or leaning

13. Bowed, bulging or leaning

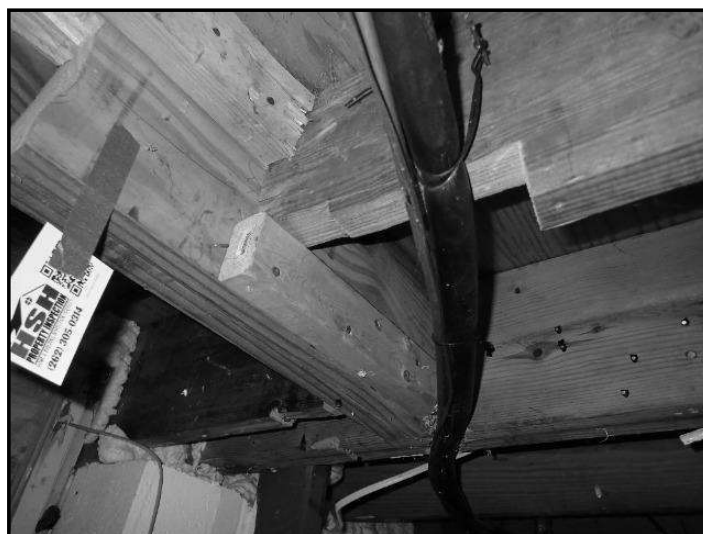
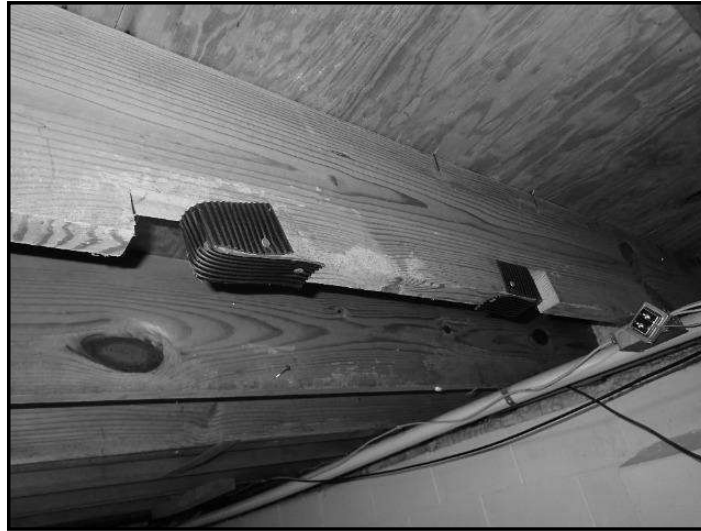
**DEFECT** - There are some damaged joists in the basement that need to be repaired/replaced.

14. Notches or holes

15. Notches or holes

16. Notches or holes

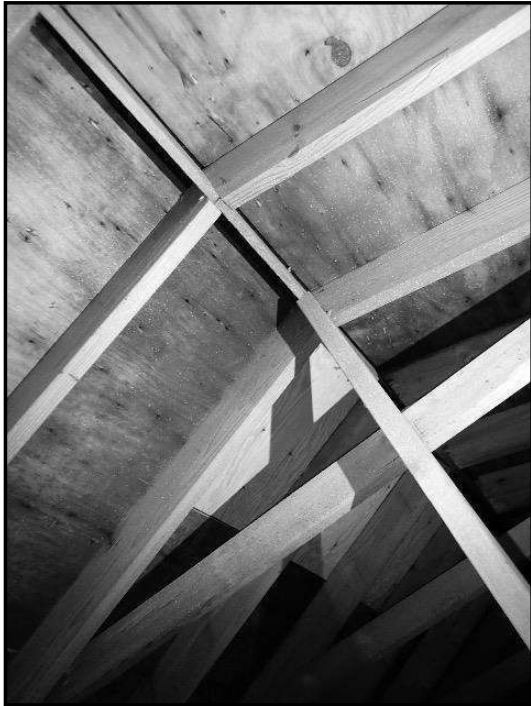
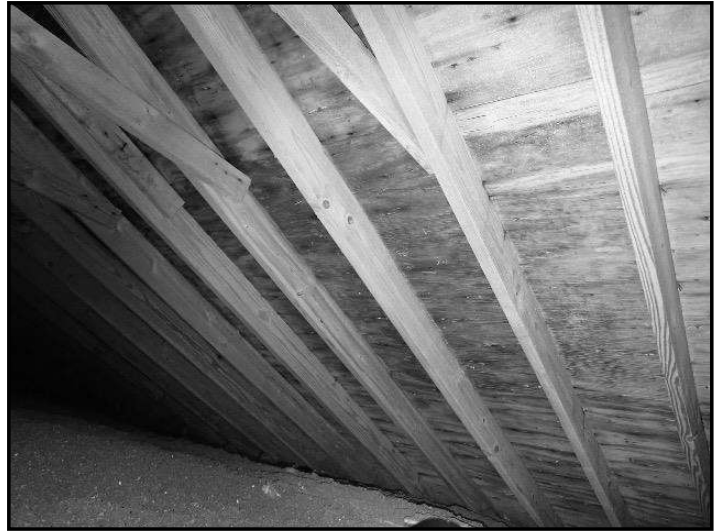
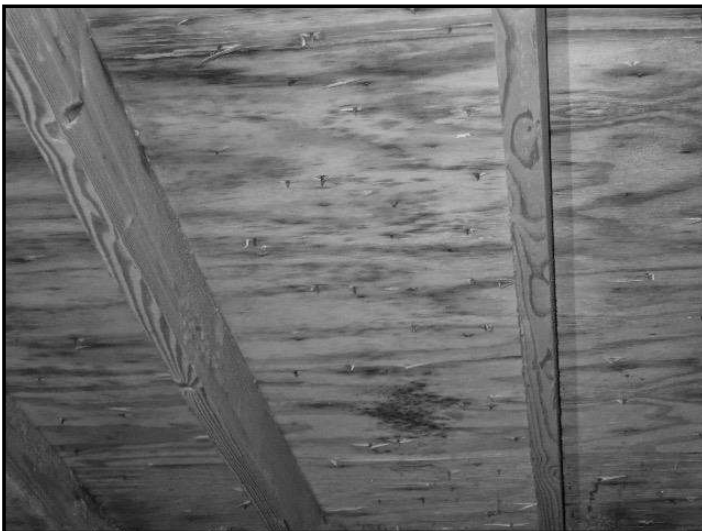
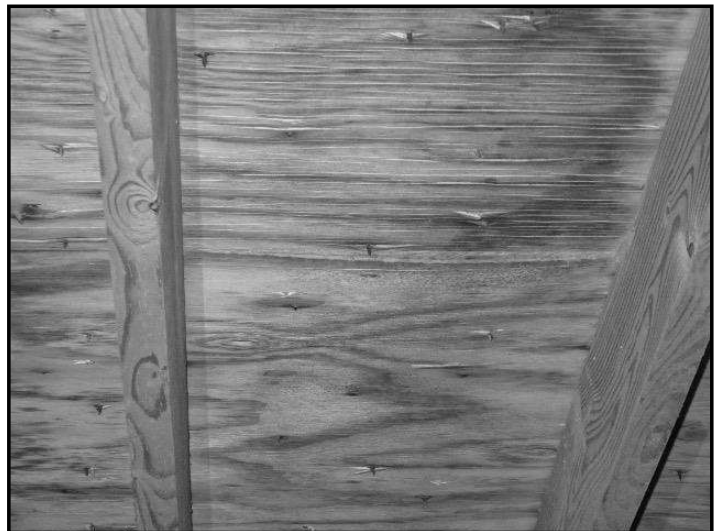
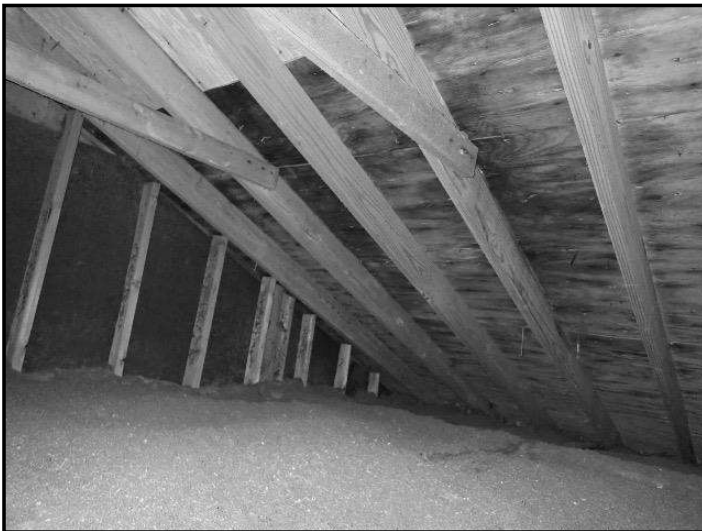
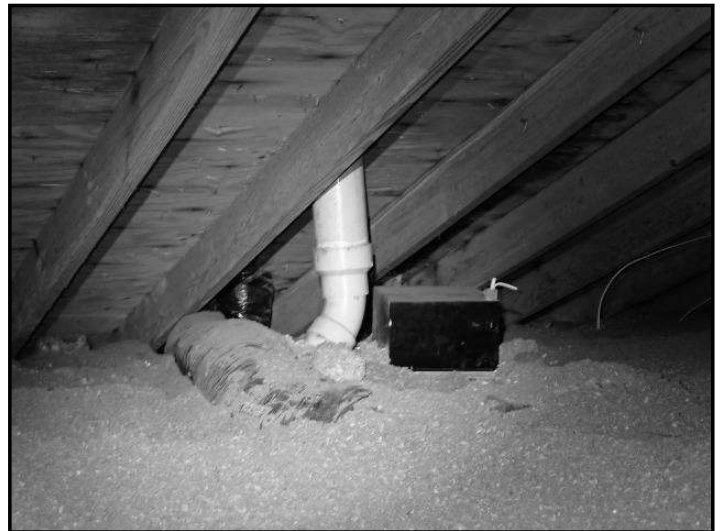
DEFECT - There is some fungal/bacterial growth in the attic, this should be evaluated/tested by a specialist to confirm, identify the cause, and be mitigated properly so it doesn't continue to spread or pose a risk to the residents. Further repairs to the attic as a part of this process may be necessary to ensure the condition doesn't return. Things to look at will be ventilation and air sealing as well as the bathroom vents. The area was not tested and samples were not taken at the time of the inspection.

17. Mold

18. Mold

19. Mold

20. Mold

21. Mold

22. Mold

23. Mold

24. Mold

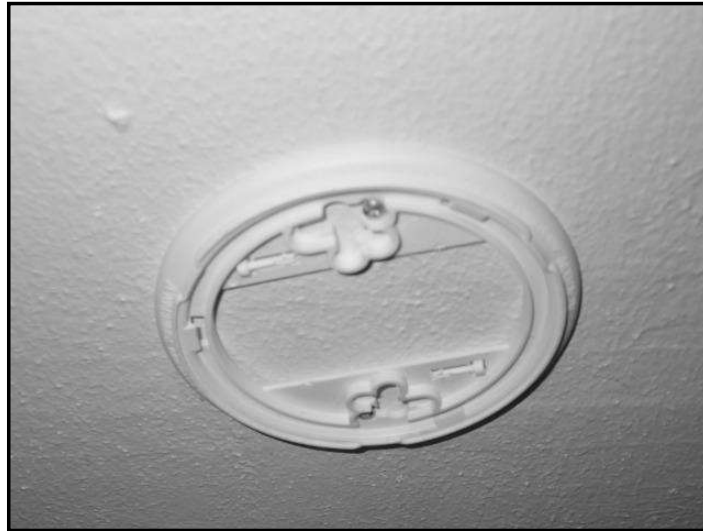
DEFECT - There should be a functioning smoke and carbon monoxide detector on each floor. They should be checked once a month and replaced every 8-10 years. Some of the areas of the home have none or are out of date. Smoke detectors should not be placed in the kitchen area.

40. Missing

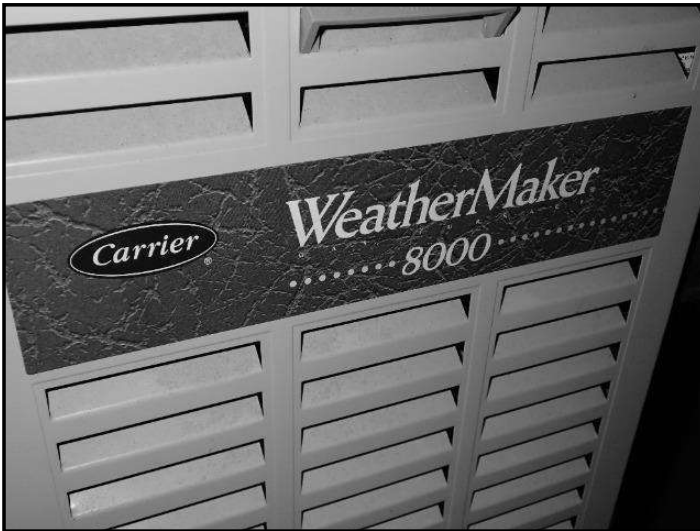
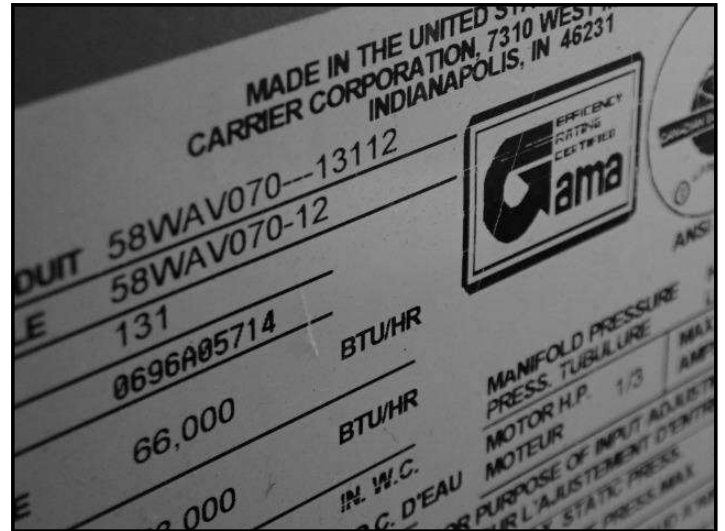
DEFECT - Further evaluation by a qualified professional HVAC technician is needed to determine the furnace viability. Carrier furnaces of this age had heat exchanger problems and there was a large recall. Given its age and condition there may be other issues discovered during this process.

41. Cracks, holes or rust

42. Cracks, holes or rust

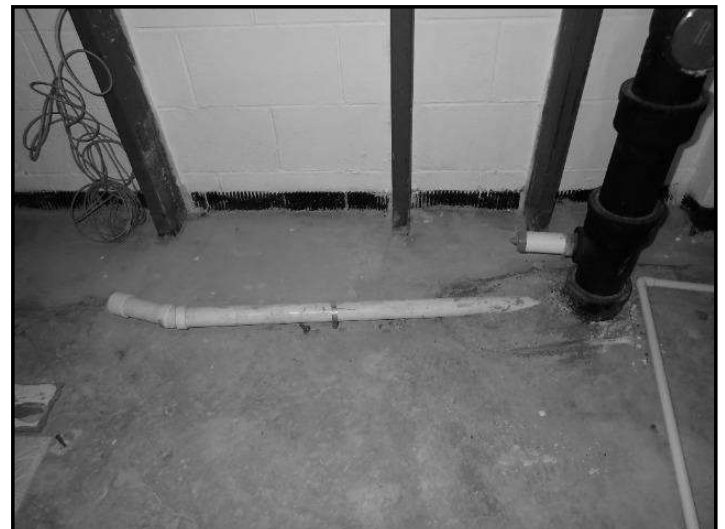
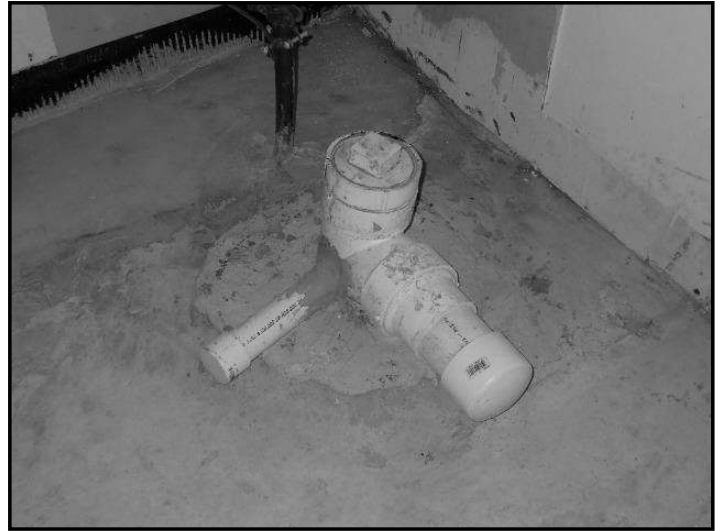
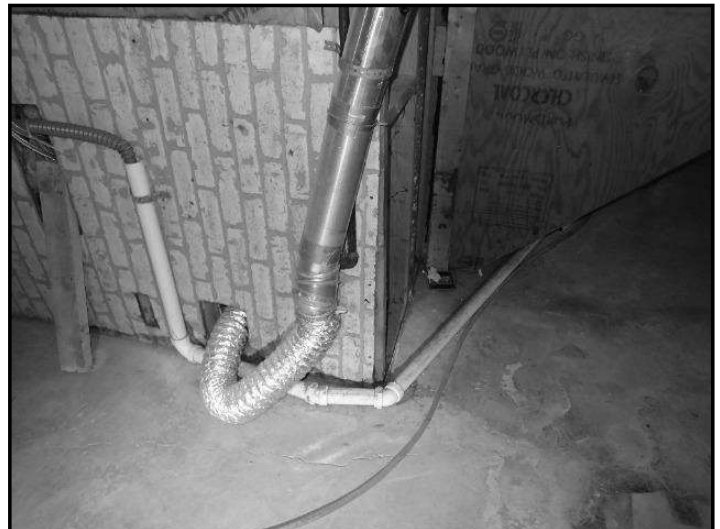
**DEFECT** - There is some poor drain waste and vent piping in the home that needs to be corrected by a qualified plumber. There are a few improper sections and pieces that need to be replaced for consistent performance in waste movement and venting. This work was not professionally done, and there may be further issues that were not demoed or observed.

44. Nonstandard materials and patches

46. Nonstandard materials and patches

48. Nonstandard materials and patches

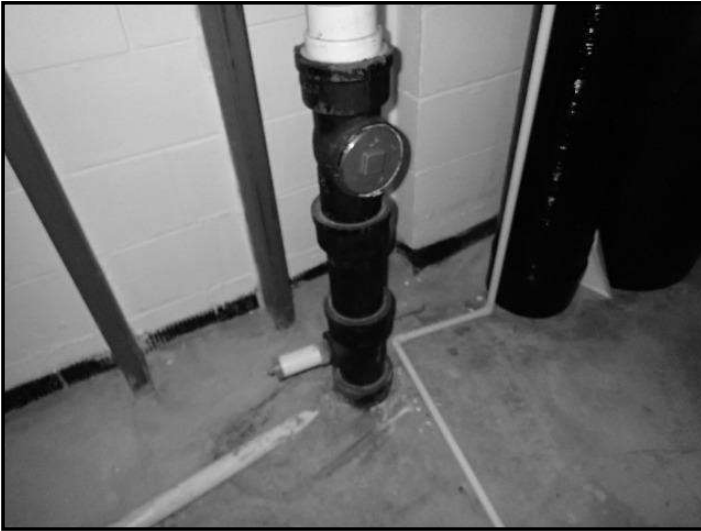
45. The sewer lateral appears to be made of cas...

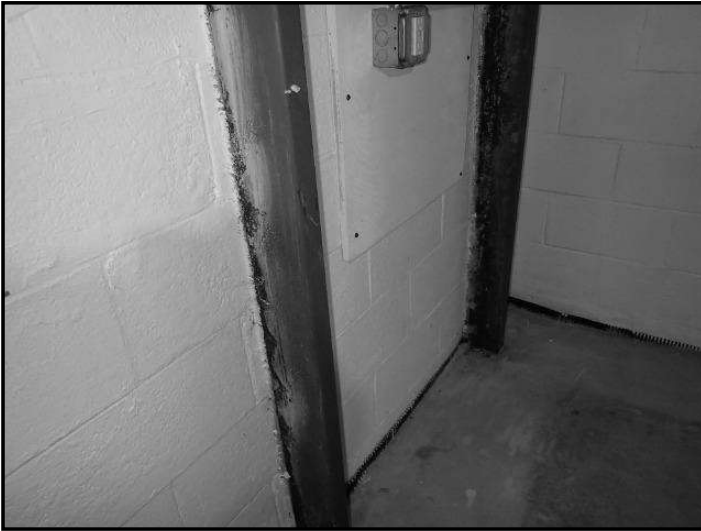
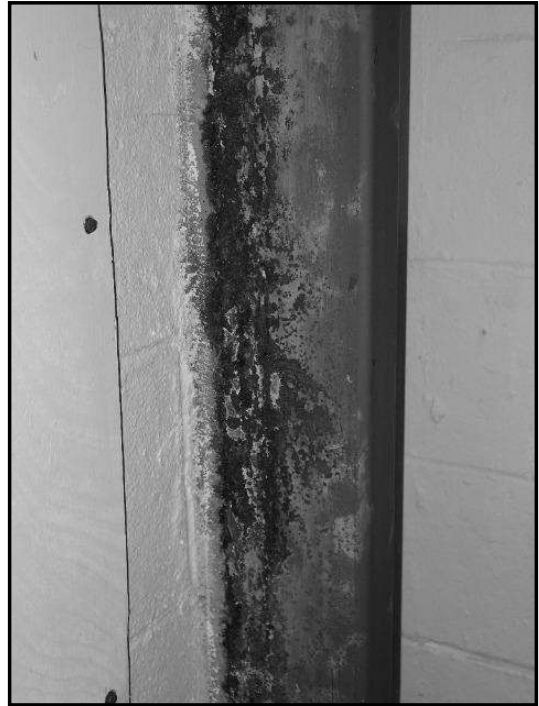
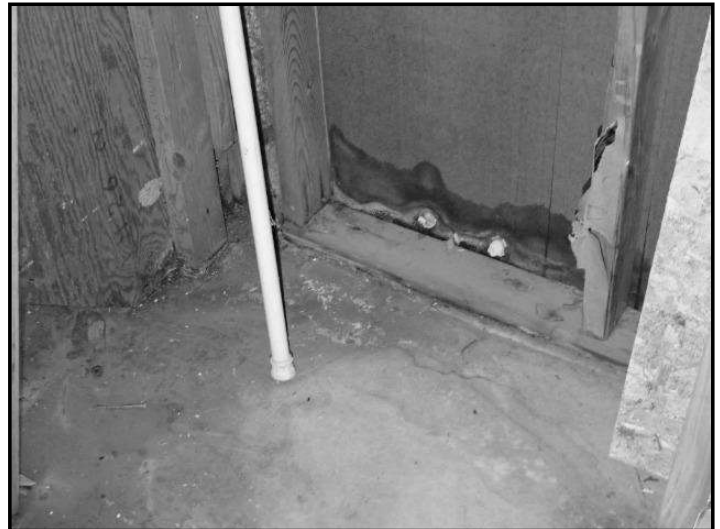
**DEFECT** - The basement is showing signs of efflorescence and moisture intrusion. The walls and floor were dry at the time of the inspection. These conditions are usually addressed by improving your grading, gutters, and downspouts. If the moisture persists there may be a need for a drain tile improvement/system. The moisture appears to be a continuing issue.

49. Efflorescence

50. Efflorescence

52. Efflorescence

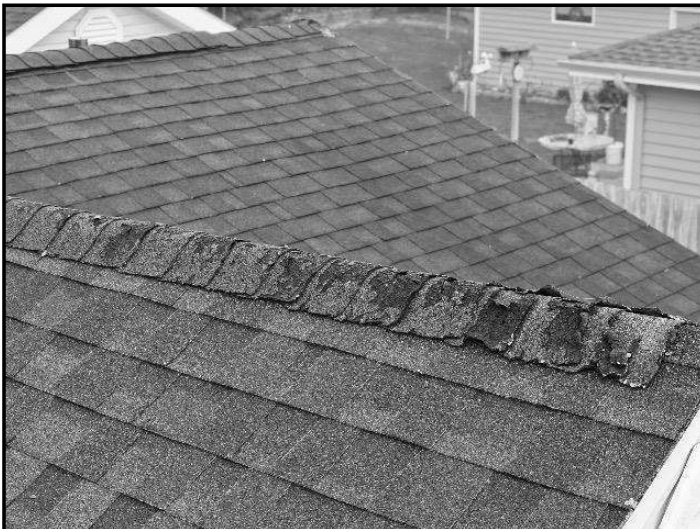
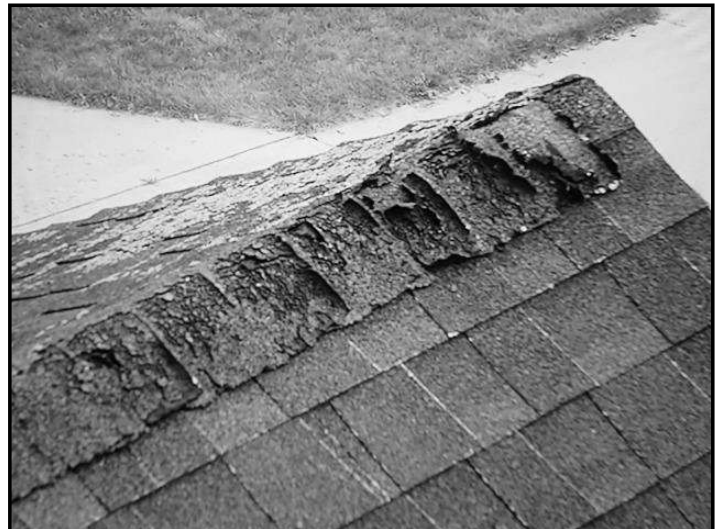
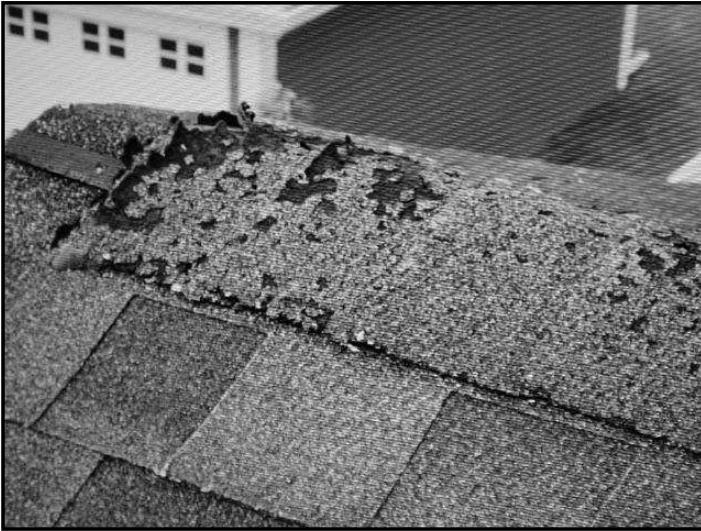
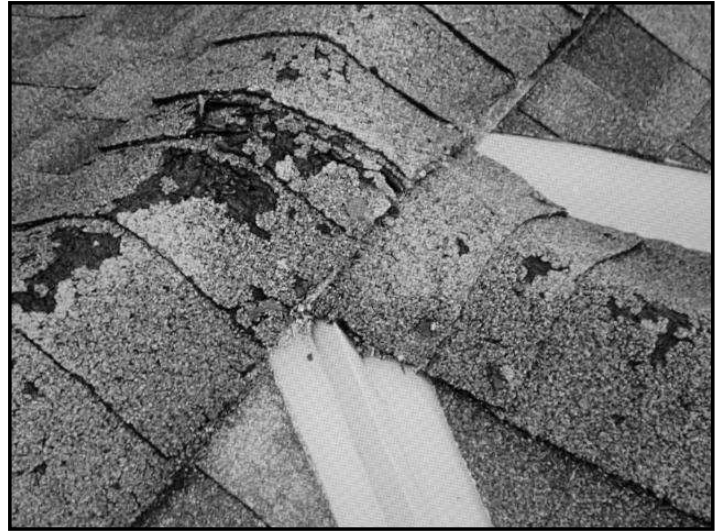
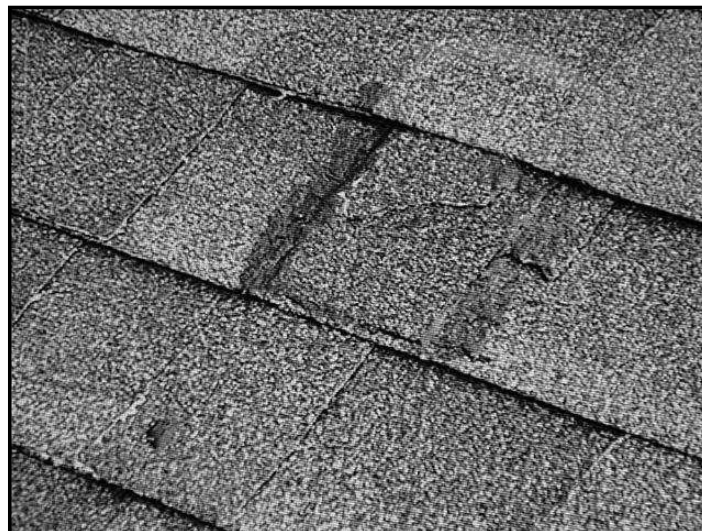
**DEFECT** - There are a number of roof repairs that need to be made. There was no visible evidence of active leaking at the time of the inspection. The roof needs to be evaluated and repaired/replaced as deemed necessary by a qualified roofing contractor.

58. Cupping, curling, clawing

59. Cupping, curling, clawing

60. Cupping, curling, clawing

61. Cupping, curling, clawing

62. Cupping, curling, clawing

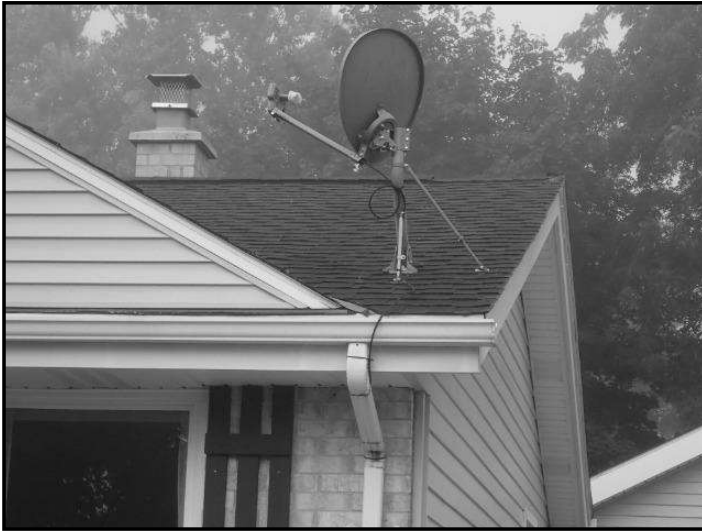
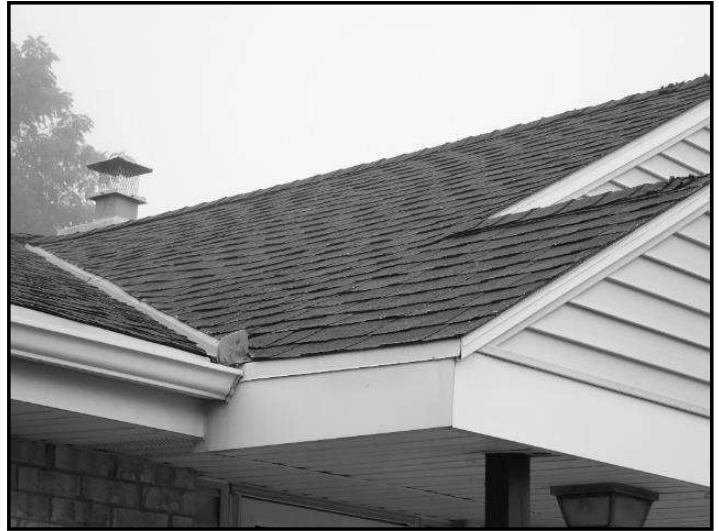
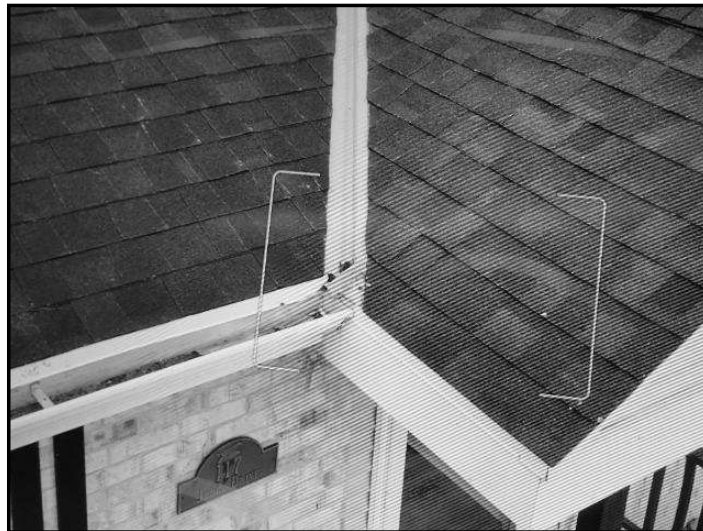
There are a few areas where the flashings need to be improved/provided. Mainly we are talking about the kick/guiding and valley flashings missing at a few areas.

63. *Inspect & repair, as needed.*

64. *Inspect & repair, as needed.*

65. *Inspect & repair, as needed.*
