EXTERIOR

117 Judge Dr, Saukville, WI September 12, 2025

Report No. 7402

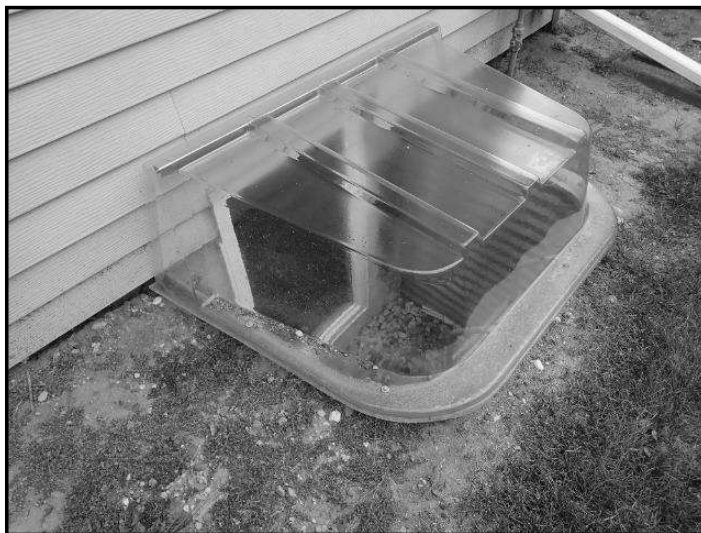
75.

3. Condition: • The egress window well should have a fall roof cover installed to prevent injury.

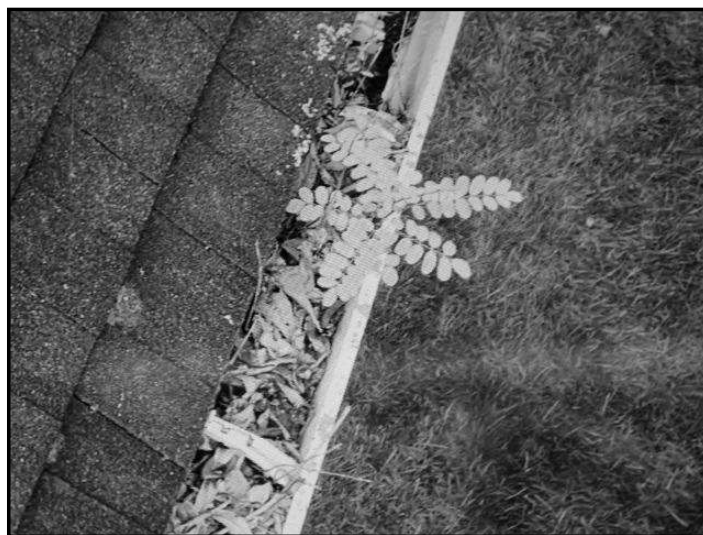
4. Condition: • Clogged

The gutters are clogged and need to be cleaned. These are regular maintenance items. Gutter guards are recommended.

76. Clogged

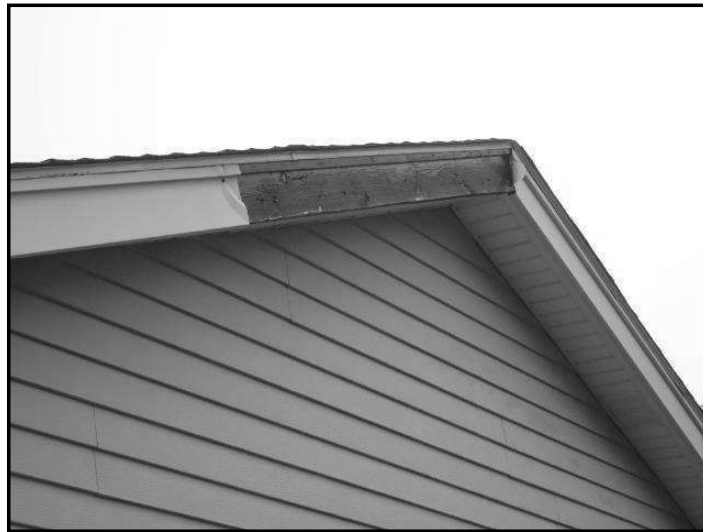
5. Condition: • Loose or missing pieces

There are a few areas on the exterior where the soffit/fascia is coming loose/missing and should be secured or replaced as necessary.

77. Loose or missing pieces

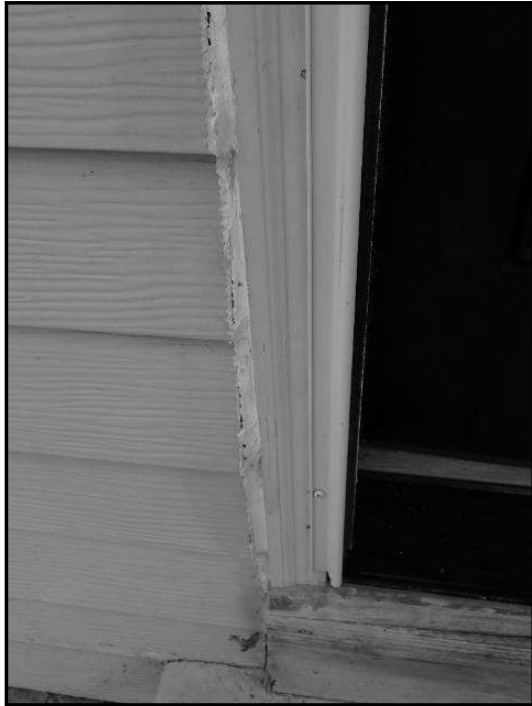
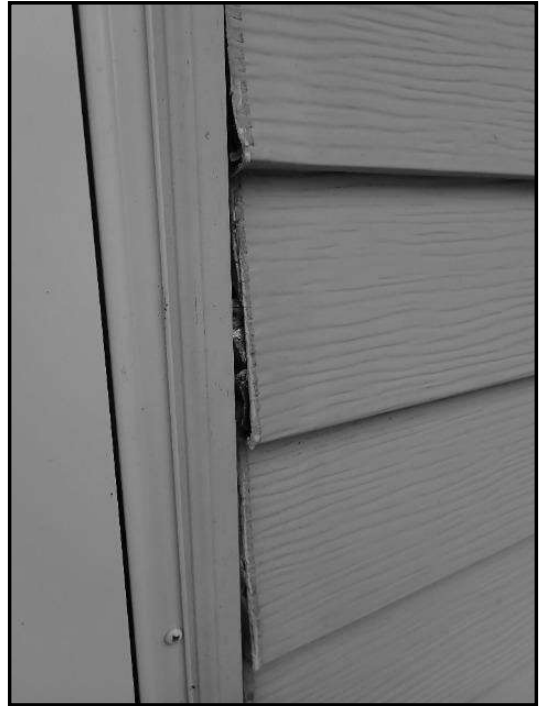
6. Condition: • Caulking missing or deteriorated

There are a few areas at the exterior that need to be caulked and sealed to prevent damage, moisture intrusion, and insect intrusion. Some areas also have poorly installed and discolored caulking that needs to be replaced. Some flashing should also be improved to prevent water intrusion (this is an improvement where materials meet the masonry to push water away..

78. Caulking missing or deteriorated

79. Caulking missing or deteriorated

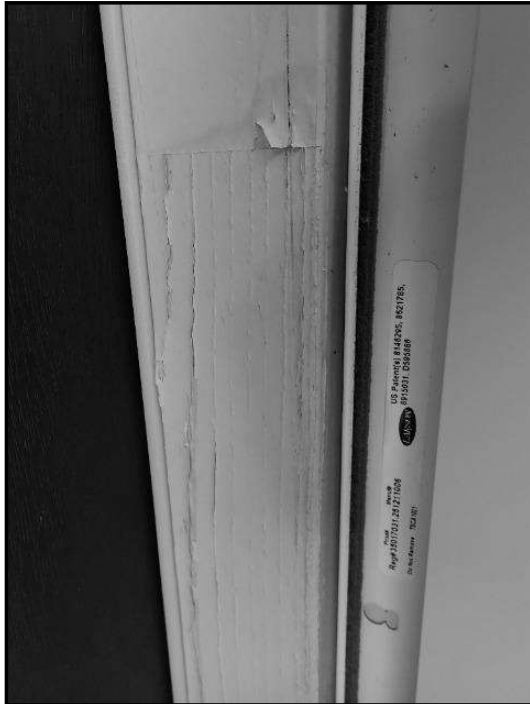
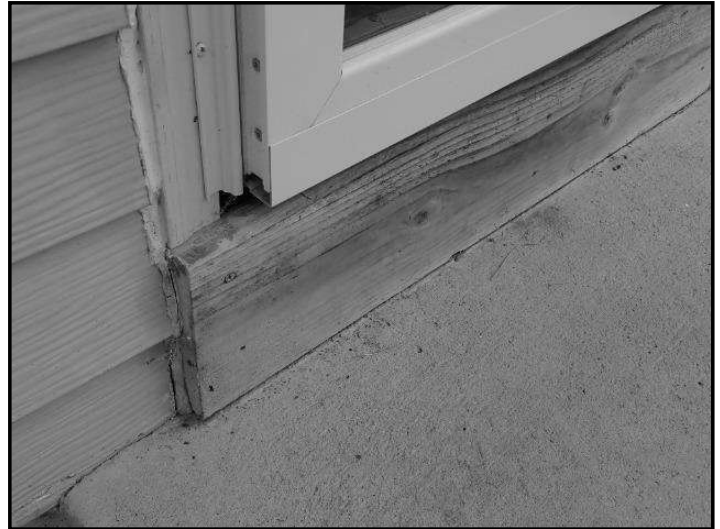
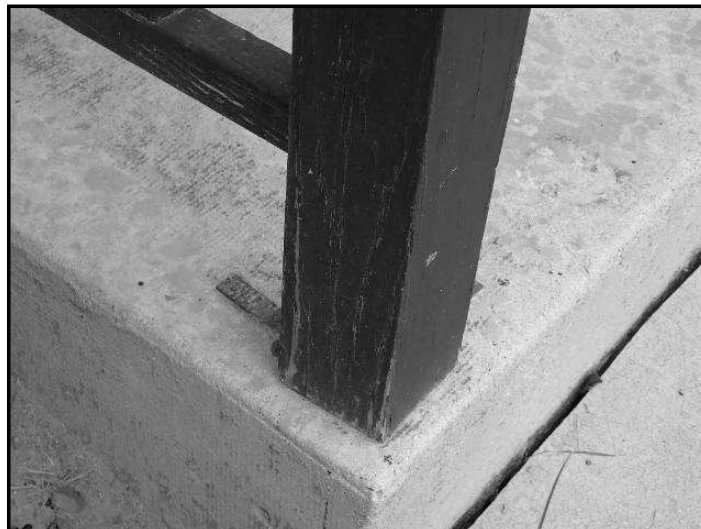
7. Condition: • Paint or stain needed

There are a few areas on the exterior that require repair, prep, and paint in order to protect the building materials and not have them deteriorate due to rot. If there is already rot/damage the affected areas should be repaired before painting or caulking. Wood trim should not be in contact with flat concrete/soil/flat work.

80. Paint or stain needed

81. Paint or stain needed

82. Paint or stain needed

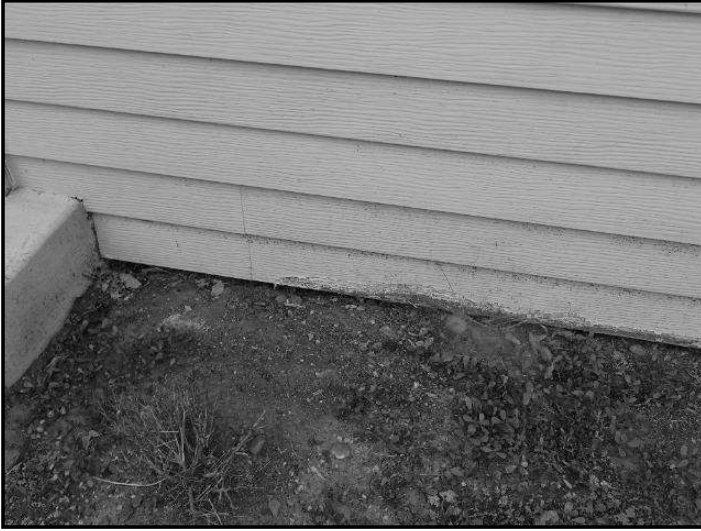
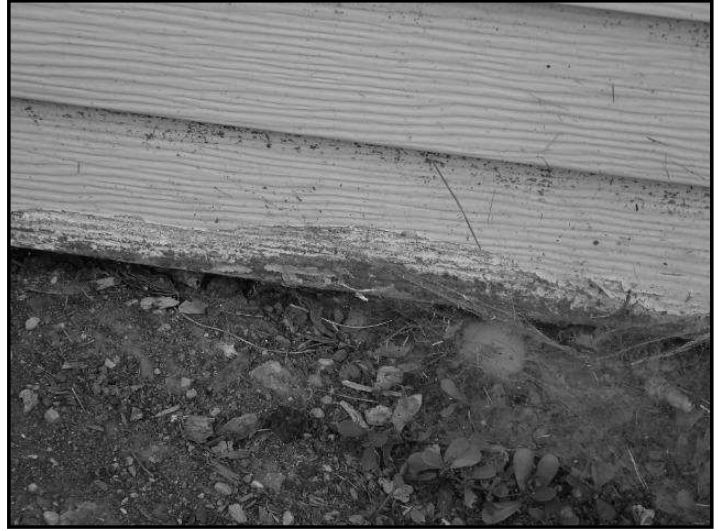
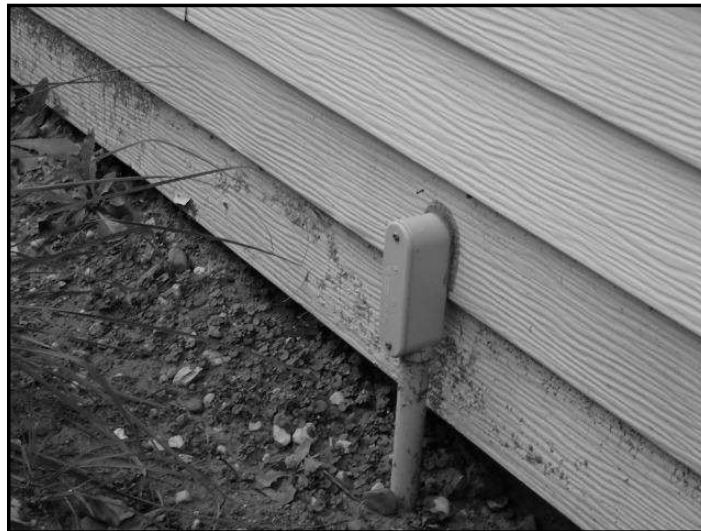
8. Condition: • Rust

There are a few areas on the house siding that are rusted or damaged and need to be repaired.

83. Rust

84. Rust

85. Rust

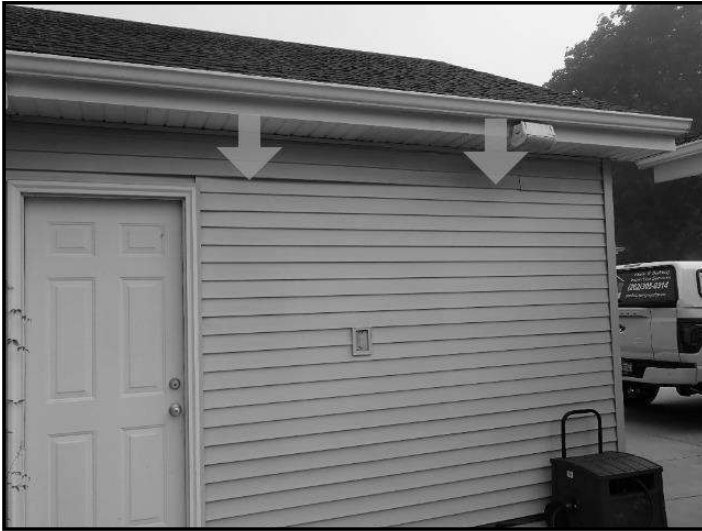
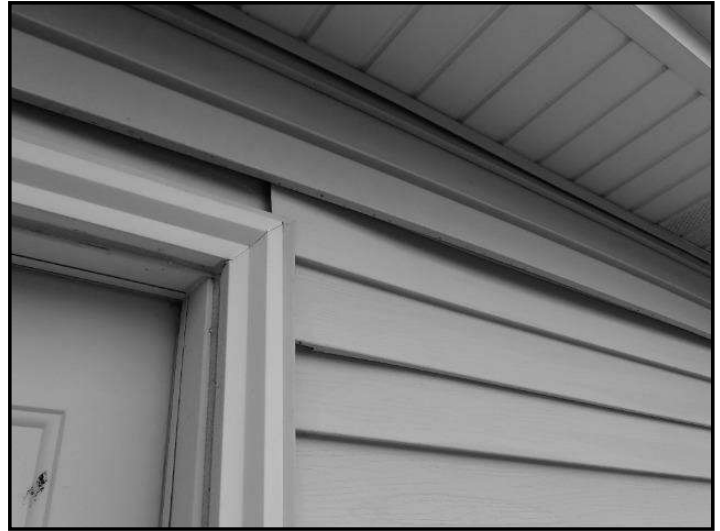
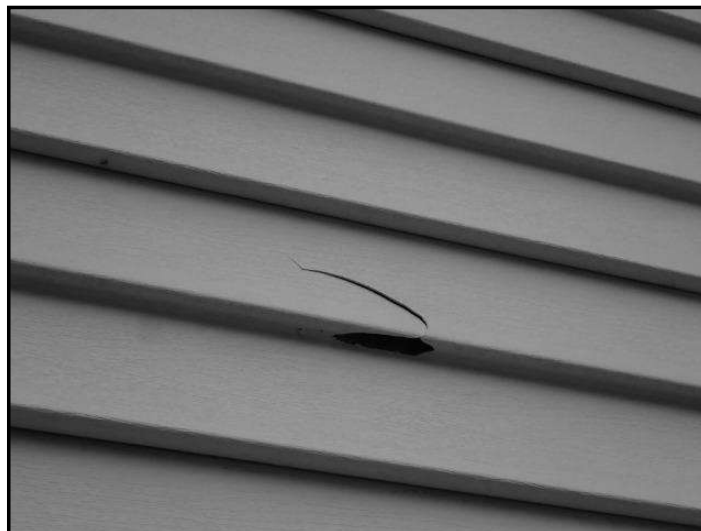
9. Condition: • Loose or missing pieces

There were a few areas where the siding should be repaired as it was loose, damaged, and poorly installed. Repairs should be made by a qualified siding installer.

86. Loose or missing pieces

87. Loose or missing pieces

88. Loose or missing pieces

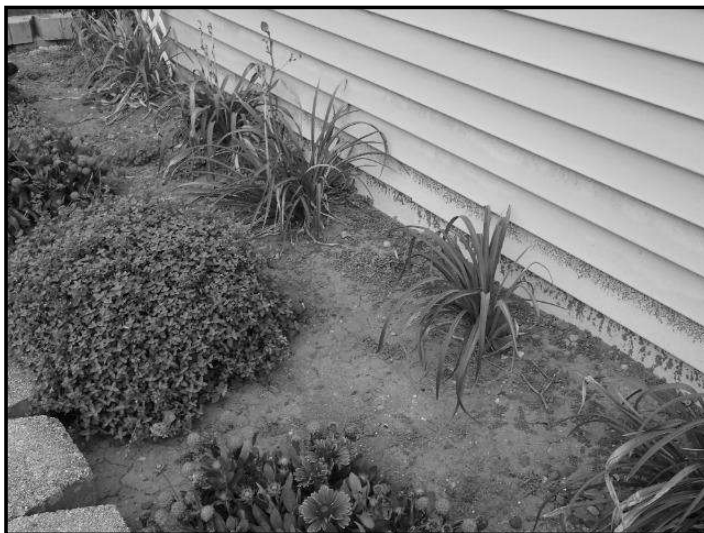
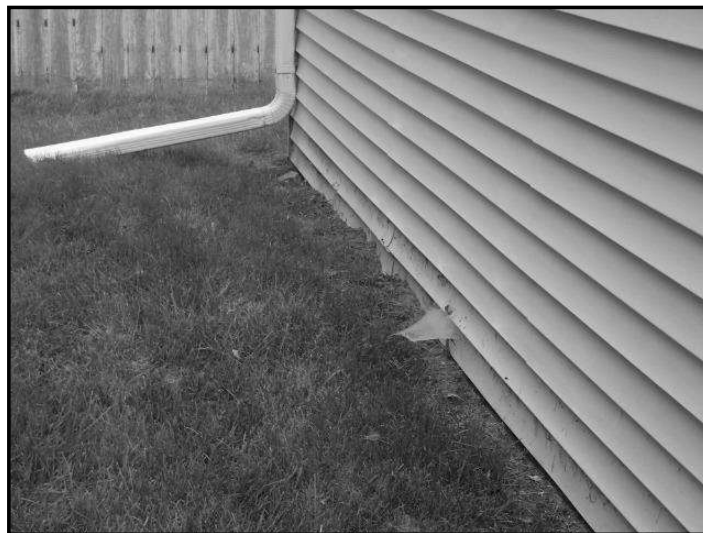
10. Condition: • Too close to grade

There are a few places around the exterior of the home where the ground comes too close to the siding. This small distance or contact makes it easier for insects, moisture and rodents to enter the home. 4 to 6 inches of foundation exposure is normal.

89. Too close to grade

90. Too close to grade

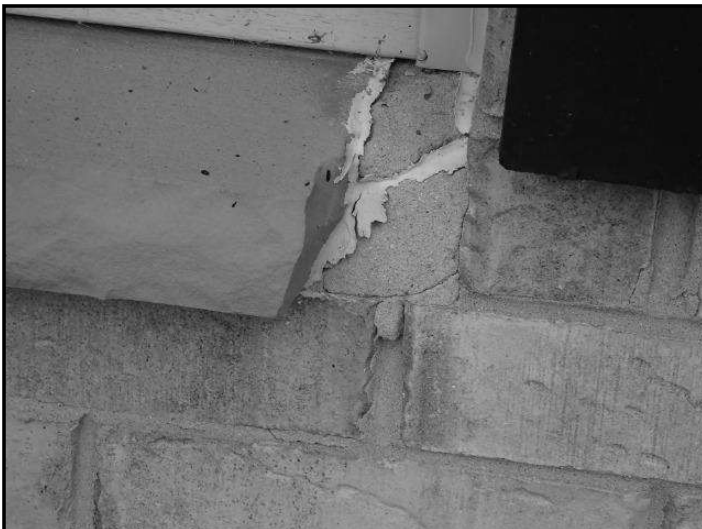
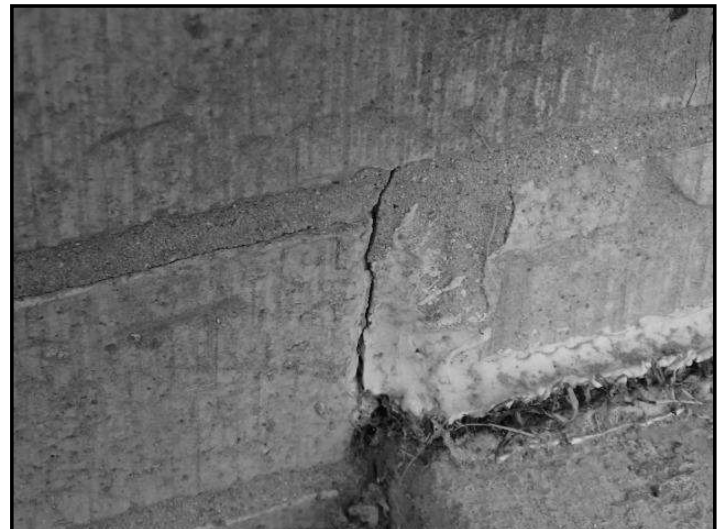
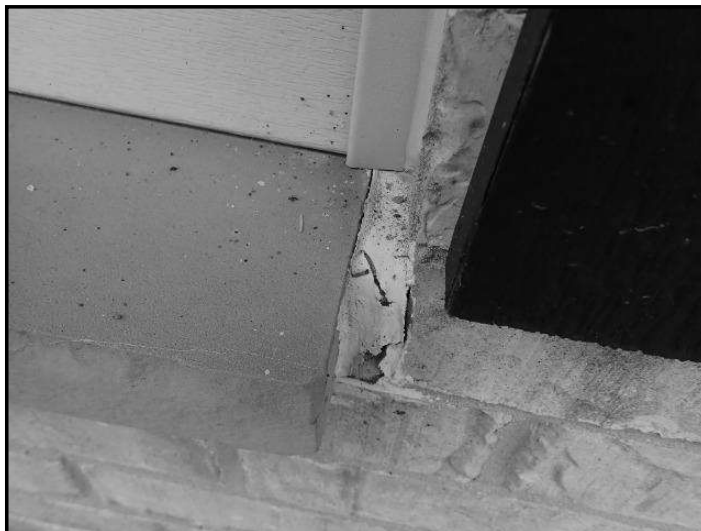
11. Condition: • Mortar deterioration

There are a few areas where the mortar/masonry needs to be repaired on the exterior of the building. Tuck pointing is the most common repair needed. Caulking/spray foam is not a proper masonry repair material. Some masonry flashing details also need to be added/improved to prevent moisture intrusion.

91. Mortar deterioration

92. Mortar deterioration

93. Mortar deterioration

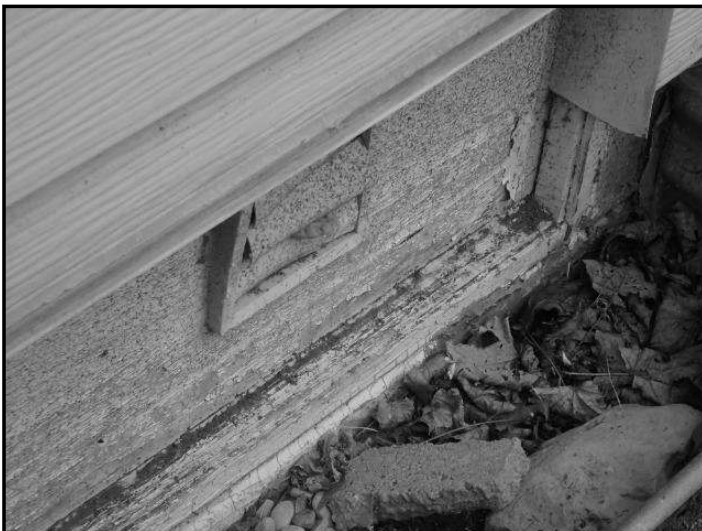
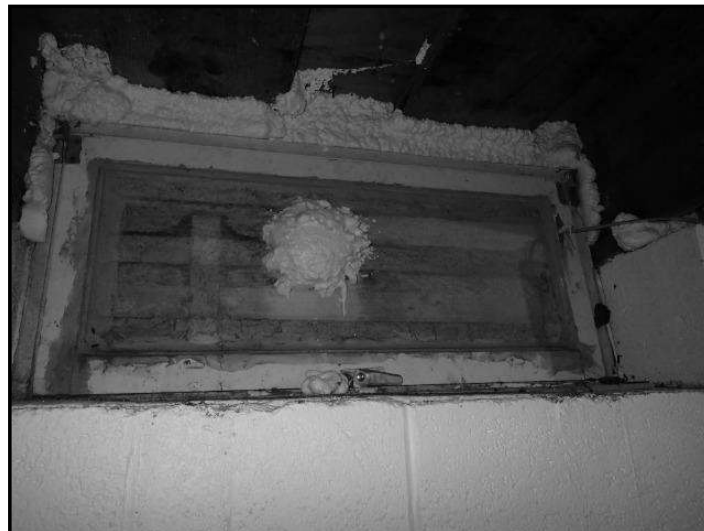
12. Condition: • Missing

There is a basement window that is damaged and needs to be repaired/replaced.

94. Missing

95. Missing

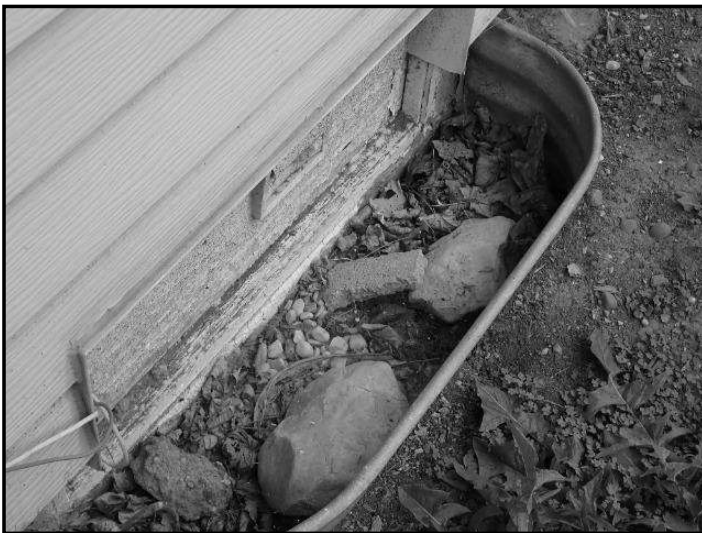
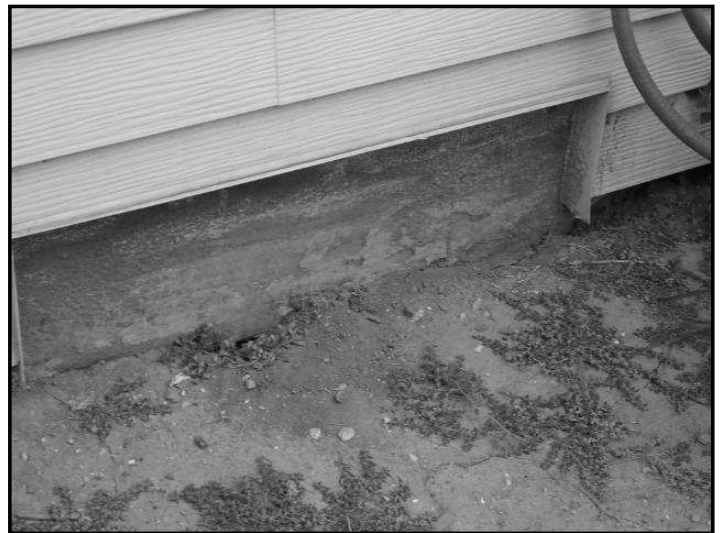
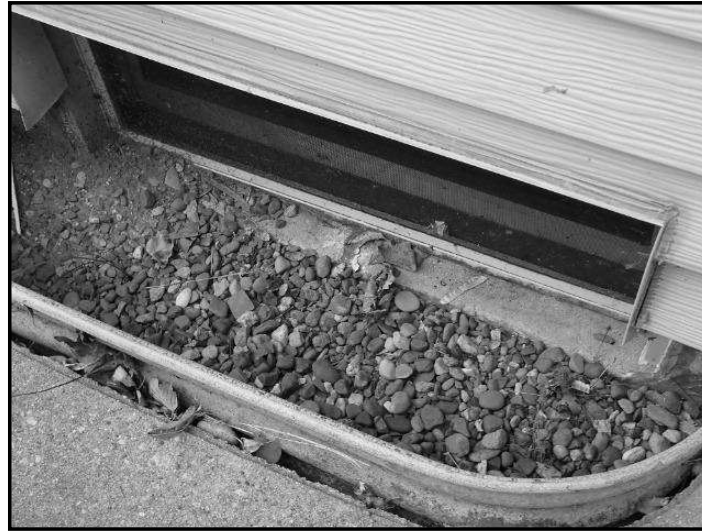
13. Condition: • Less than 6 inches below window

The gravel/drainage at the bottom should be 6" below the window and the wall of the well should be continuous to 3" above the soil level.

96. Less than 6 inches below window

97. Less than 6 inches below window

98. Less than 6 inches below window

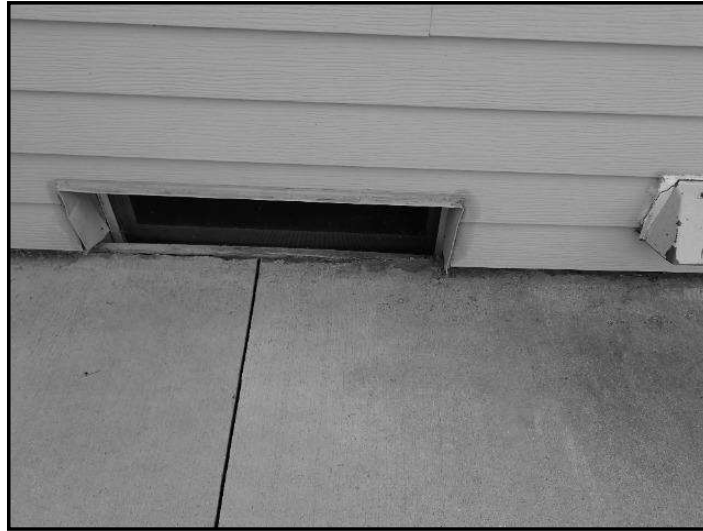
14. Condition: • Missing

There should be a properly installed window well on each of the basement windows. The drainage gravel should be 6" below the sill of the window and the top lip should be 3" or more above the grade.

99. Missing

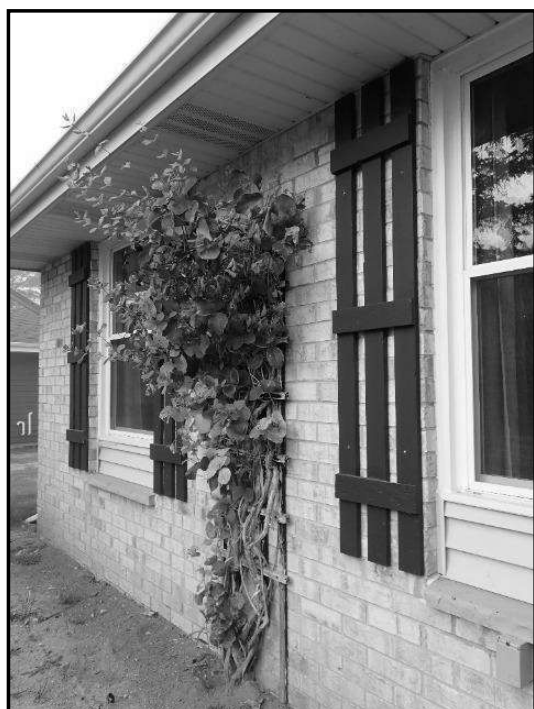
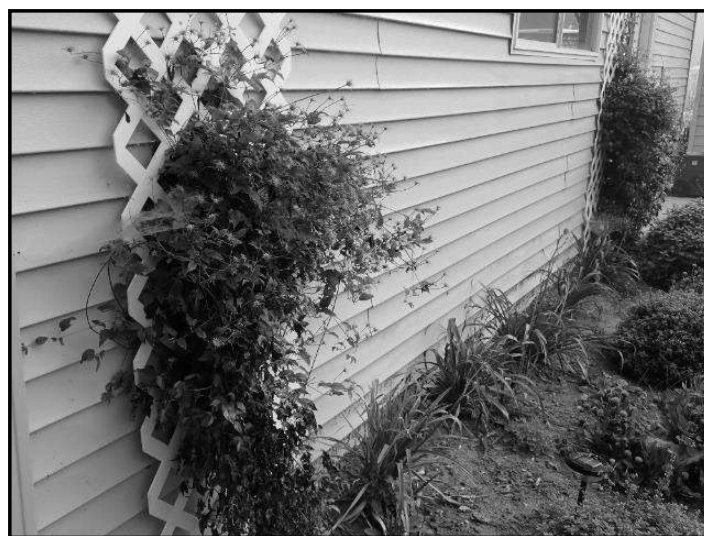
15. Condition: • Trees or shrubs too close to building

All foliage should be trimmed back at least 6" from the building materials and all trees should be trimmed back 3 feet from the structure. A few of the trees/shrubs/vines are too close to the structure and should be removed.

100. Trees or shrubs too close to building

101. Trees or shrubs too close to building

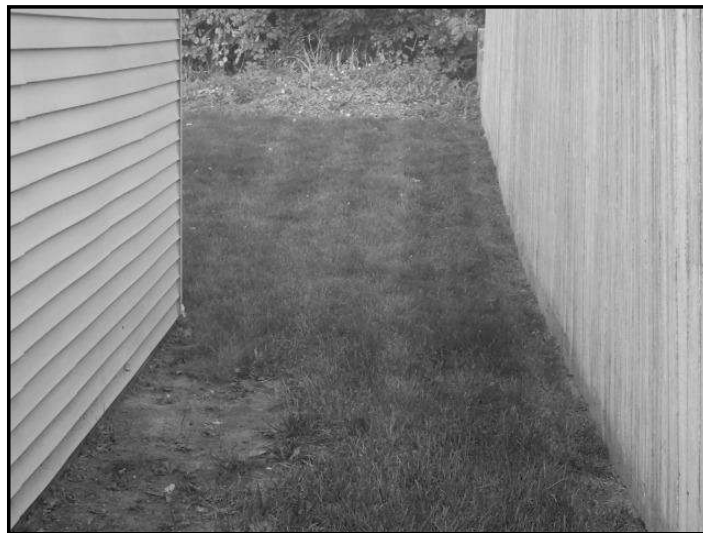
16. Condition: • Improper slope or drainage

There are a few areas where the grading needs to be improved to correctly distribute water to prevent water intrusion.

102. Improper slope or drainage

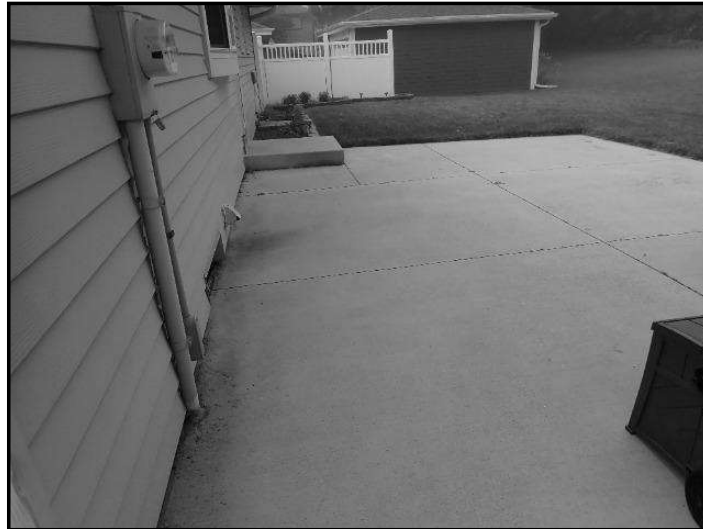
17. **Condition:** • Improper slope or drainage

DEFECT - The rear patio has a poor slope and needs to be corrected to move water away from the home not towards it.

103. Improper slope or drainage

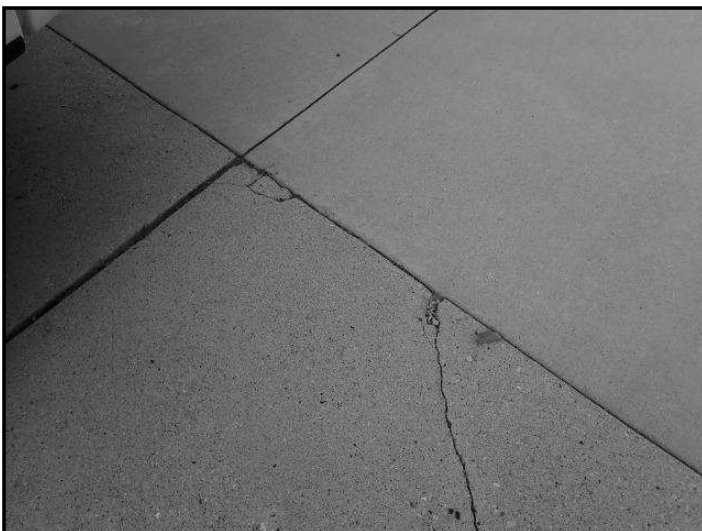
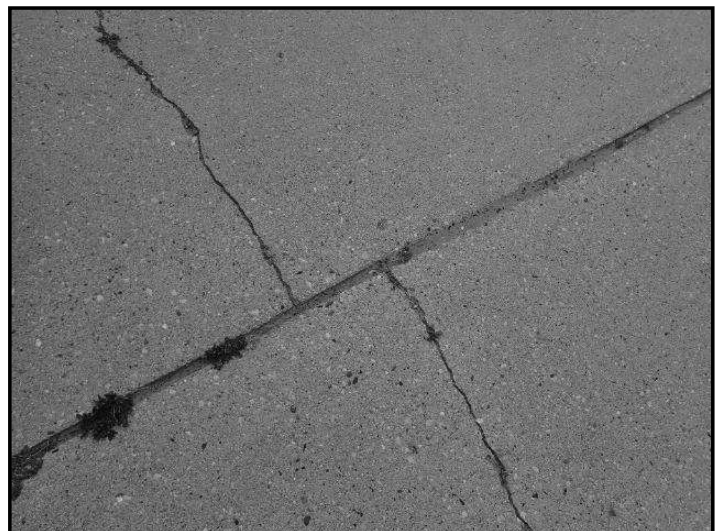
18. Condition: • Cracked or damaged surfaces

The driveway is cracked and needs to be repaired/replaced. The driveway damage does not appear to be a major function issue.

104. Cracked or damaged surfaces

105. Cracked or damaged surfaces

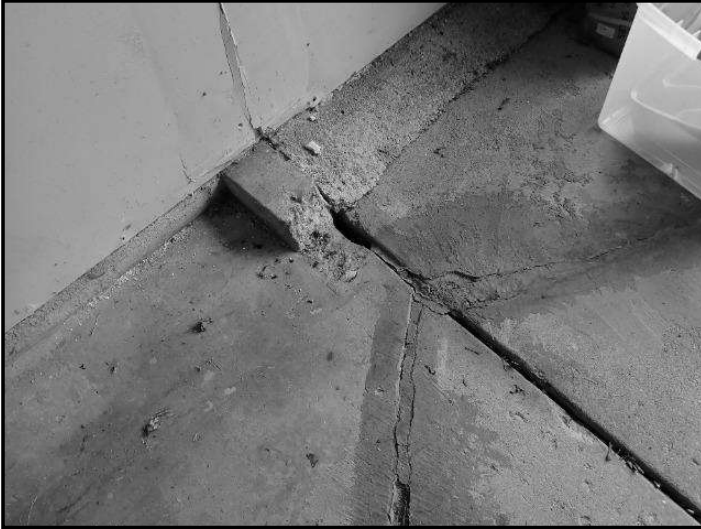
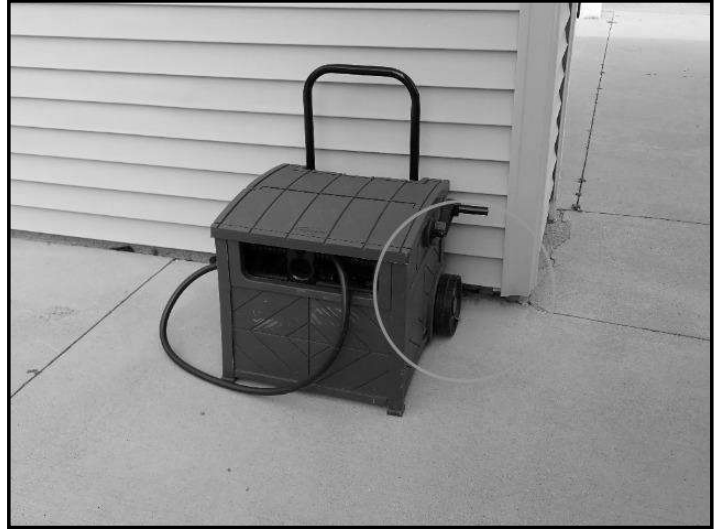
19. Condition: • The garage foundation was added onto at some point is damaged at the point of the additional section.

The foundation should be repaired to ensure long-term structural stability.

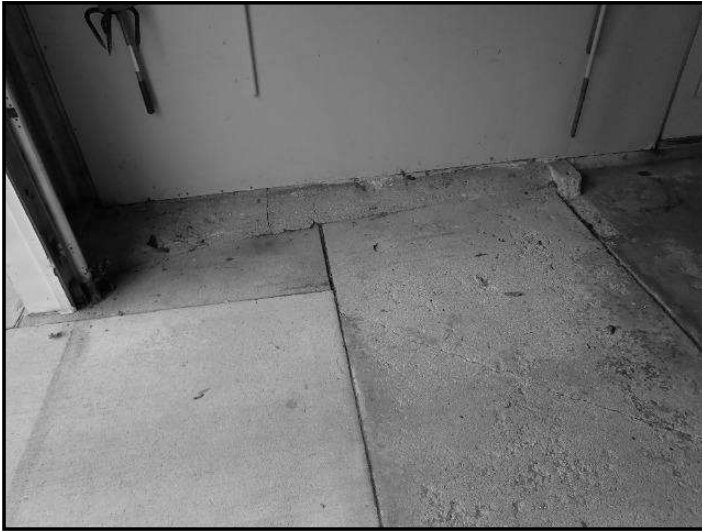
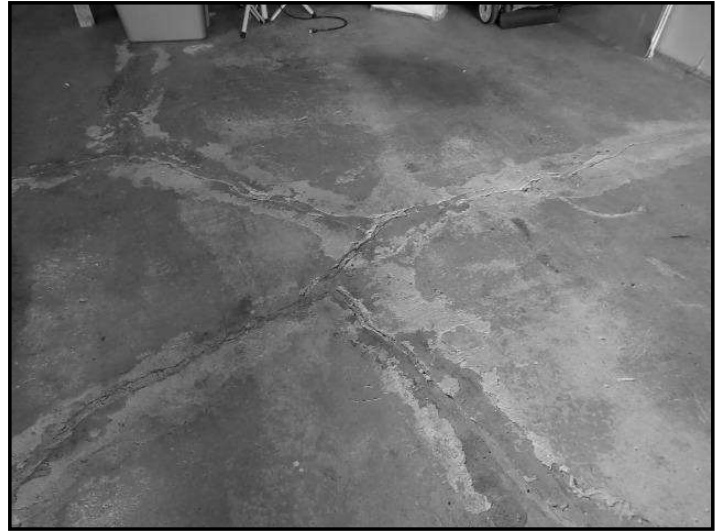
20. Condition: • Cracked

The garage floor has some cracking and salt damage that should be cleaned and sealed with a penetrating concrete sealer to prevent further damage from occurring. The sealant will at least slow or prevent further damage.

109. Cracked

110. Cracked

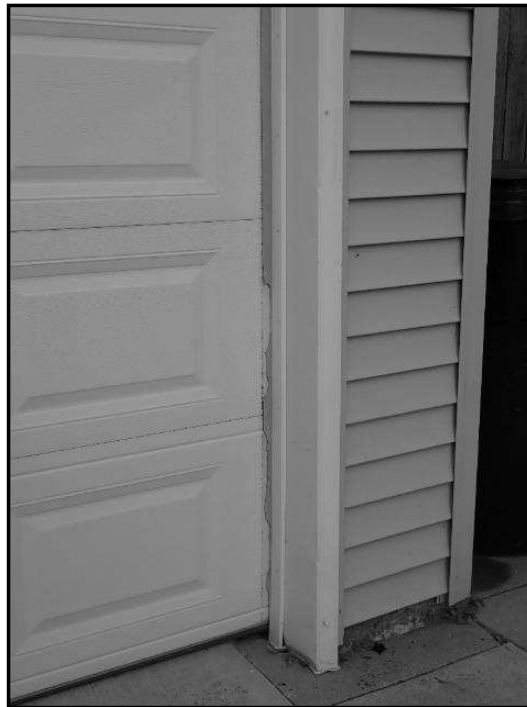
21. Condition: • Weatherstripping damaged or missing.

The weather stripping at the garage needs to be improved/replaced.

111. Weatherstripping damaged or missing.

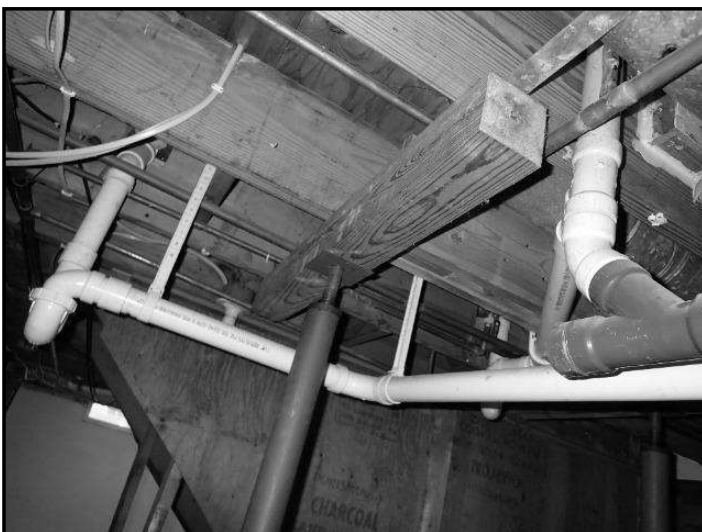
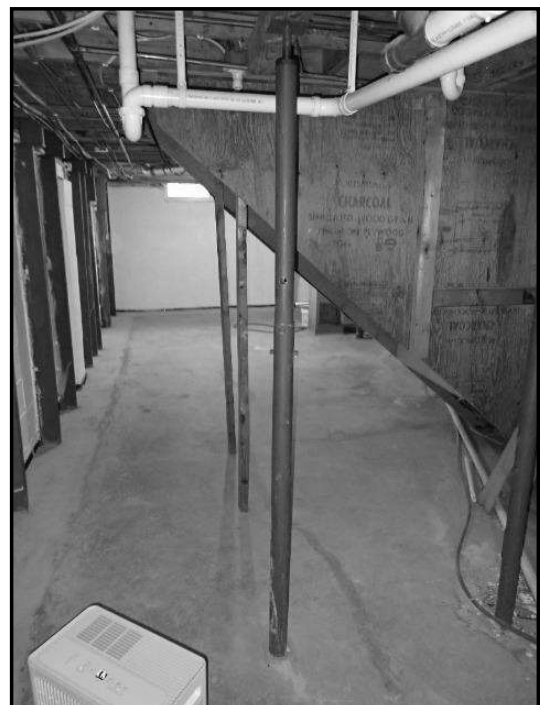
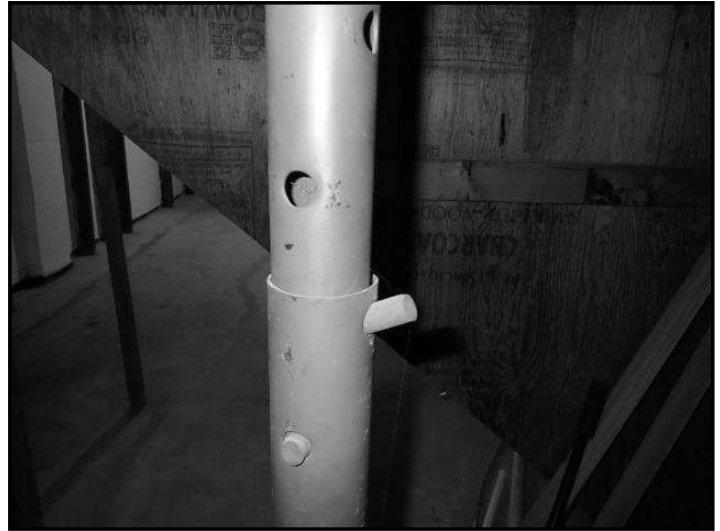
22. Condition: • Poorly secured at top or bottom

DEFECT - The temporary supports used in the basement are not proper permanent structural columns and need to be improved/corrected. There also needs to be a proper footing under each. The columns also need to be secured at the top and bottom.

126. Poorly secured at top or bottom

127. Poorly secured at top or bottom

129. Poorly secured at top or bottom

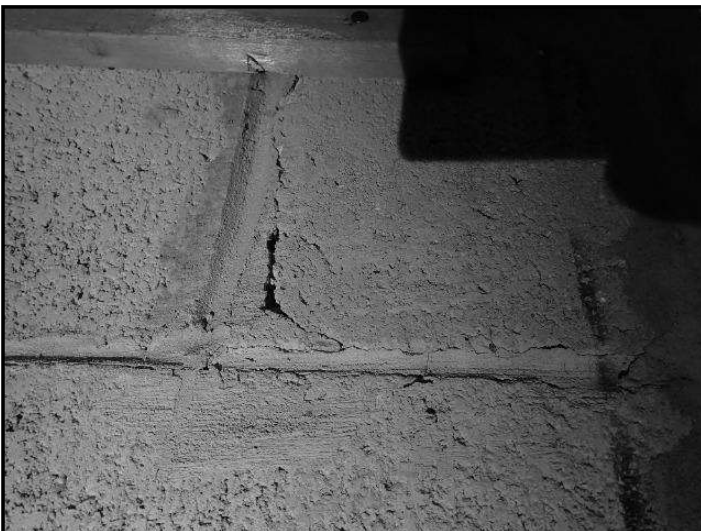
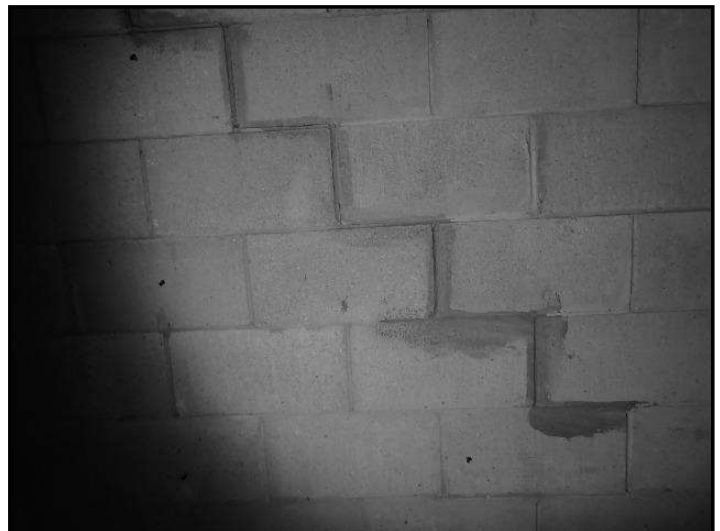
23. Condition: • Cracked

The foundation has some cracking/damage that will need to be monitored/repared.

130. Cracked

131. Cracked

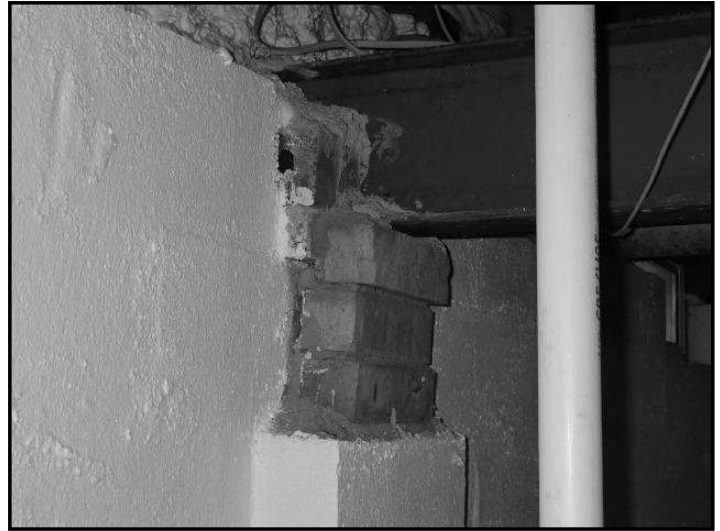
24. Condition: • Bowed, bulging or leaning

DEFECT- The foundation walls of the home should be evaluated as there was horizontal/vertical cracking and the walls were out of plumb by greater than 1/2". The foundation and drain tile should be evaluated by a foundation specialist or structural engineer to determine proper repairs that are necessary.

133. Bowed, bulging or leaning

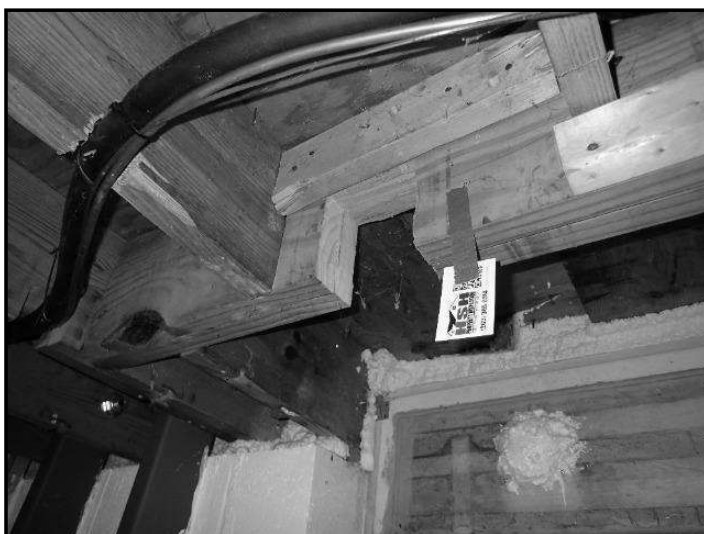
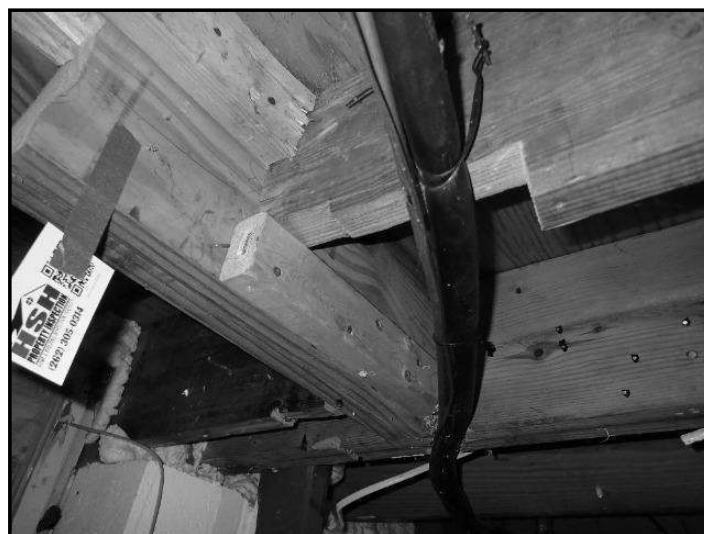
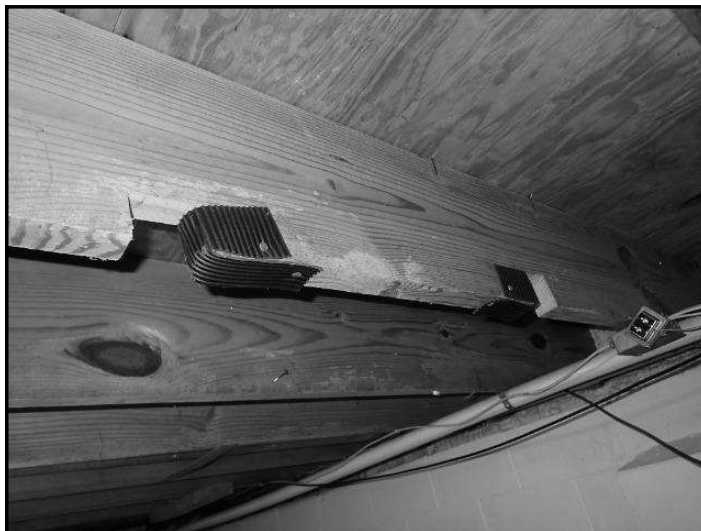
25. Condition: • Notches or holes

DEFECT - There are some damaged joists in the basement that need to be repaired/replaced.

135. Notches or holes

136. Notches or holes

137. Notches or holes

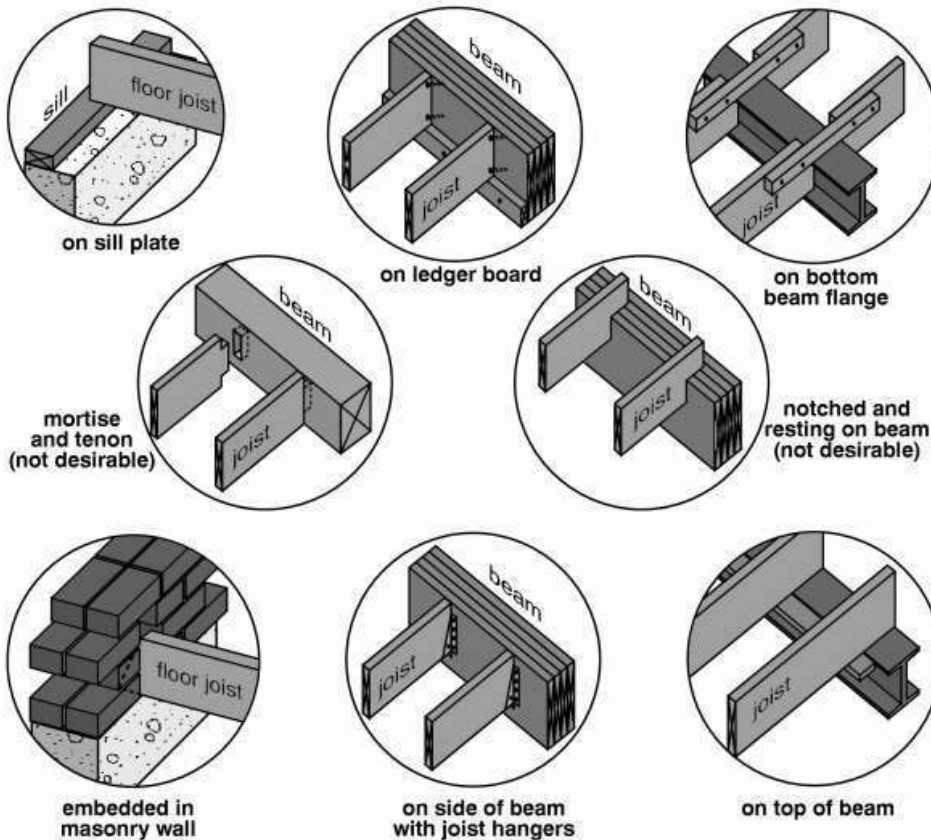
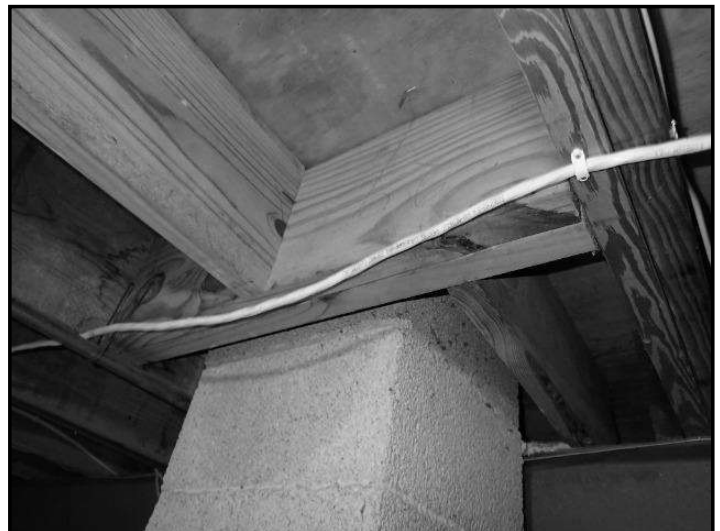
26. Condition: • Poor end bearing, joist hanger connections

There are a few areas where joist hangers and brackets need to be added to the joists to ensure the structural stability in the area.

138. Poor end bearing, joist hanger connections

139. Poor end bearing, joist hanger connections
