STRUCTURE

117 Judge Dr, Saukville, WI September 12, 2025

Report No. 7402

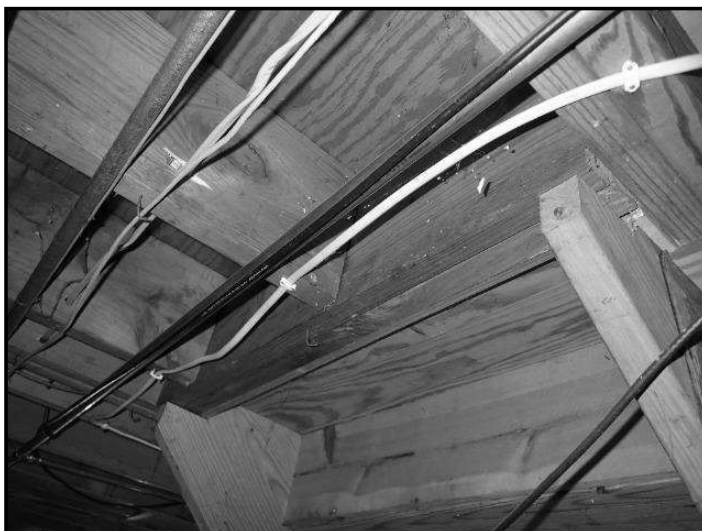
138. Poor end bearing, joist hanger connections

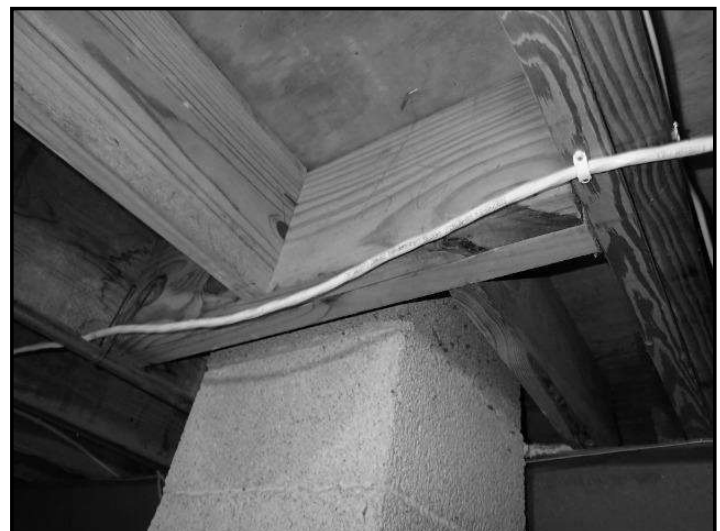
139. Poor end bearing, joist hanger connections

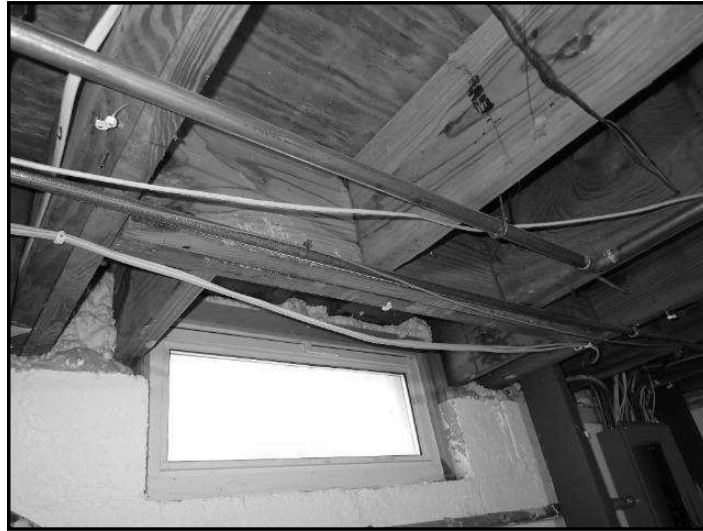
140. Poor end bearing, joist hanger connections

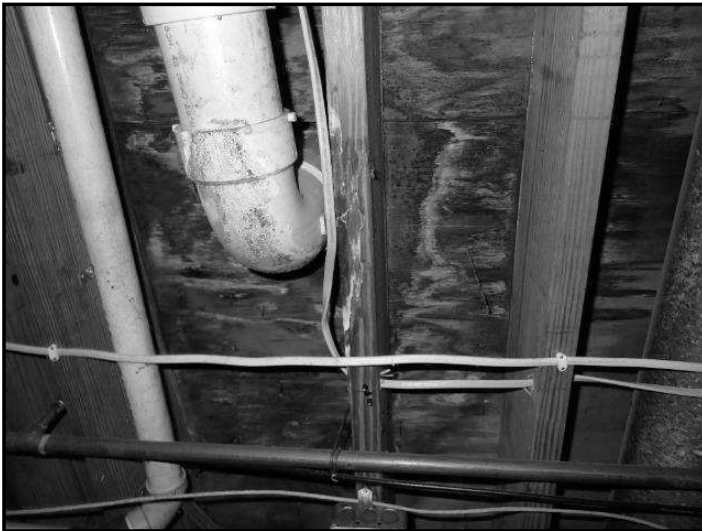
27. Condition: • Water stains

There is some water damage in the floor sheathing from prior water leaks that needs to be repaired/replaced. the area was dry at the time of the inspection.

141. Water stains

Task: Repair Improve Correct

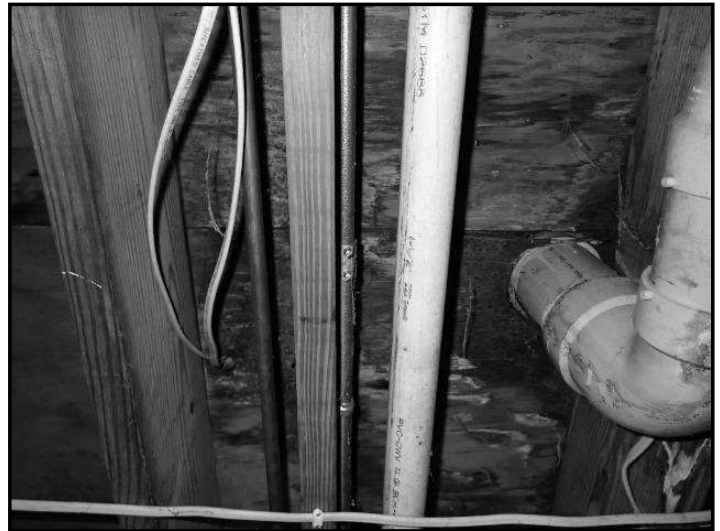
142. Water stains

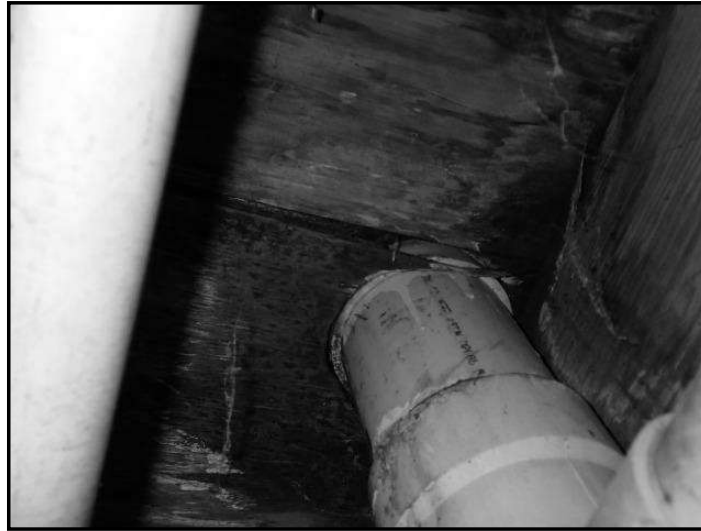
143. Water stains

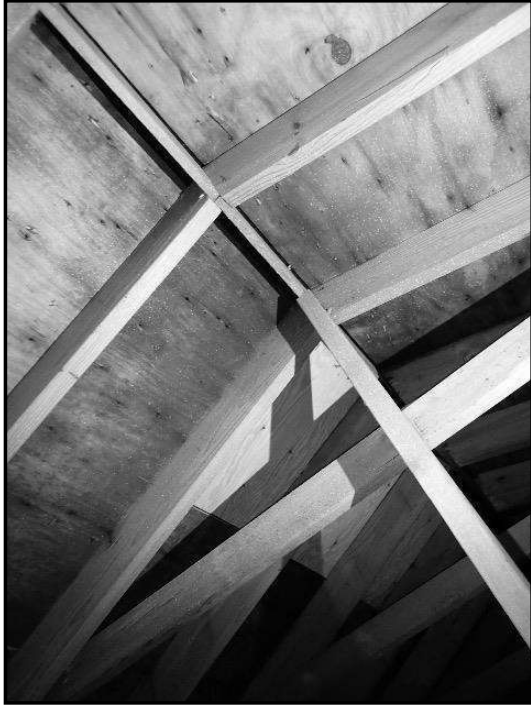
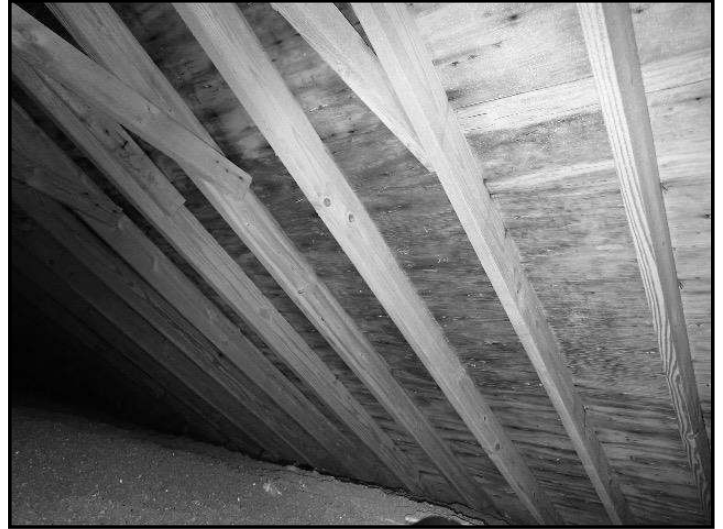
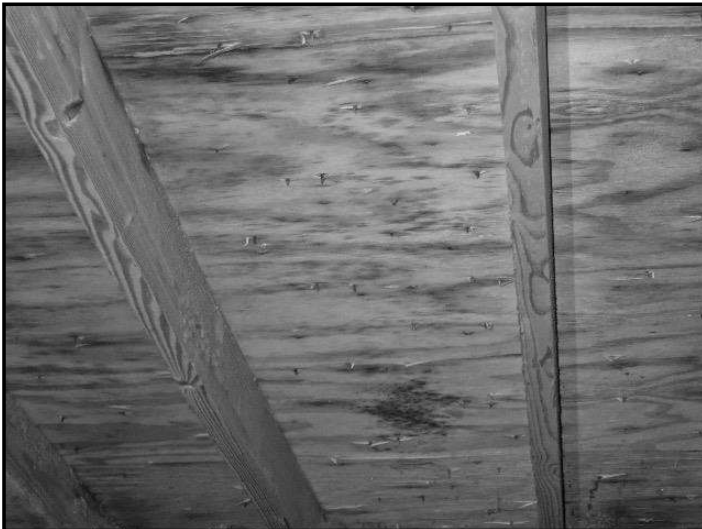
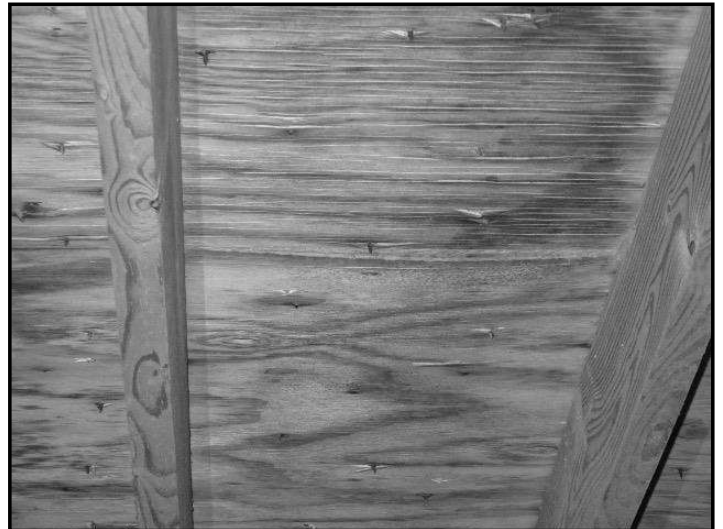
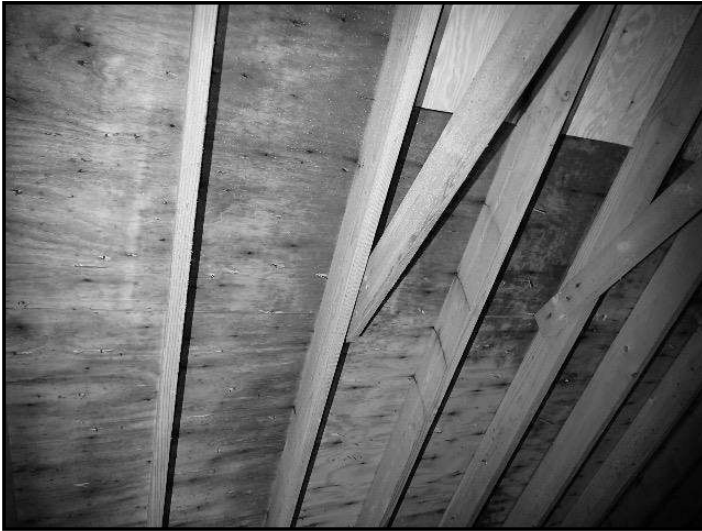
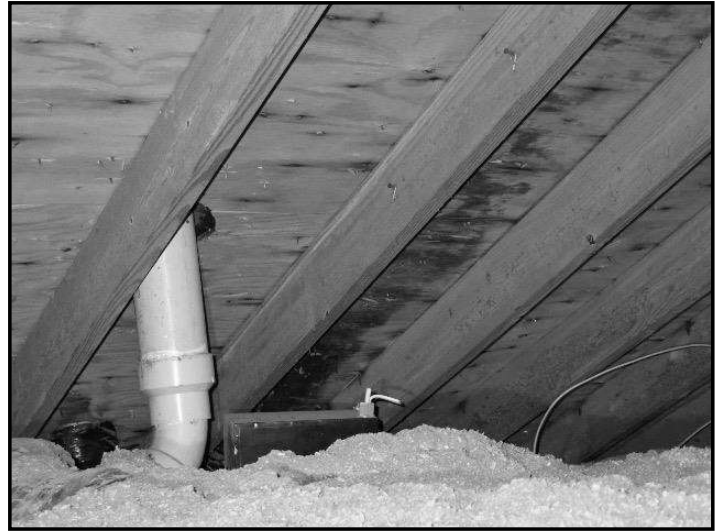
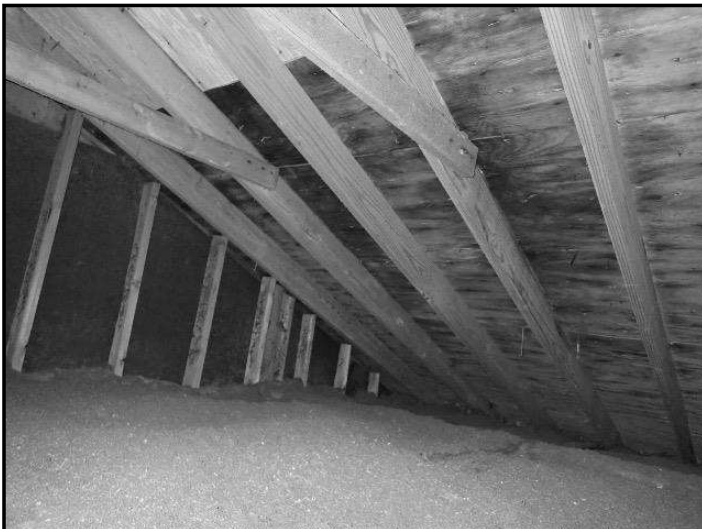
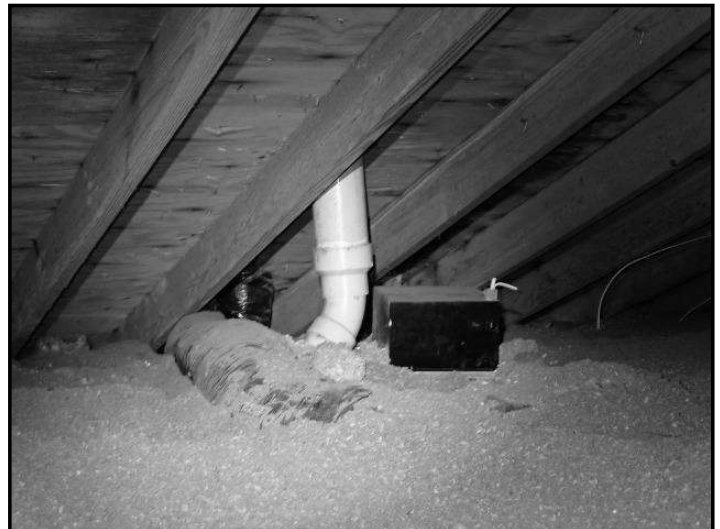
28. Condition: • Mold

DEFECT - There is some fungal/bacterial growth in the attic, this should be evaluated/tested by a specialist to confirm, identify the cause, and be mitigated properly so it doesn't continue to spread or pose a risk to the residents. Further repairs to the attic as a part of this process may be necessary to ensure the condition doesn't return. Things to look at will be ventilation and air sealing as well as the bathroom vents. The area was not tested and samples were not taken at the time of the inspection.

Implication(s): Weakened structure | Chance of structural movement

Task: Further evaluation Improve Correct

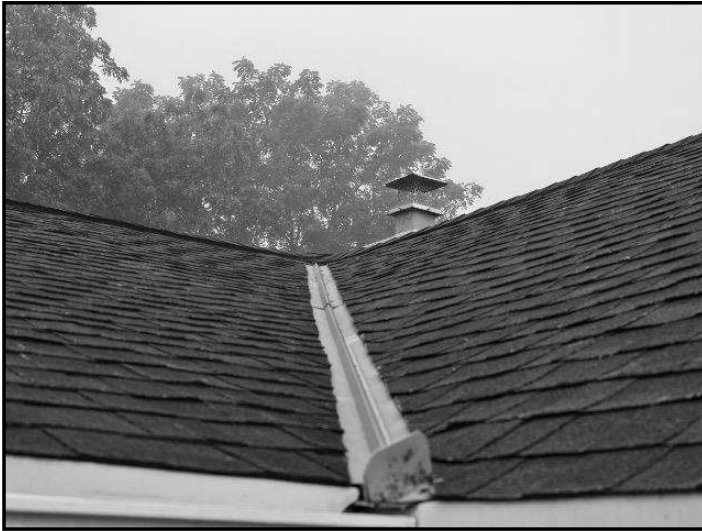
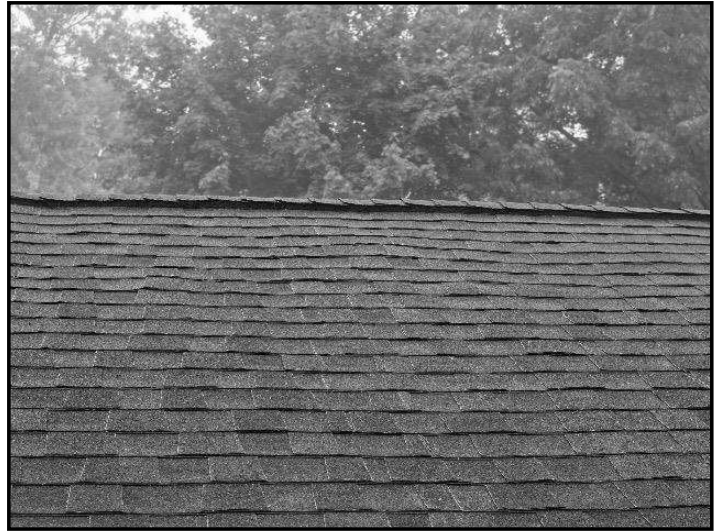
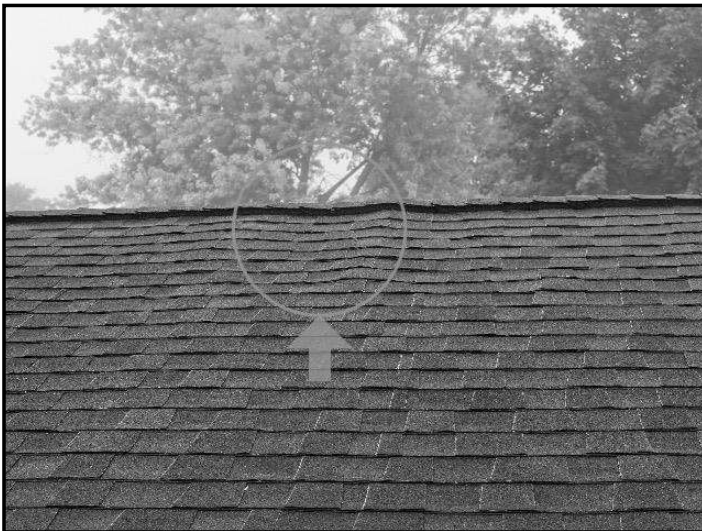
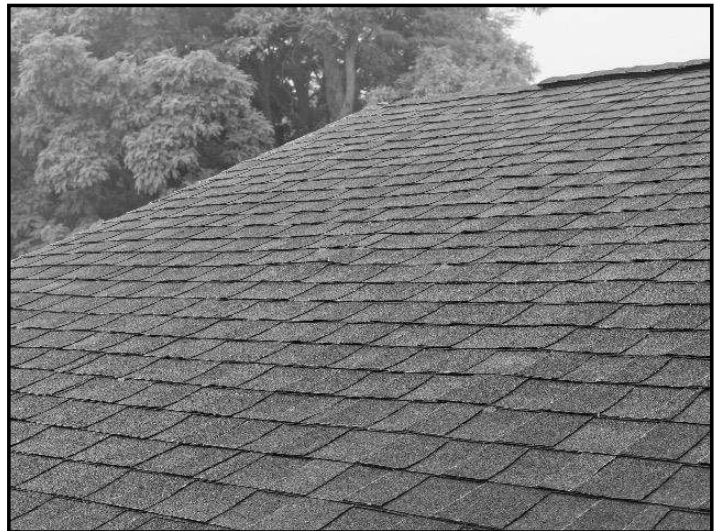
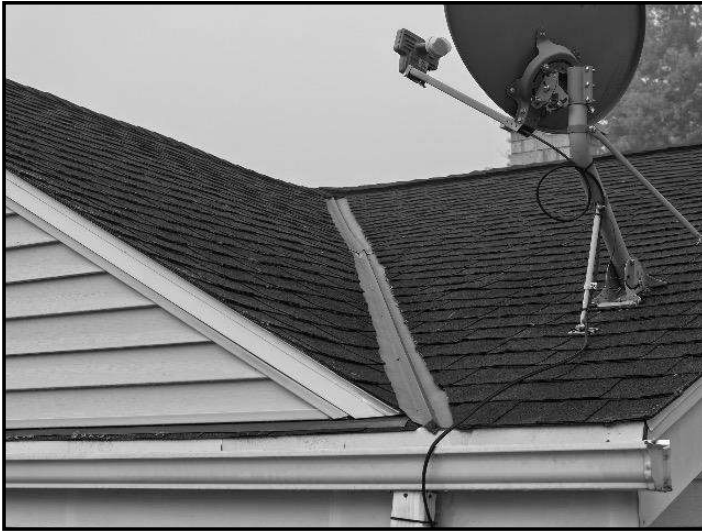
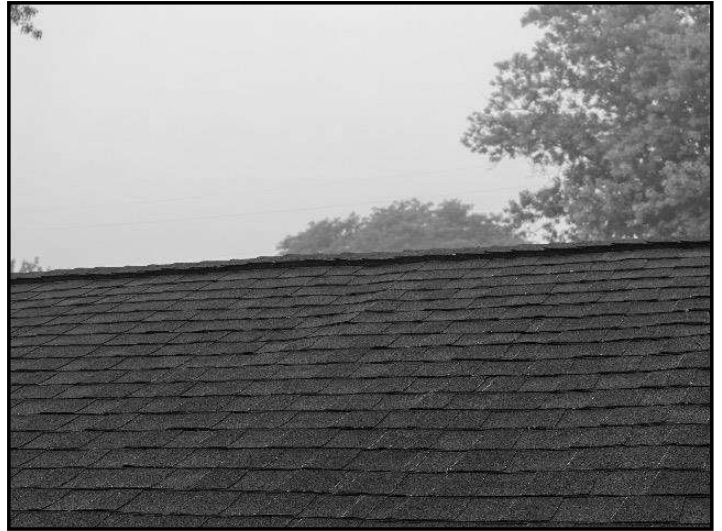
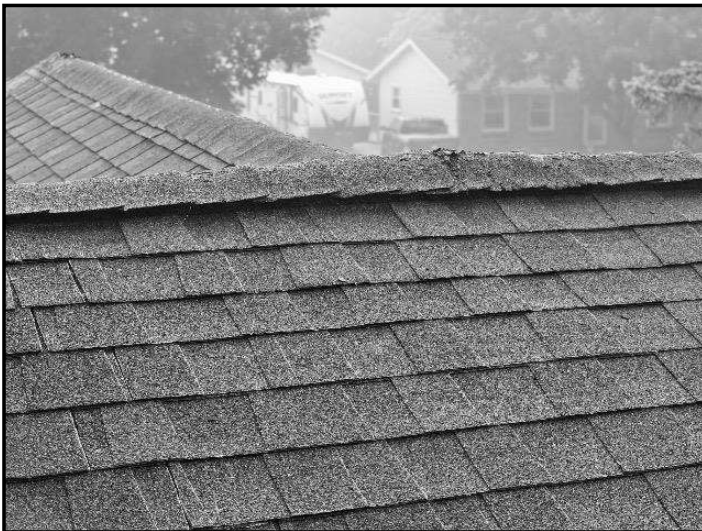
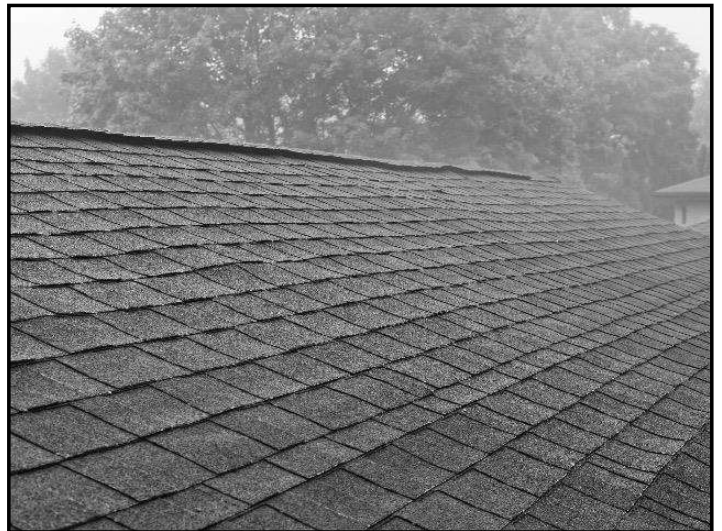
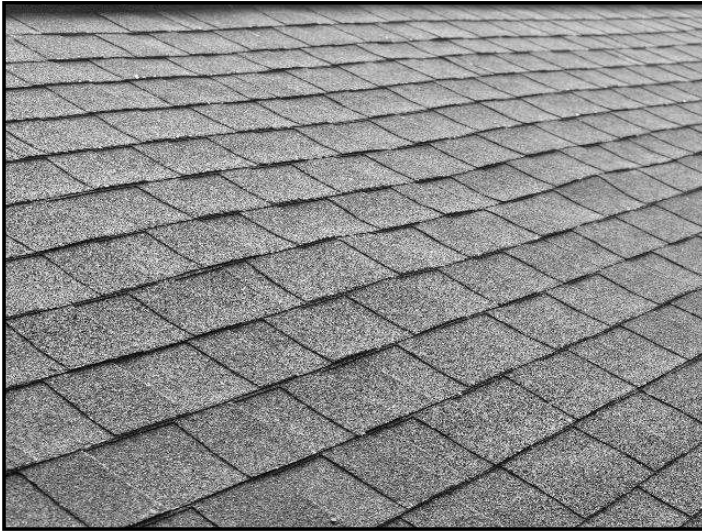
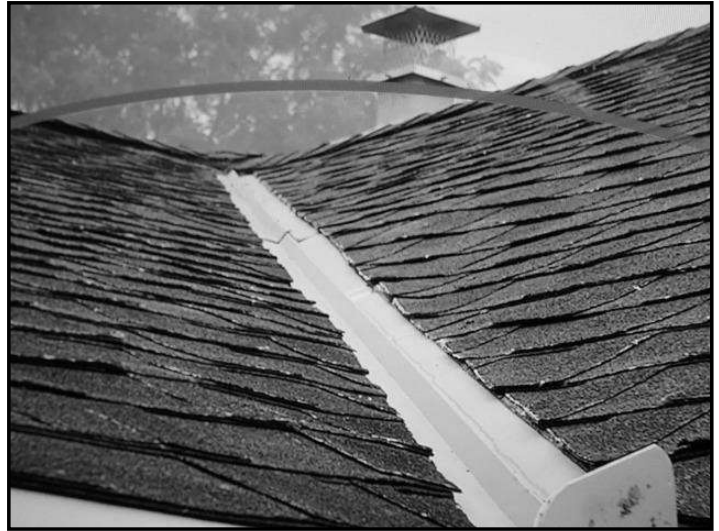
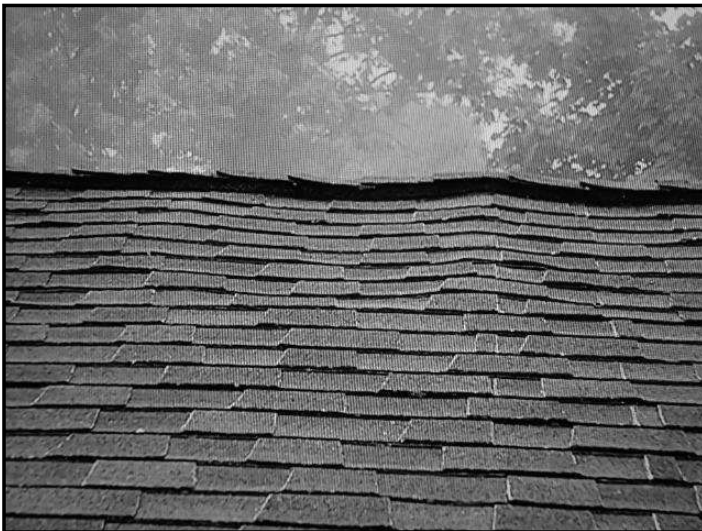
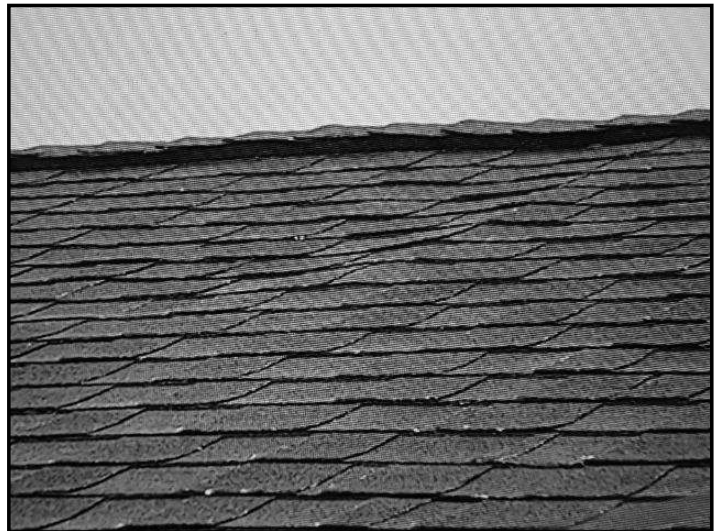
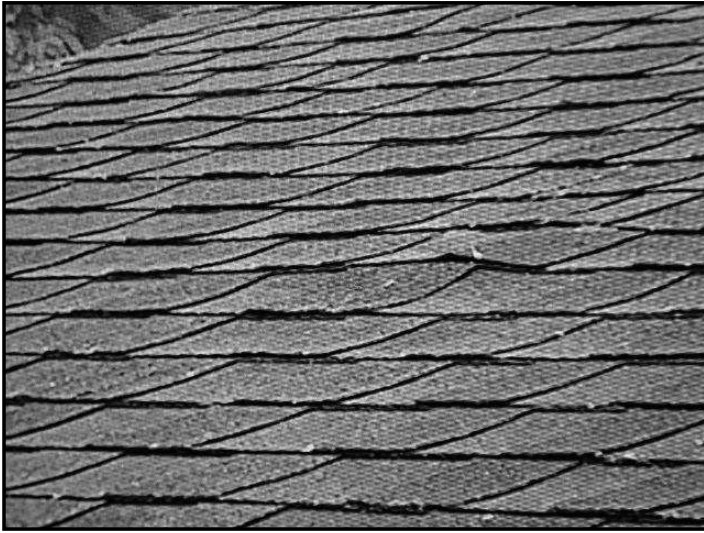
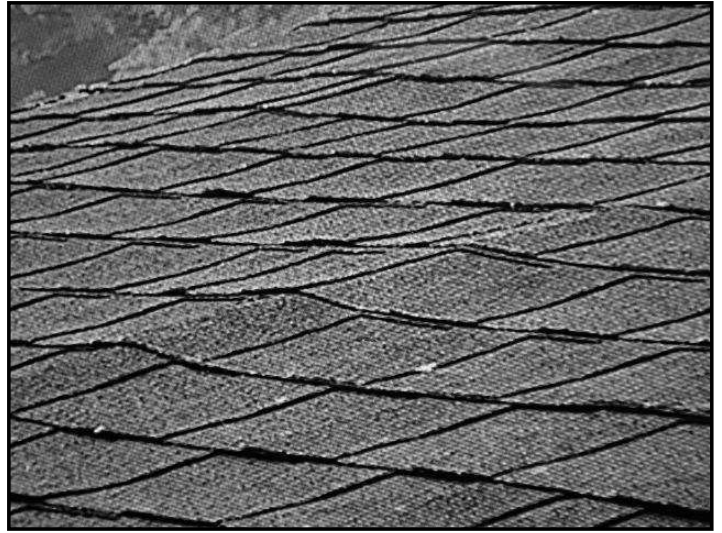
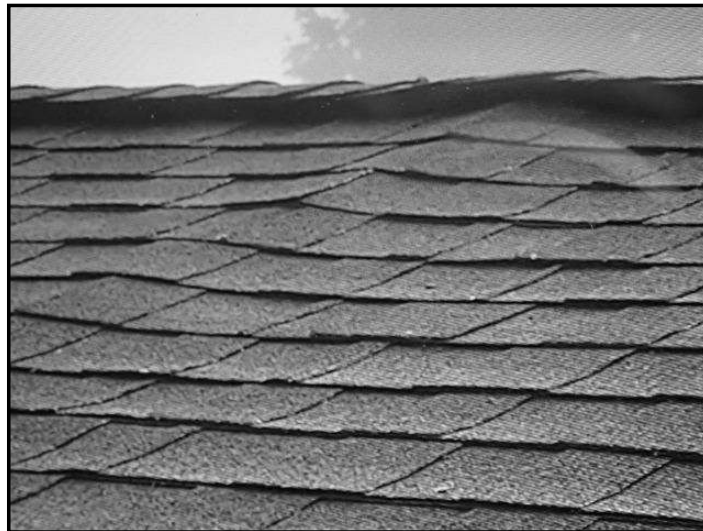
29. Condition: • Sagging

DEFECT - There are a number of areas showing warped and water damaged sheathing that needs to be replaced. Walking/standing on the roof could be very dangerous.

Implication(s): Weakened structure | Chance of structural movement

Task: Repair or replace Further evaluation Improve Correct

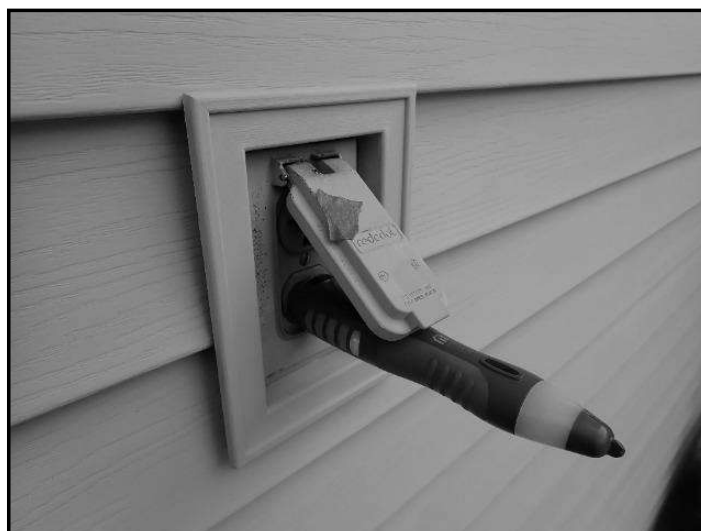
DISTRIBUTION SYSTEM \ Outlets (receptacles)**30. Condition:** • GFCI/GFI needed (Ground Fault Circuit Interrupter)

There should be a properly installed and grounded GFCI receptacle within 6ft of all water sources. (Especially at kitchens, bathrooms, and laundry areas). The kitchens, bathrooms, exterior, and laundry area are of the greatest concern.

179. *GFCI/GFI needed (Ground Fault Circuit...*

Task: Improve Correct

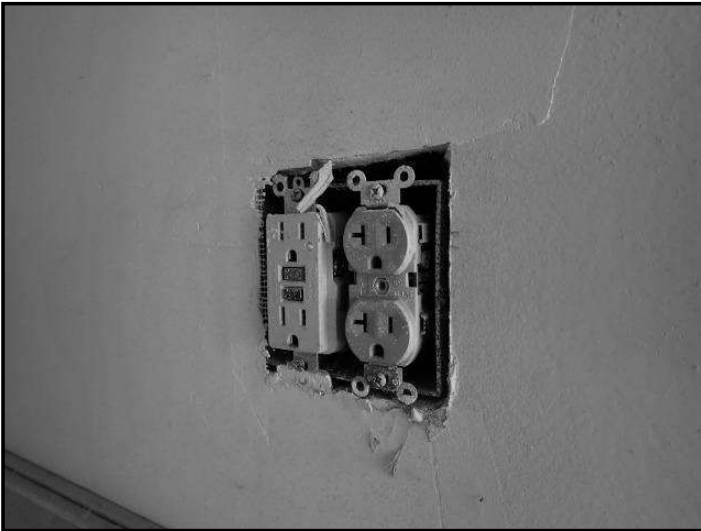
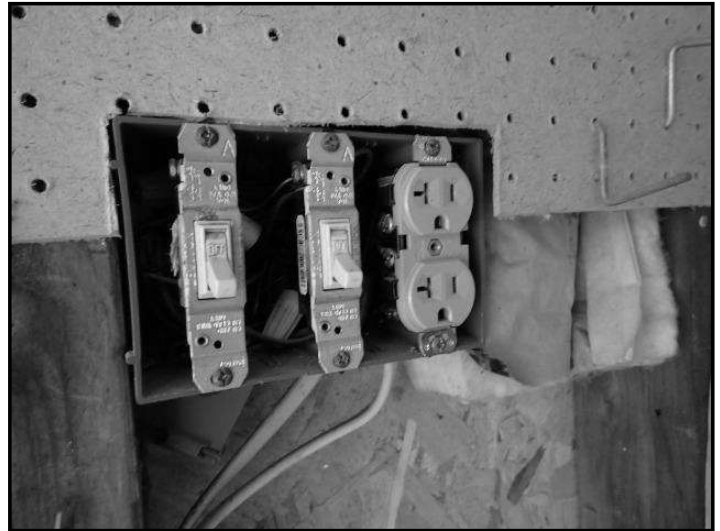
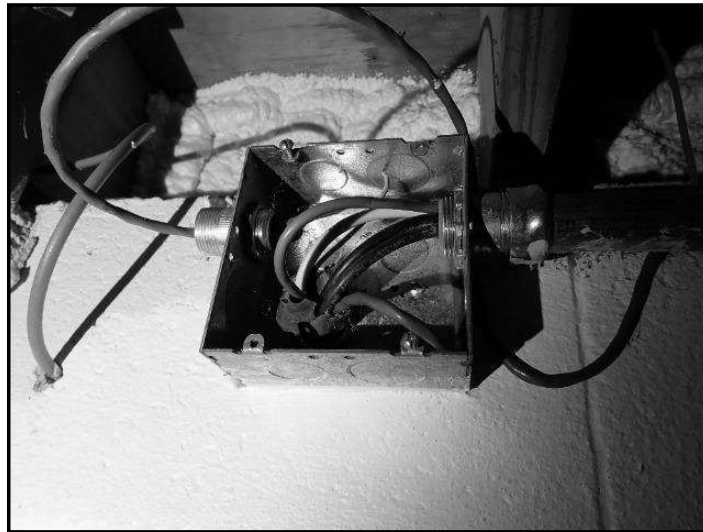
31. Condition: • Missing

There are various areas where the cover plates are missing that should be provided. Any others found should be replaced as well.

Task: Provide Improve Correct

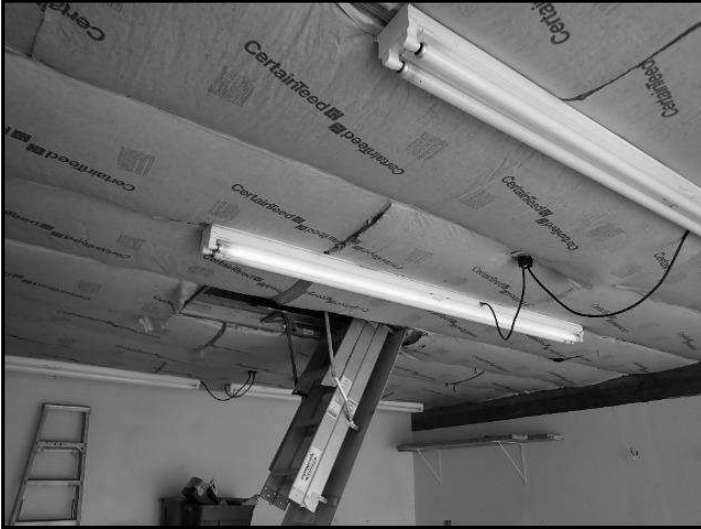
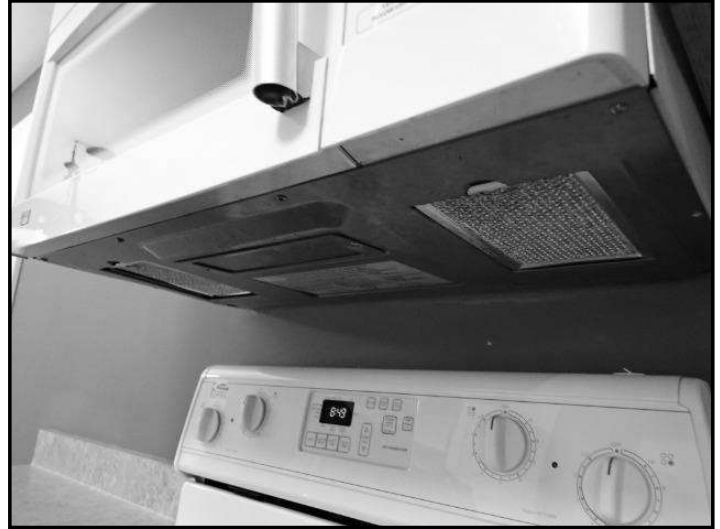
32. Condition: • Inoperative

There are a few lights that were inoperative at the time of the inspection and may just need bulbs.

Task: Repair or replace Improve Correct

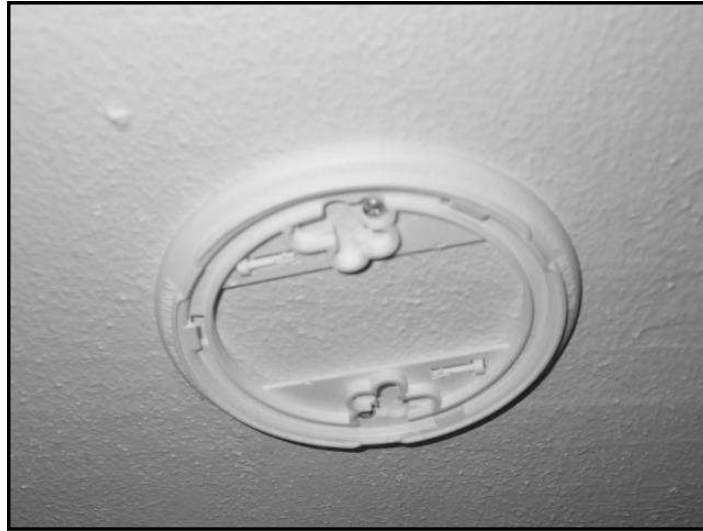
33. Condition: • Missing

DEFECT - There should be a functioning smoke and carbon monoxide detector on each floor. They should be checked once a month and replaced every 8-10 years. Some of the areas of the home have none or are out of date. Smoke detectors should not be placed in the kitchen area.

185. *Missing*

Task: Provide Improve Correct

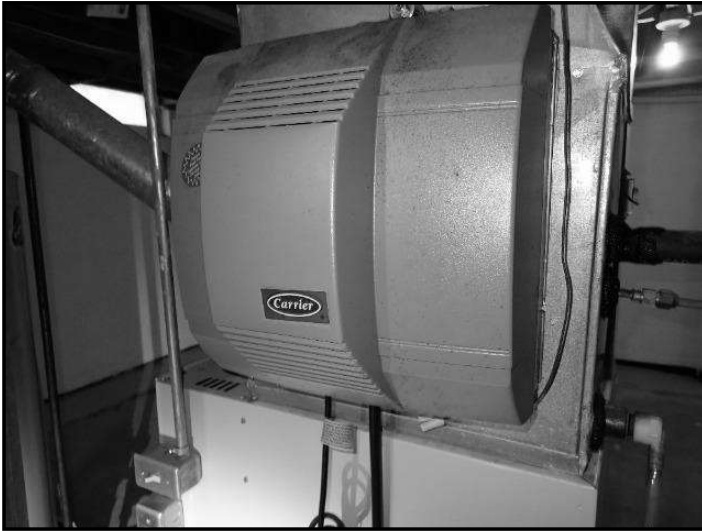
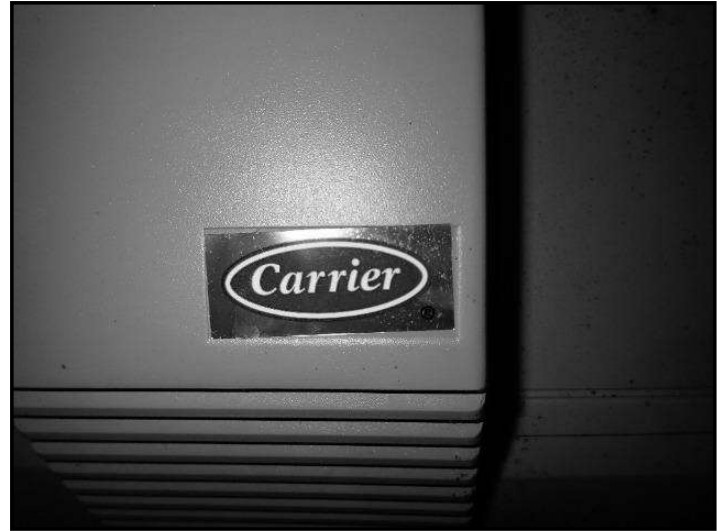
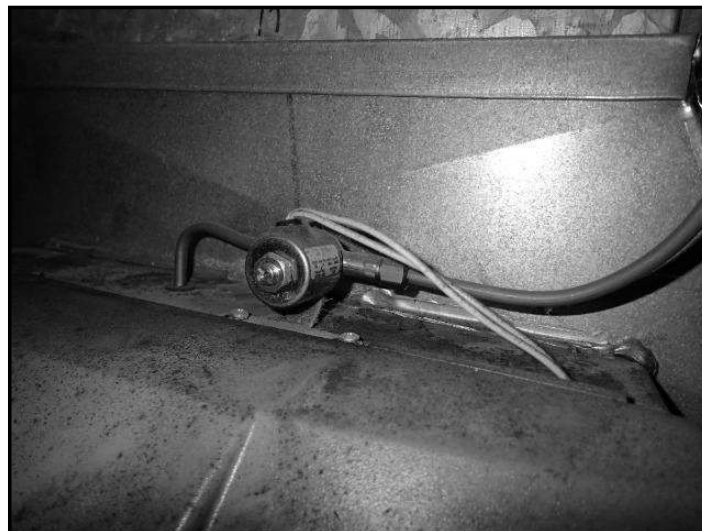
- 34. Condition:** • Inoperative motor or solenoid valve

The humidification system was not functional at the time of the inspection and the most likely cause is a malfunctioning solenoid valve.

Task: Further evaluation Improve Correct

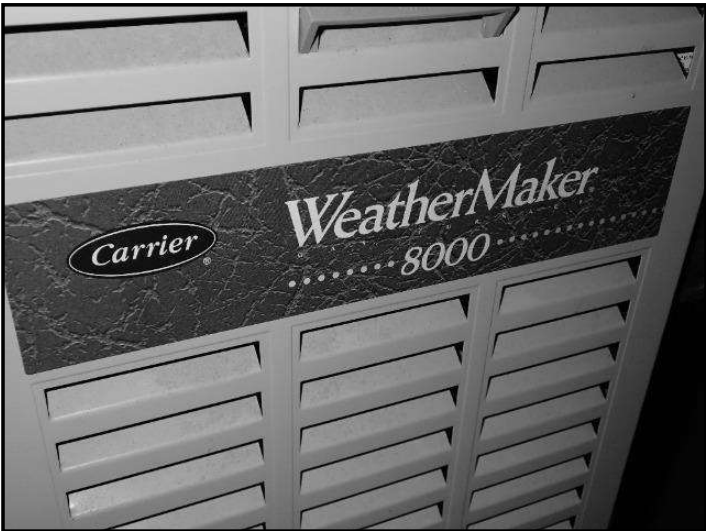
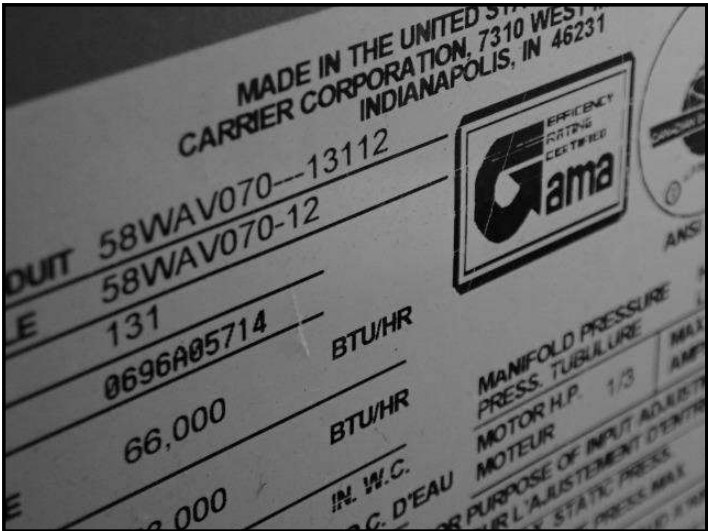
35. Condition: • Cracks, holes or rust

DEFECT - Further evaluation by a qualified professional HVAC technician is needed to determine the furnace viability. Carrier furnaces of this age had heat exchanger problems and there was a large recall. Given its age and condition there may be other issues discovered during this process.

Implication(s): Reduced system life expectancy | Hazardous combustion products entering home

Task: Further evaluation
