117 Judge Dr, Saukville, WI September 12, 2025

Report No. 7402

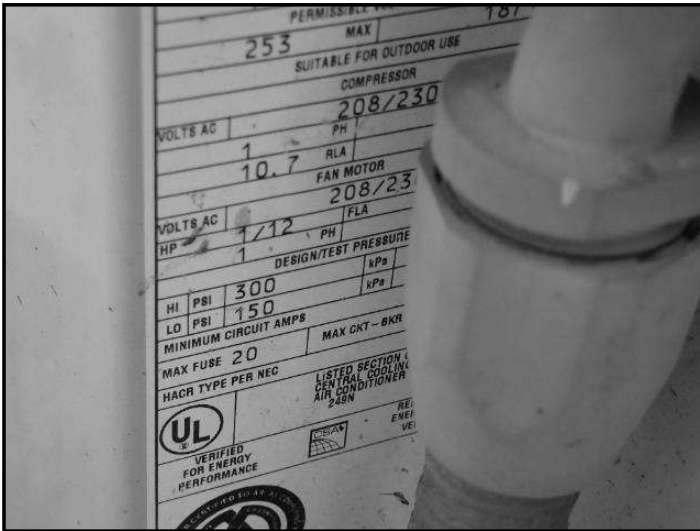
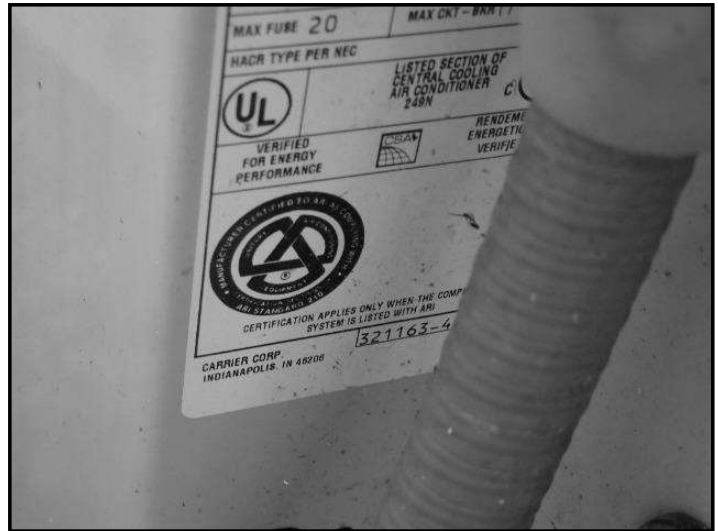
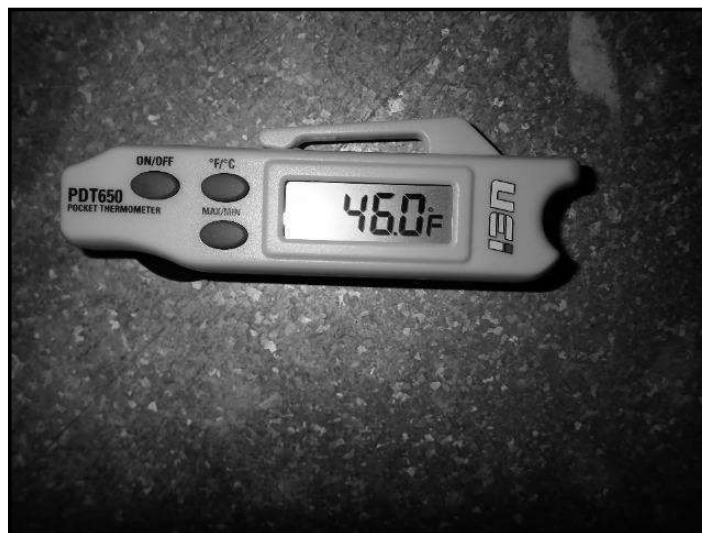
Cooling capacity: • 18,000 BTU/hr

Compressor approximate age: • 29 years

Typical life expectancy: • 12 to 15 years

Failure probability:

• High

Due to age, manufacturers listed life expectancy, and condition. The unit did operate as expected during the inspection.

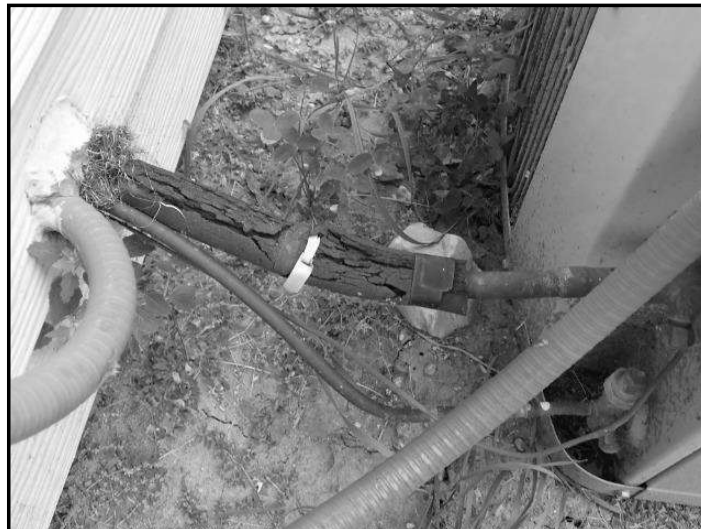
36. Condition: • Insulation - missing

The insulation on the refrigerant line to the A/C unit should be replaced. It should be continuous from the exterior unit to the furnace.

Implication(s): Reduced system life expectancy | Increased cooling costs | Reduced comfort

214. Insulation - missing

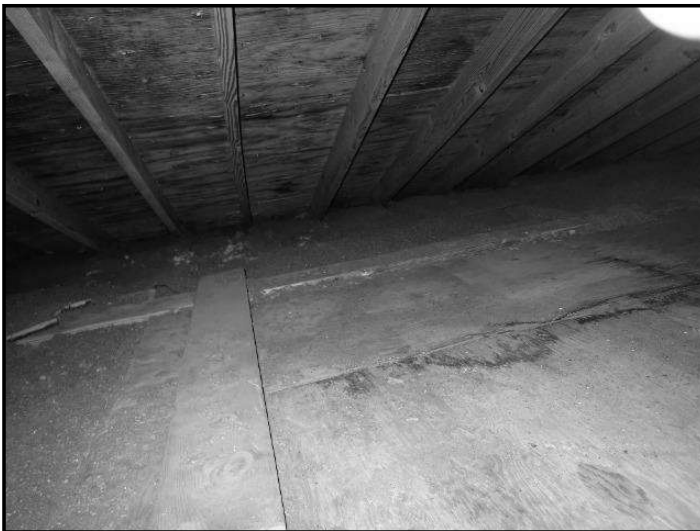
37. Condition: • Amount less than current standards

The amount of insulation in some areas of the home does not meet current minimum expectations for a house in the state of Wisconsin and should be improved to provide an R-Value rating above R-30 consistently throughout.

230. Amount less than current standards

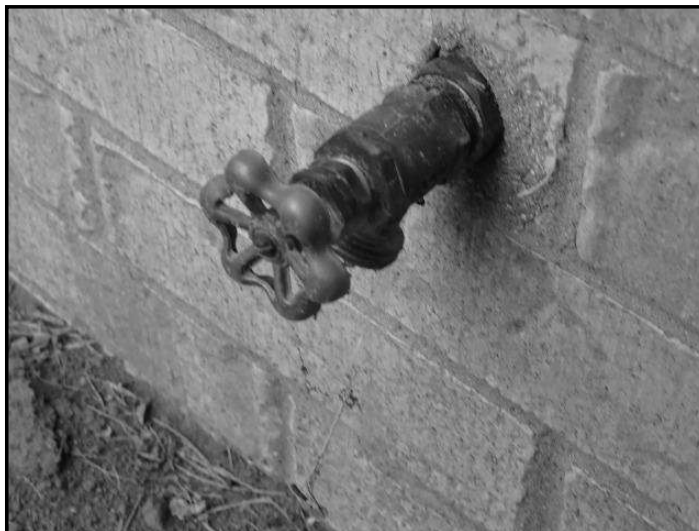
The exterior hose bib's should be upgraded to frost free Silcocks. Some were not functional at the time of the inspection and likely are just off.

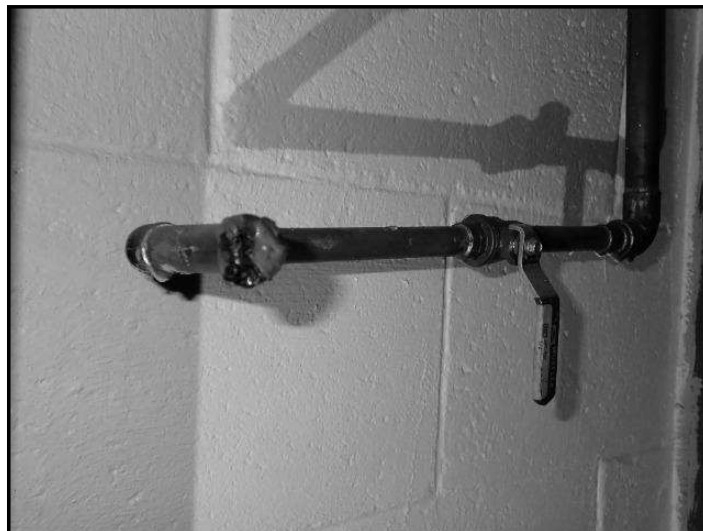
38. Condition: • Leak

There are a few leaking/corroded plumbing joints in the that need to be repaired.

Implication(s): Chance of water damage to structure, finishes and contents | System inoperative

250. Leak

Task: Repair or replace Improve Correct

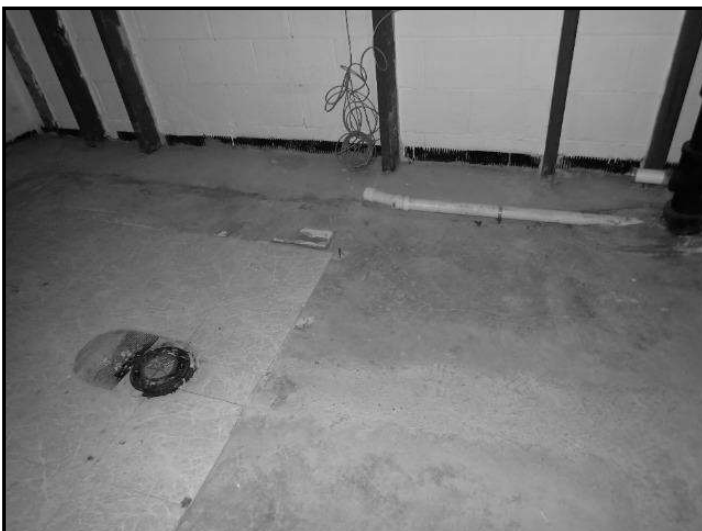
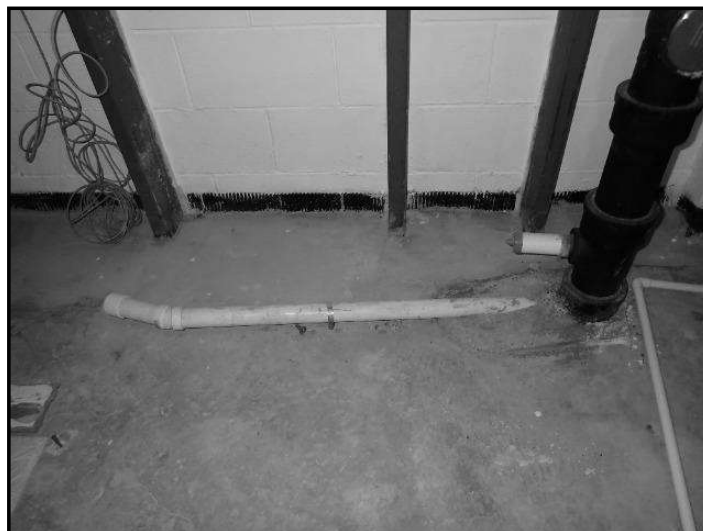
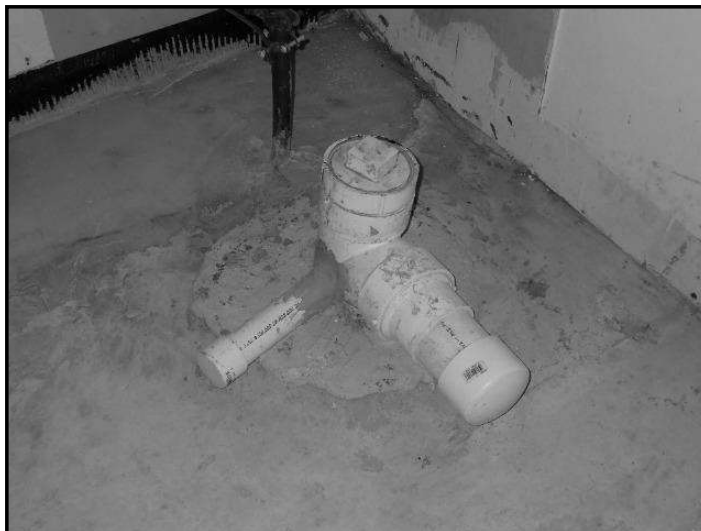
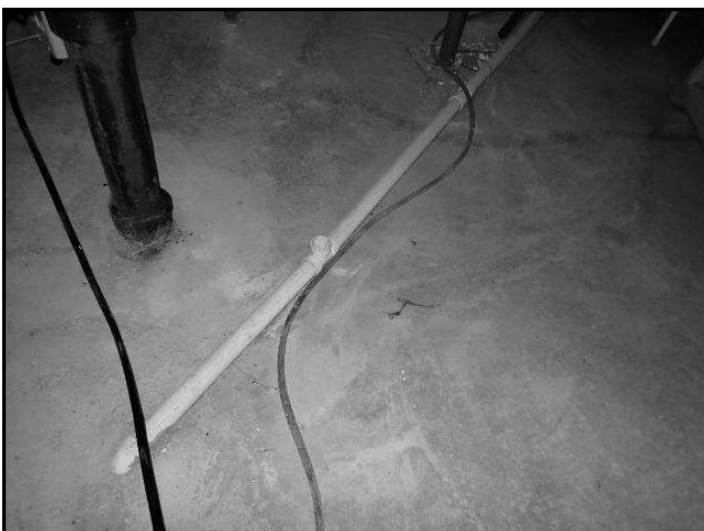
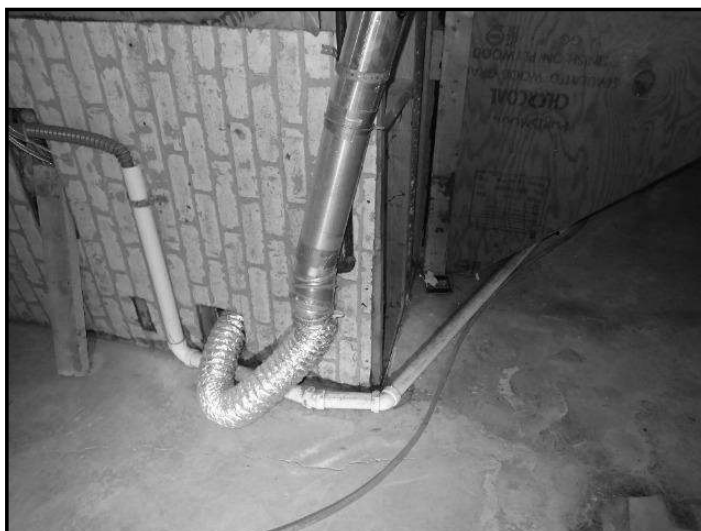
39. Condition: • Nonstandard materials and patches

DEFECT - There is some poor drain waste and vent piping in the home that needs to be corrected by a qualified plumber. There are a few improper sections and pieces that need to be replaced for consistent performance in waste movement and venting. This work was not professionally done, and there may be further issues that were not demoed or observed.

Implication(s): Chance of water damage to structure, finishes and contents | Sewage entering the building

Task: Further evaluation Improve Correct

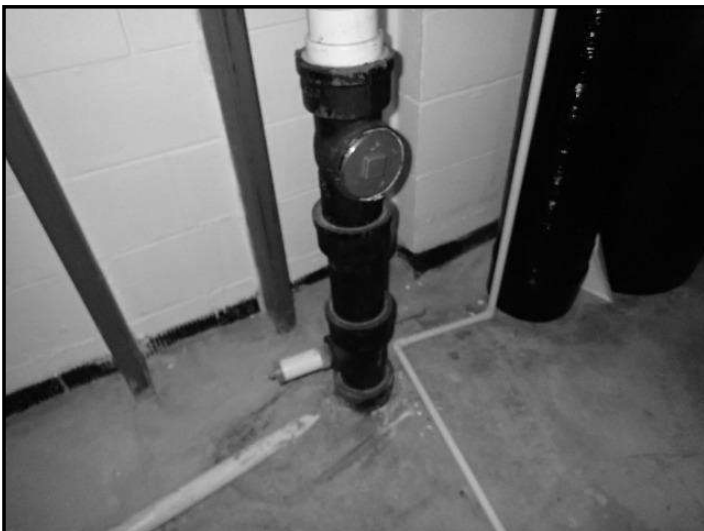
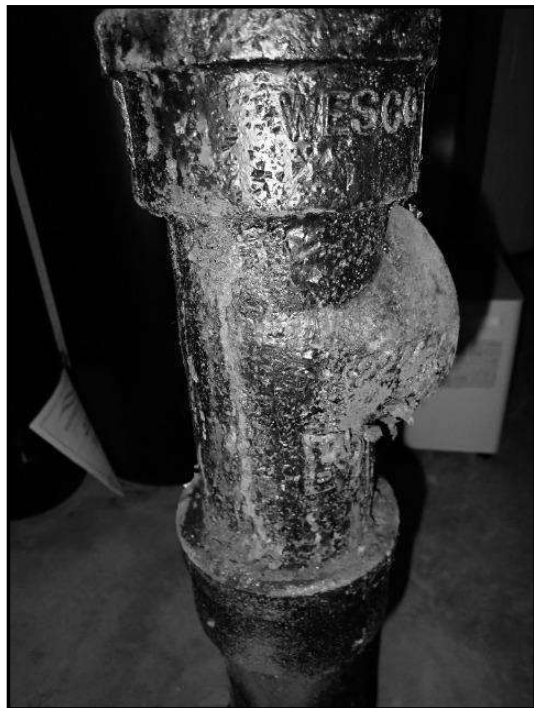
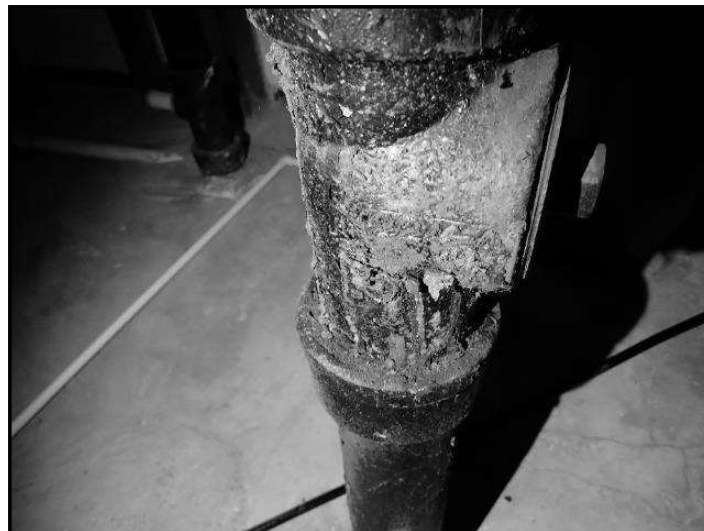
40. Condition: • The sewer lateral appears to be made of cast iron and it is very aged. The lateral should be evaluated by a qualified professional as it may be damaged or deteriorated. Some parts of the cast iron drain lines are showing signs of rot/damage within the home.

Task: Repair or replace Further evaluation Improve Correct

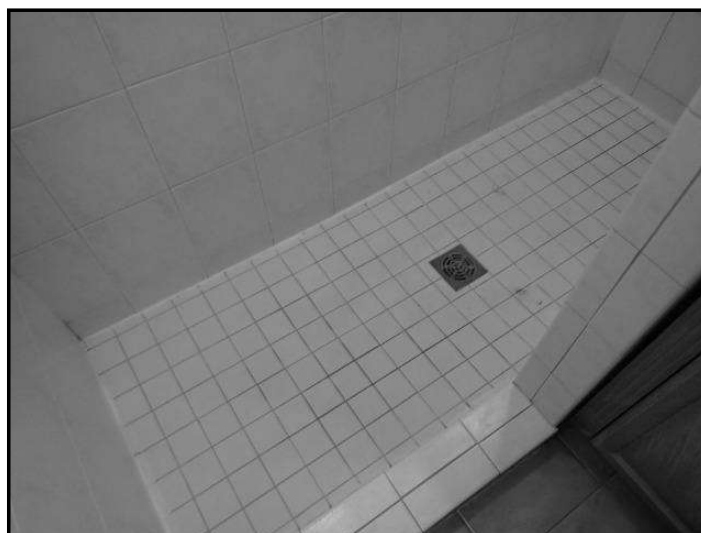
41. Condition: • Leak

The tile shower pans showed no signs of leaking, but will eventually and will require regular maintenance.

259. Leak

Task: Improve Monitor

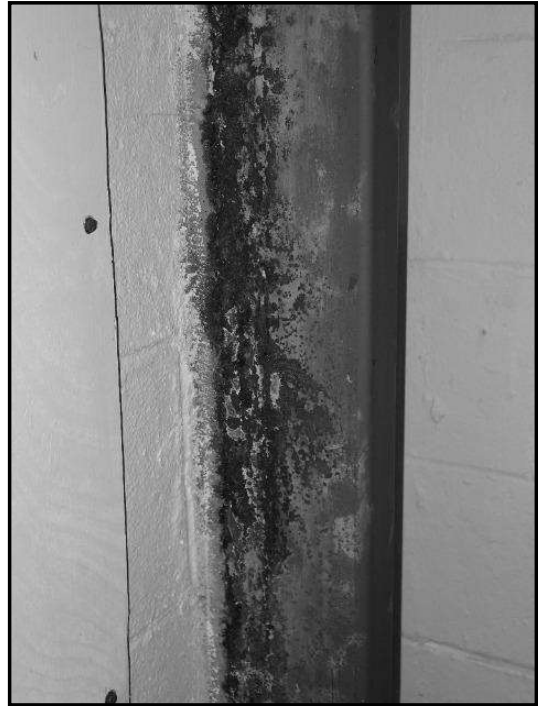
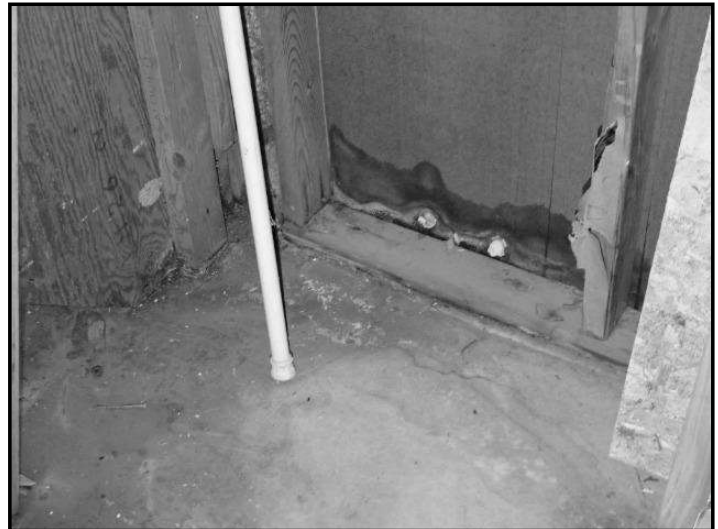
42. Condition: • Efflorescence

DEFECT - The basement is showing signs of efflorescence and moisture intrusion. The walls and floor were dry at the time of the inspection. These conditions are usually addressed by improving your grading, gutters, and downspouts. If the moisture persists there may be a need for a drain tile improvement/system. The moisture appears to be a continuing issue.

Task: Further evaluation Improve Correct

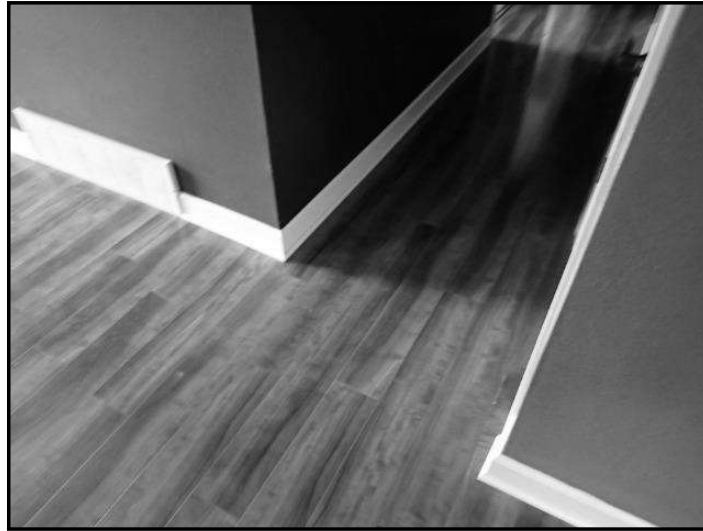
43. Condition: • Mechanical damage

There are a few areas where the floors are unlevel/uneven. The cause for the condition was not identified nor visible at the time of the inspection and would require further evaluation.

264. Mechanical damage

Task: Improve Correct

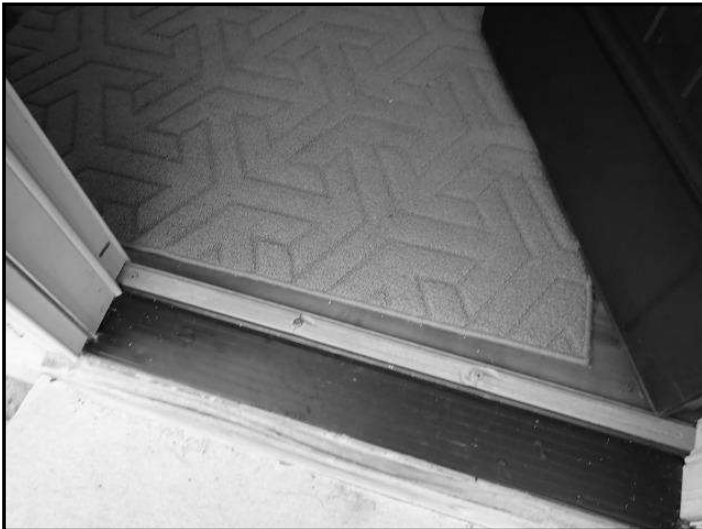
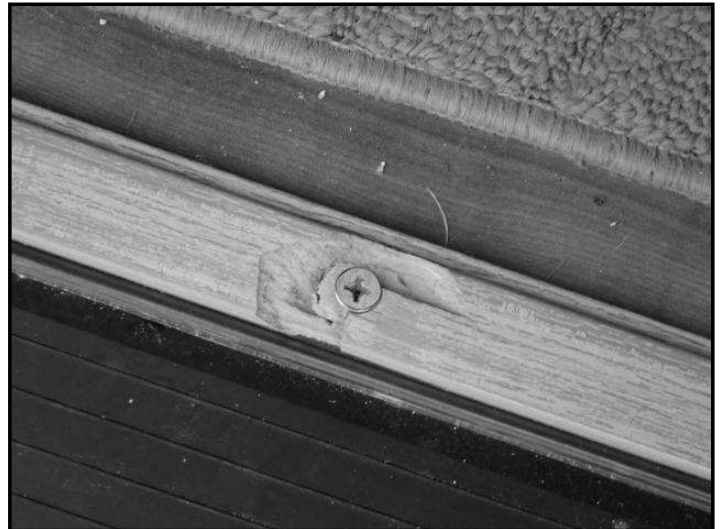
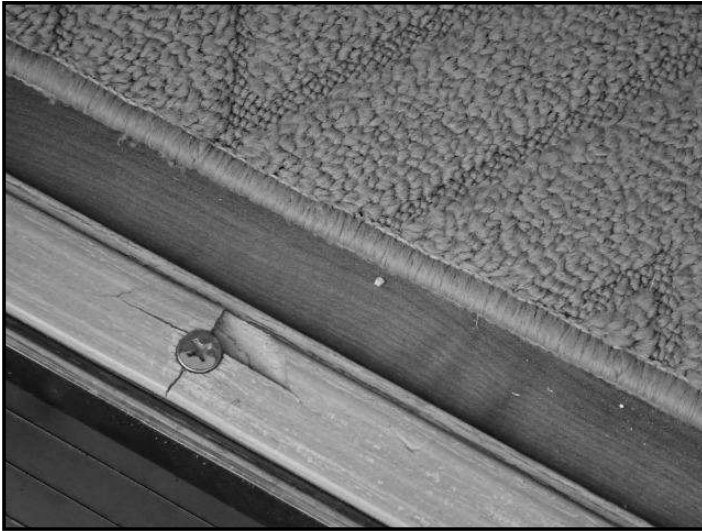
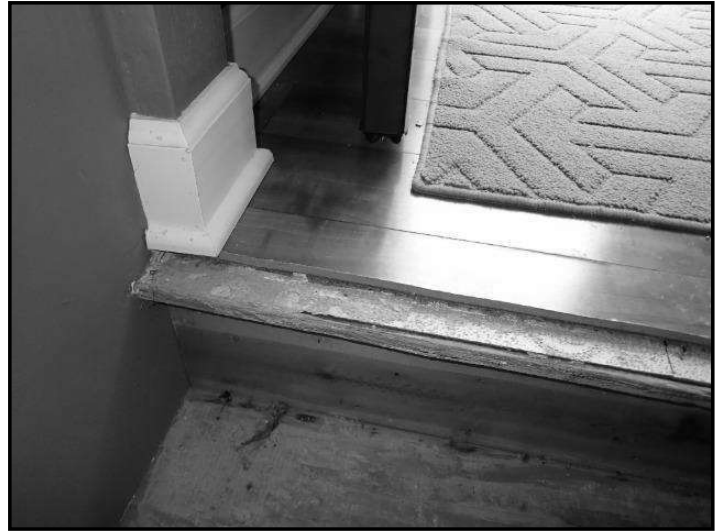
44. Condition: • There are a few areas where the flooring is damaged and needs to be repaired.

Task: Repair Improve Correct

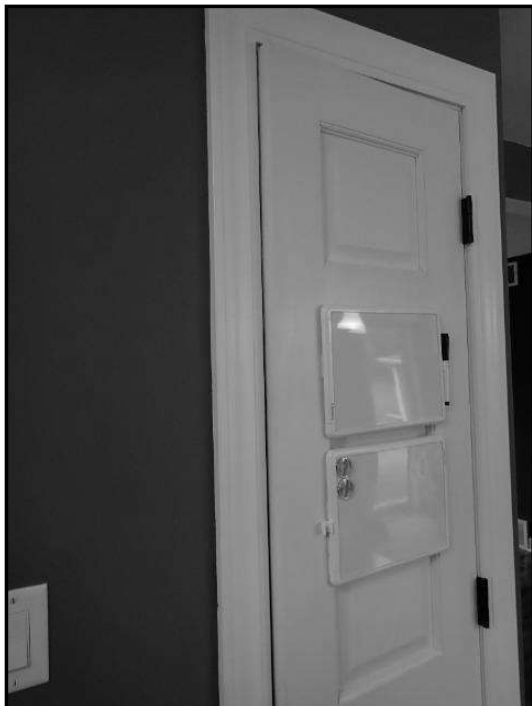
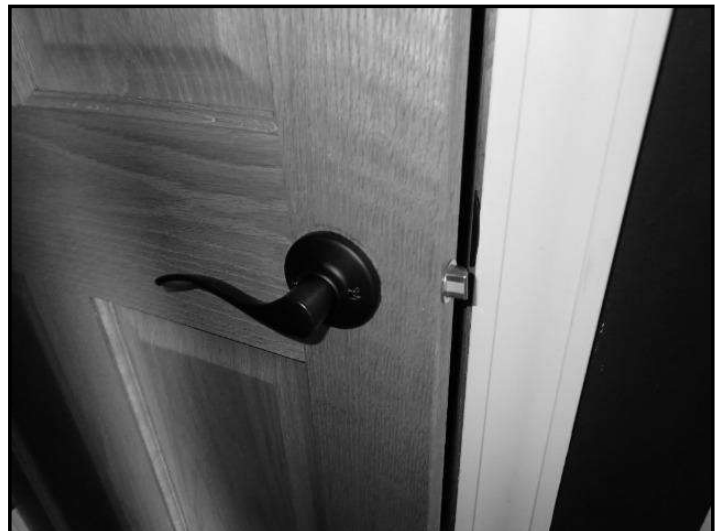
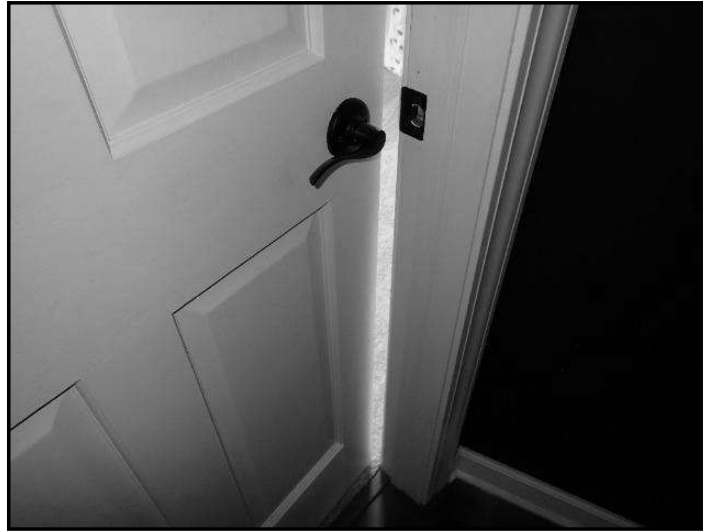
45. Condition: • Stiff

There are a few doors that are stiff to operate, or don't latch properly and likely just need to be adjusted/repaired to function properly.

Task: Improve Correct

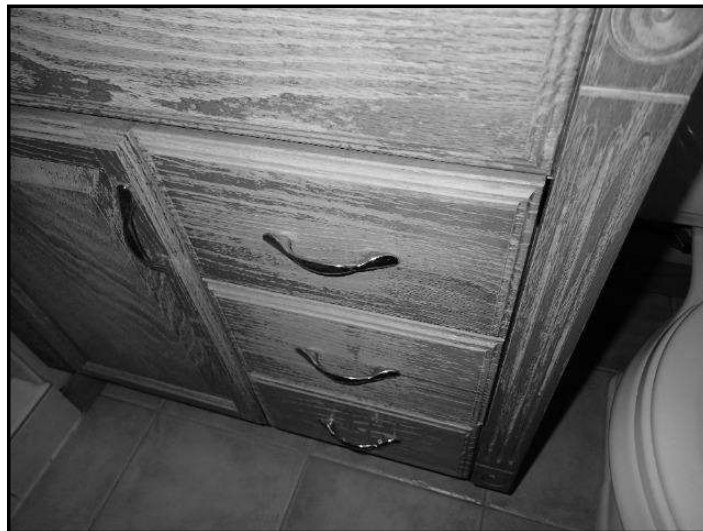
272.

46. Condition: • The cabinetry is damaged in a few areas we need to be repaired.

Task: Improve Correct

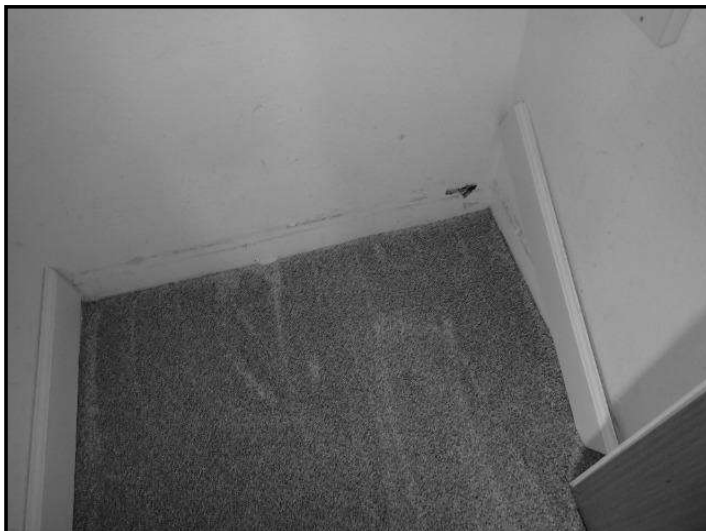
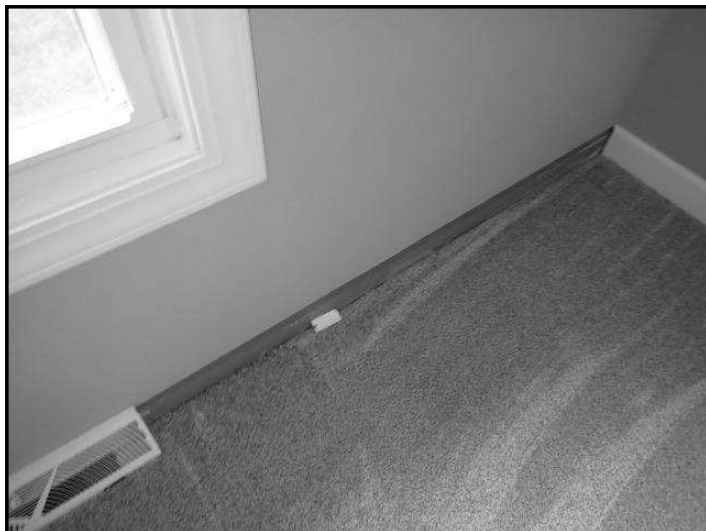
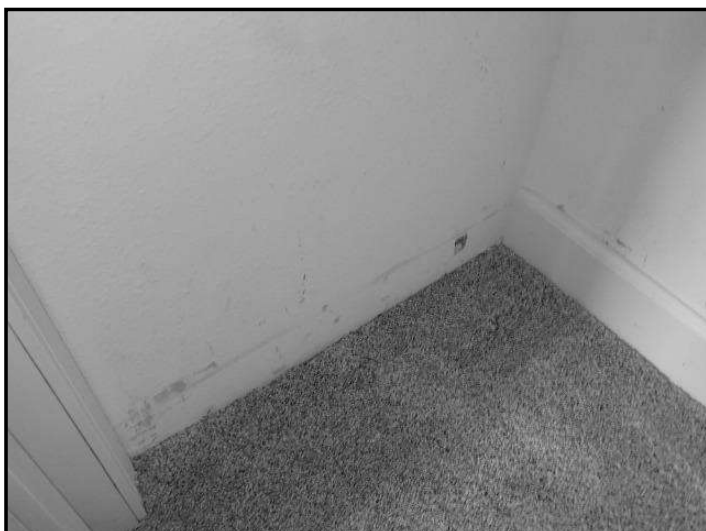
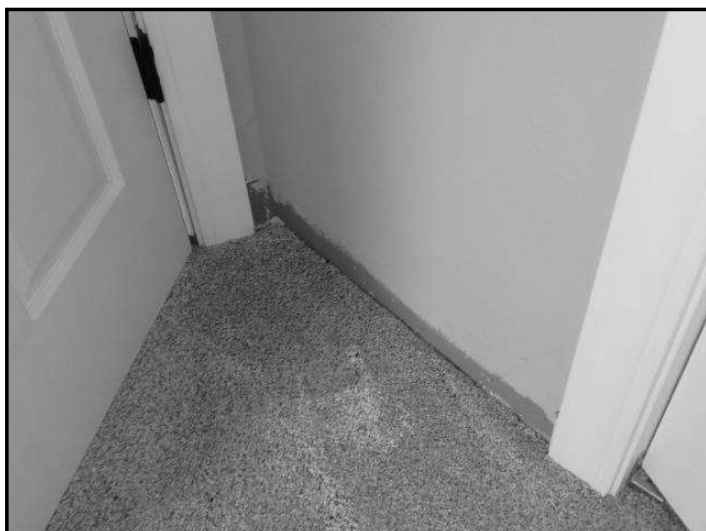
47. Condition: • Missing

The interior trim is missing or damaged in a few areas and needs to be repaired/replaced.

Task: Repair or replace Improve Correct

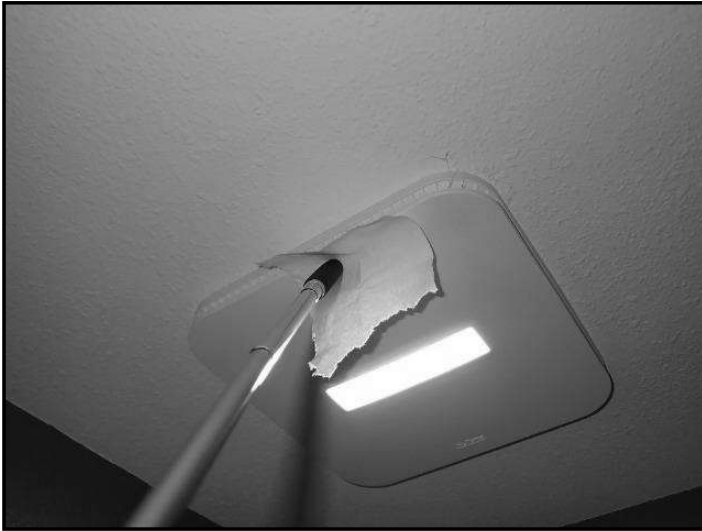
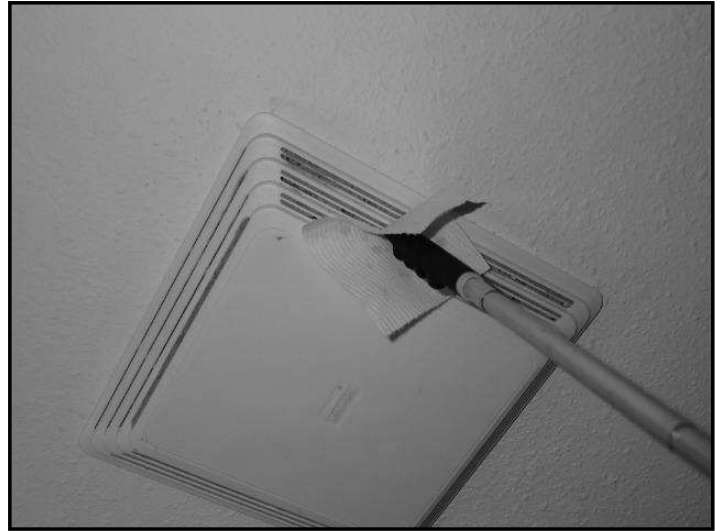
48. Condition: • Inadequate air movement

The bathroom fans are not functioning as expected in and need to be repaired or replaced.

Implication(s): Chance of condensation damage to finishes and/or structure

Task: Further evaluation Improve Correct

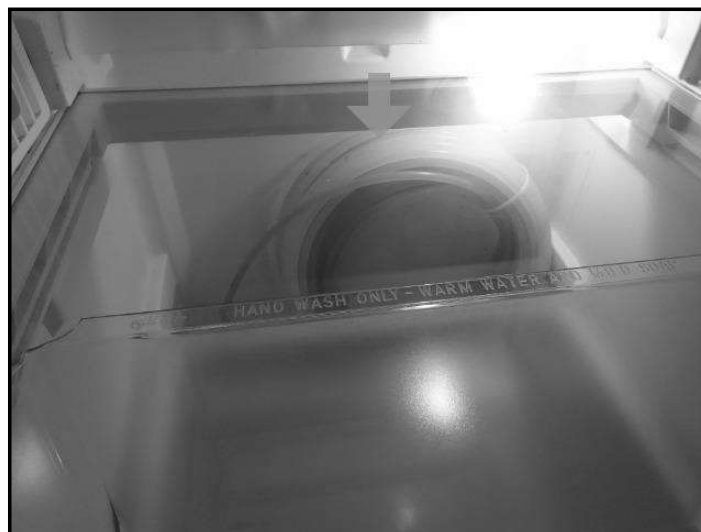
279.

49. Condition: • There is a long piece of tubing in the back of the refrigerator for which a purpose was not ascertained.

Task: Further evaluation

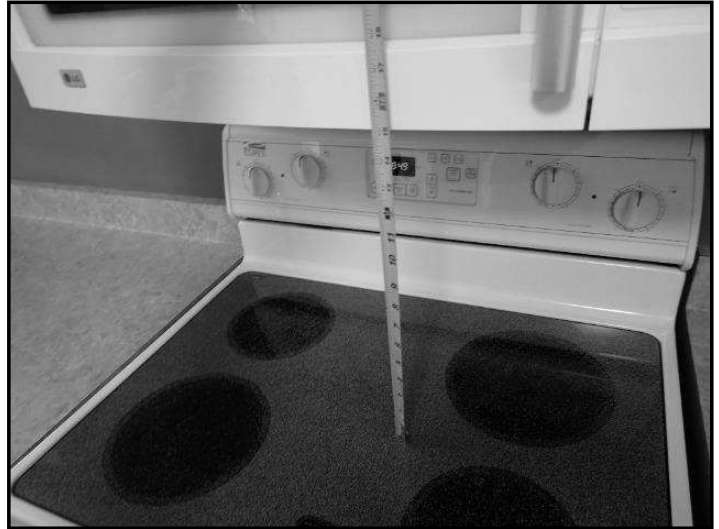
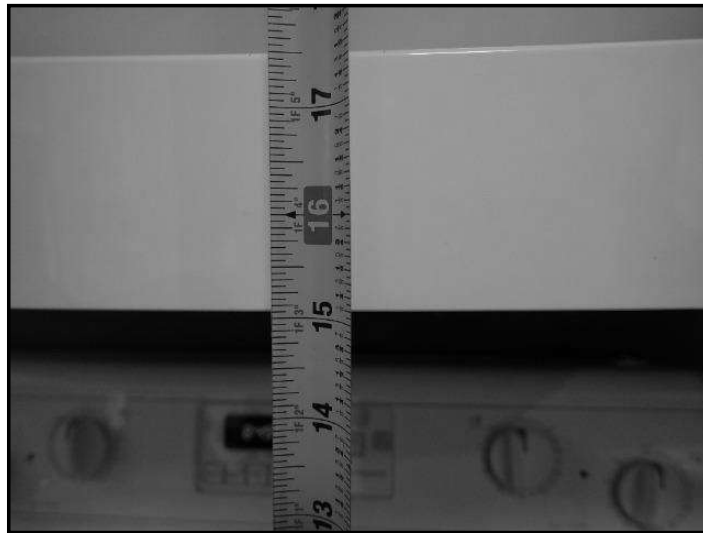
50. Condition: • Microwave is too close to the cooktop and could be damaged due to excessive heat. The unit should be raised or consider a low profile Microwave that will have all the same features.

Task: Improve Correct

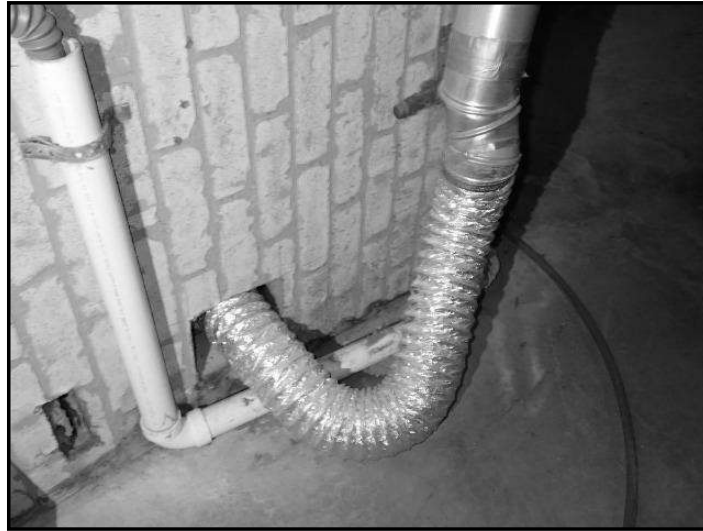
51. Condition: • Plastic dryer vent

DEFECT - The dryer duct is made of plastic/aluminum foil and should be replaced as the plastic is flammable. I recommend a smooth walled or flexible metal dryer vent to reduce maintenance and also reduce the risk of fire.

Implication(s): Equipment ineffective | Fire hazard

283. *Plastic dryer vent*

Task: Improve Correct
