## RESIDENTIAL REPORT

1701 Jackson Street  
New Holstein, WI 53061

Rachel Hansen  
APRIL 20, 2024

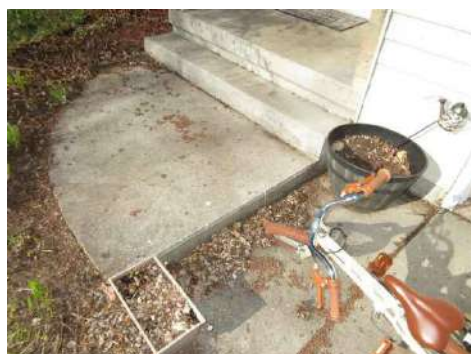
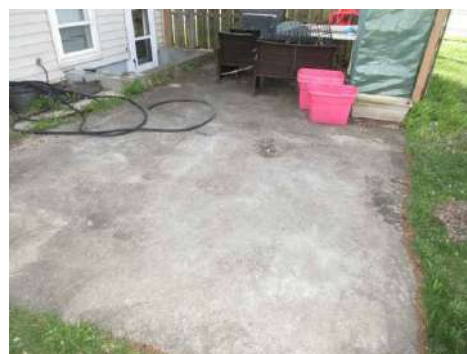
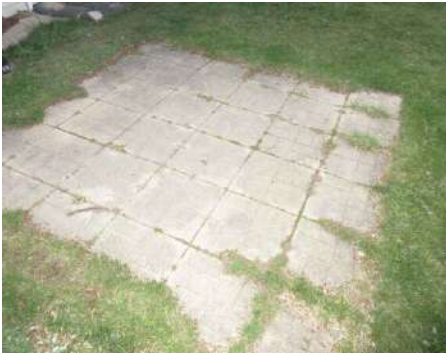
**Flatwork: General Observations**

Water may pond – common (possible safety hazard in winter), Sub-Standard size step(s) – caution!, Public walkway(s) not inspected, Not all visible, Cracks/Settling/Trip hazards, DIY installations - Pavers

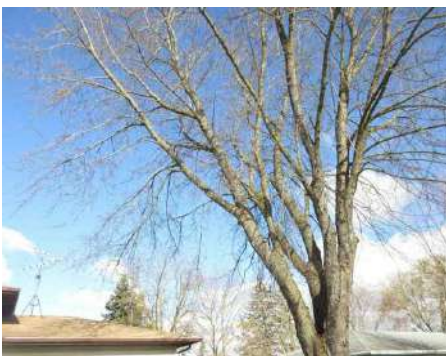
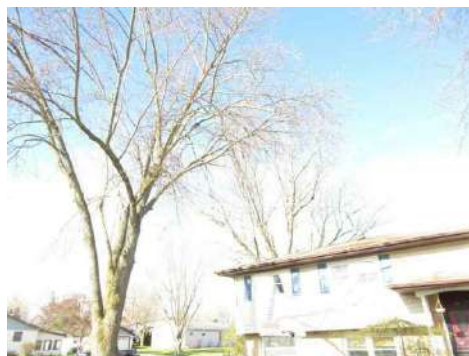
**Landscaping: Large Trees**

Large trees close to home and/or garage may affect house and/or garage (ex: insects, plumbing, drainage, structural) today we look for the obvious though we recommend consulting the owner on any adverse history.

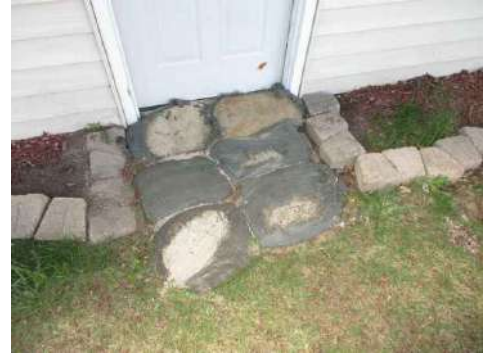
#### SUB-STANDARD REPAIRS

Evidence of substandard repairs (water may seep into the garage). If not corrected moisture damage may result. Consult professional for evaluation and corrective action.

Recommendation

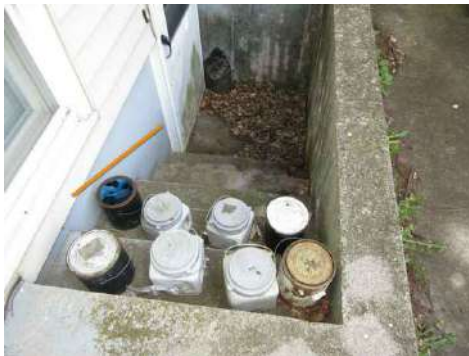
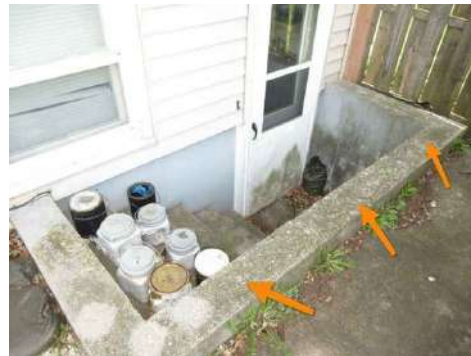
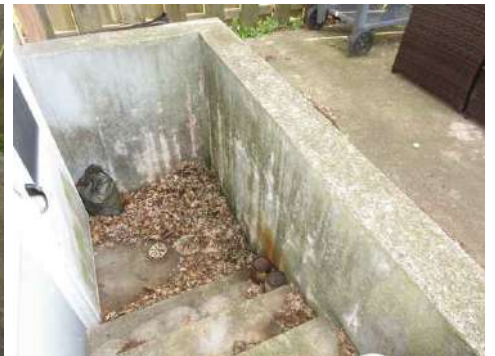
### 2.2.1 Bulkhead Entrance / Basement Egress

#### RECOMMEND RAILING/BALUSTERS

Recommend installing railing and balusters at the steps and top of retaining wall. If not installed a fall hazard exists. Consult professional for evaluation and corrective action.

Recommendation

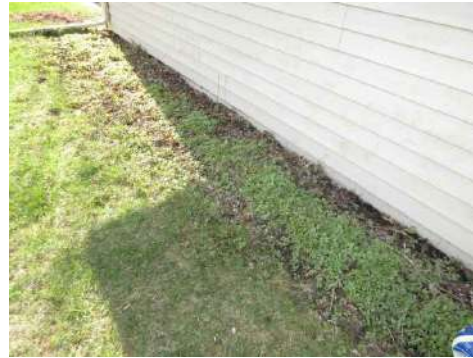
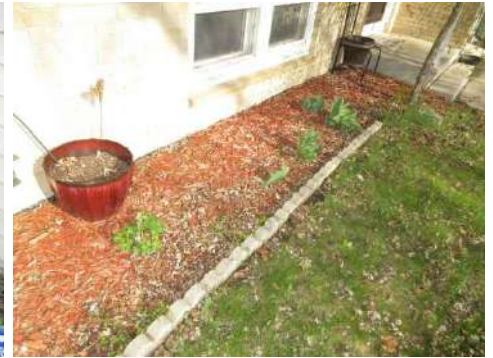
2.5.1 Landscaping

**RECOMMEND GRADING IMPROVEMENTS**

The grading around the structures could use improvement (common with most homes). If not maintained water seepage/damage may result. In general - grading should have a pitch of 1" drop per foot extended for 6' away from the structure with no siding-to-dirt contact. Recommend evaluate/repair per professional.

Contact a qualified landscaping contractor

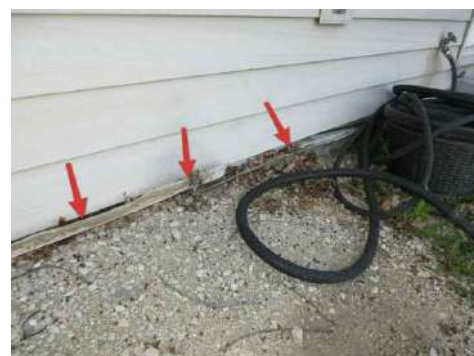
Loose metal flashing observed at the west side of the home at grade level - purpose unknown. Consult owner/professional as needed and repair/remove as needed.

Contact a qualified professional.

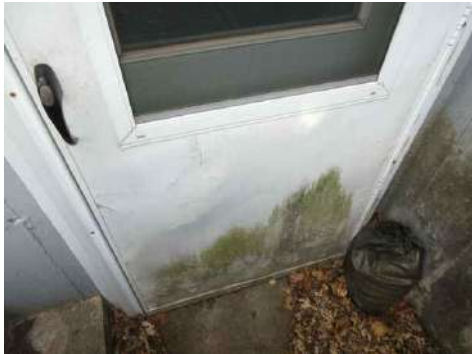
**EXTERIOR DOORS NEED REPAIR**

The exterior doors appear to need repairs. If not repaired the doors may not operate as intended. Consult professional for evaluation and corrective action.

Corroded storm door - lower-level entrance

Contact a qualified door repair/installation contractor.

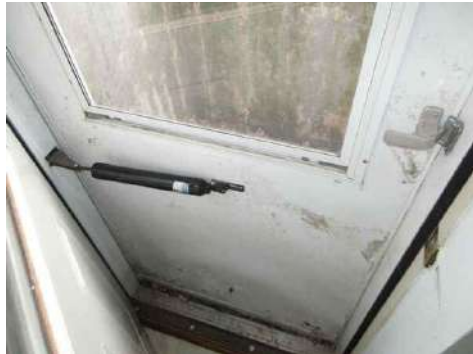
Corroded storm door - lower-level entrance

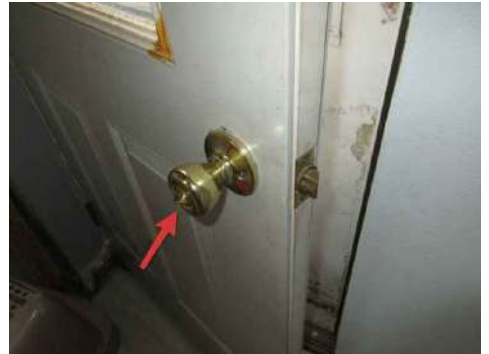
Door does not lock - lower level door

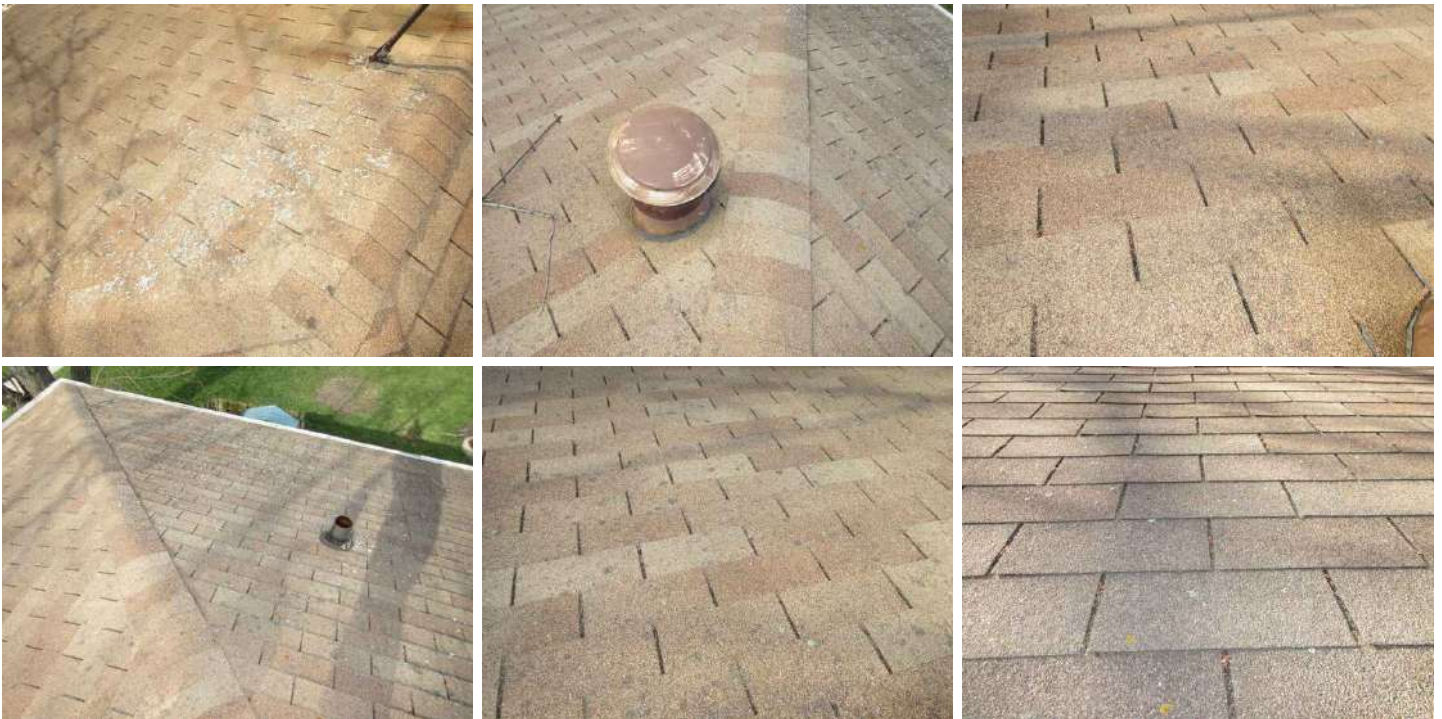
### EVIDENCE OF HAIL DAMAGE

The roof appears to have hail damage. If not repaired the roof may not last its average life expectancy. Consult professional for evaluation and corrective action.

Contact a qualified roofing professional.

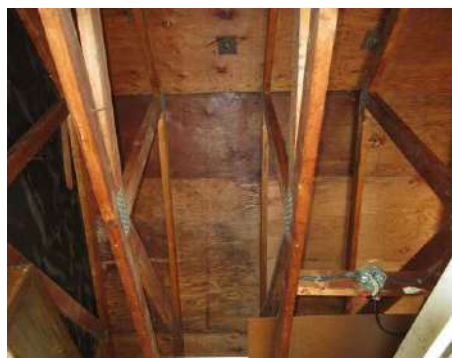
**In General - Moisture Stains On Sheathing (dry)**

In general - moisture stain(s) noted at roof sheathing appear old and randomly read dry today with meter possible past/active leak (source not confirmed). Consult owner/professional as needed.

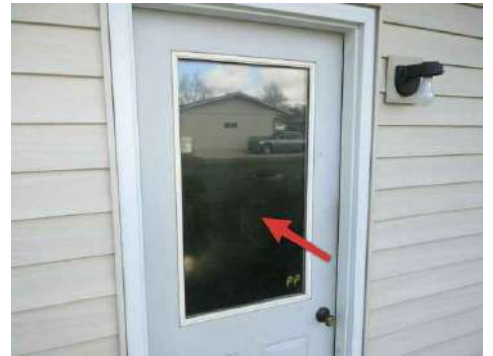
The service door window has a potential insulated glass leak (foggy glass). A window with an insulated glass leak still operates as intended, but it loses insulation value and may fog up. Contact a door professional to evaluate and repair as needed.

Contact a qualified professional.

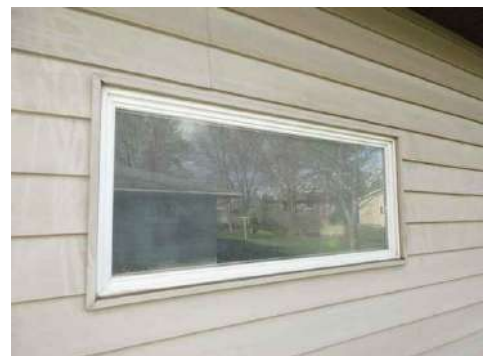
The garage window has a potential insulated glass leak (foggy glass). A window with an insulated glass leak still operates as intended, but it loses insulation value and may fog up. Contact a door professional to evaluate and repair as needed.

Contact a qualified professional.

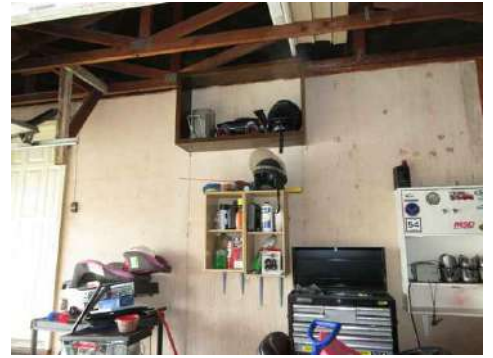
## 6.7.1 Firewall

Safety Hazard**COULD NOT CONFIRM FIREWALL**

The material between the house and garage should be fire rated. This could not be confirmed today - appears to be a paneling. Recommend professional evaluate further, and repair as needed.

Contact a qualified professional.

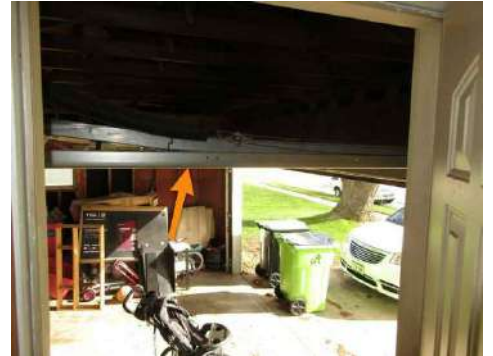
## 6.8.1 Fire Door

Safety Hazard**LOW HEAD CLEARANCE**

Low head clearance observed at the house entrance - caution! Repair as needed per professional.

Contact a qualified professional.

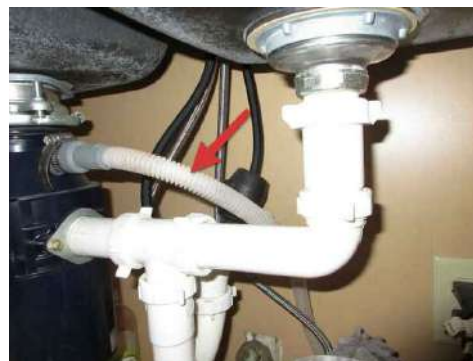
Drain goes to disposal and there is not air gap device

Contact a qualified plumbing contractor.

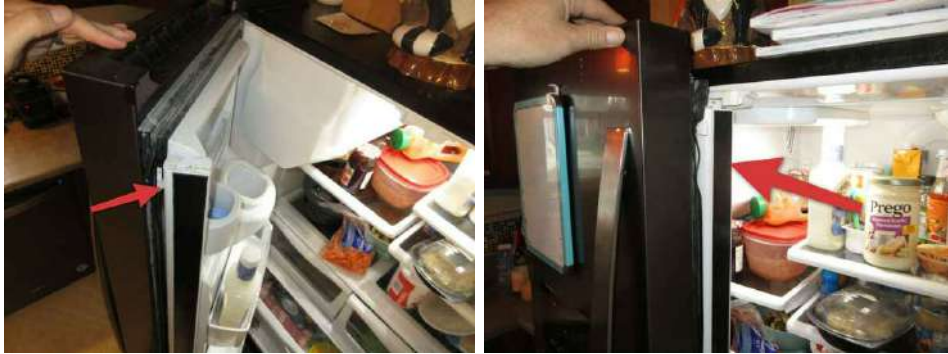
**DAMAGED**

Refrigerator shows damage in area(s). If not corrected it may not operate as intended. Consult professional for evaluation and corrective action.

Contact a qualified appliance repair professional.

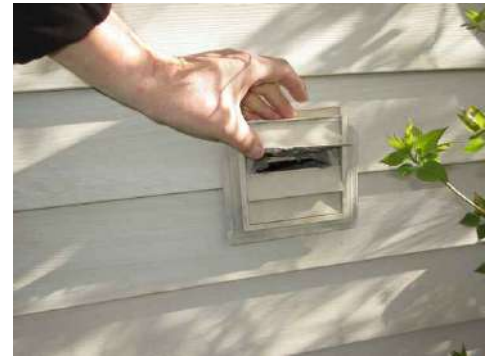
Dryer vent hood is dirty at exterior. This may indicate a dirty vent pipe which can result in improper dry ventilation. Recommend cleaning per professional.

Contact a qualified professional.

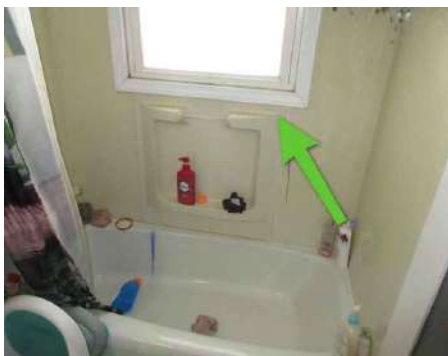
### Shower / Tub Surround(s): Protect Window

Protect window from shower water or future repairs/maintenance may be needed - monitor.

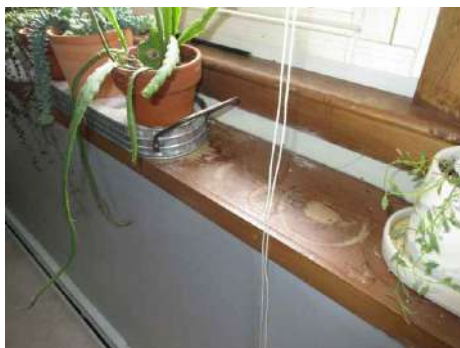
Moisture stains on windowsills appear to be from water plants - consult owner to confirm

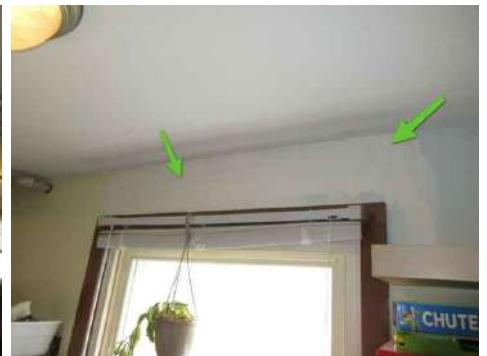
Spot painting areas

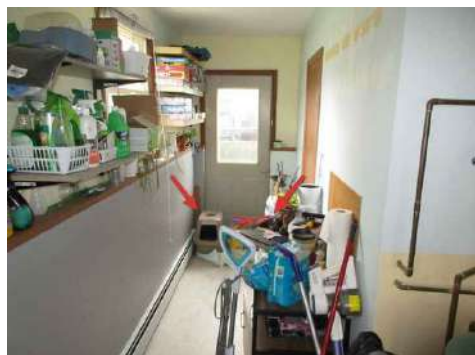
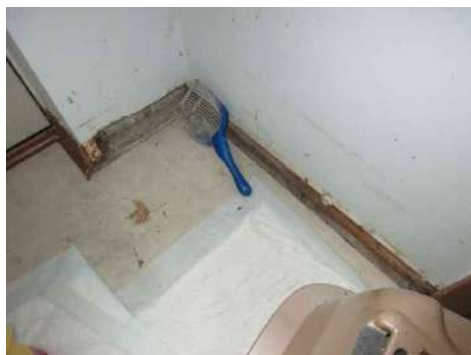
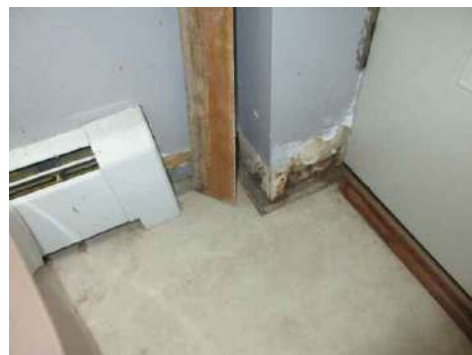
### EVIDENCE OF MOISTURE DAMAGE

Evidence today of past moisture damage at lower-level basement entrance (may be from past seepage at basement entrance - though not confirmed). Consult owner on history and professional as needed for corrective action.

Contact a qualified professional.

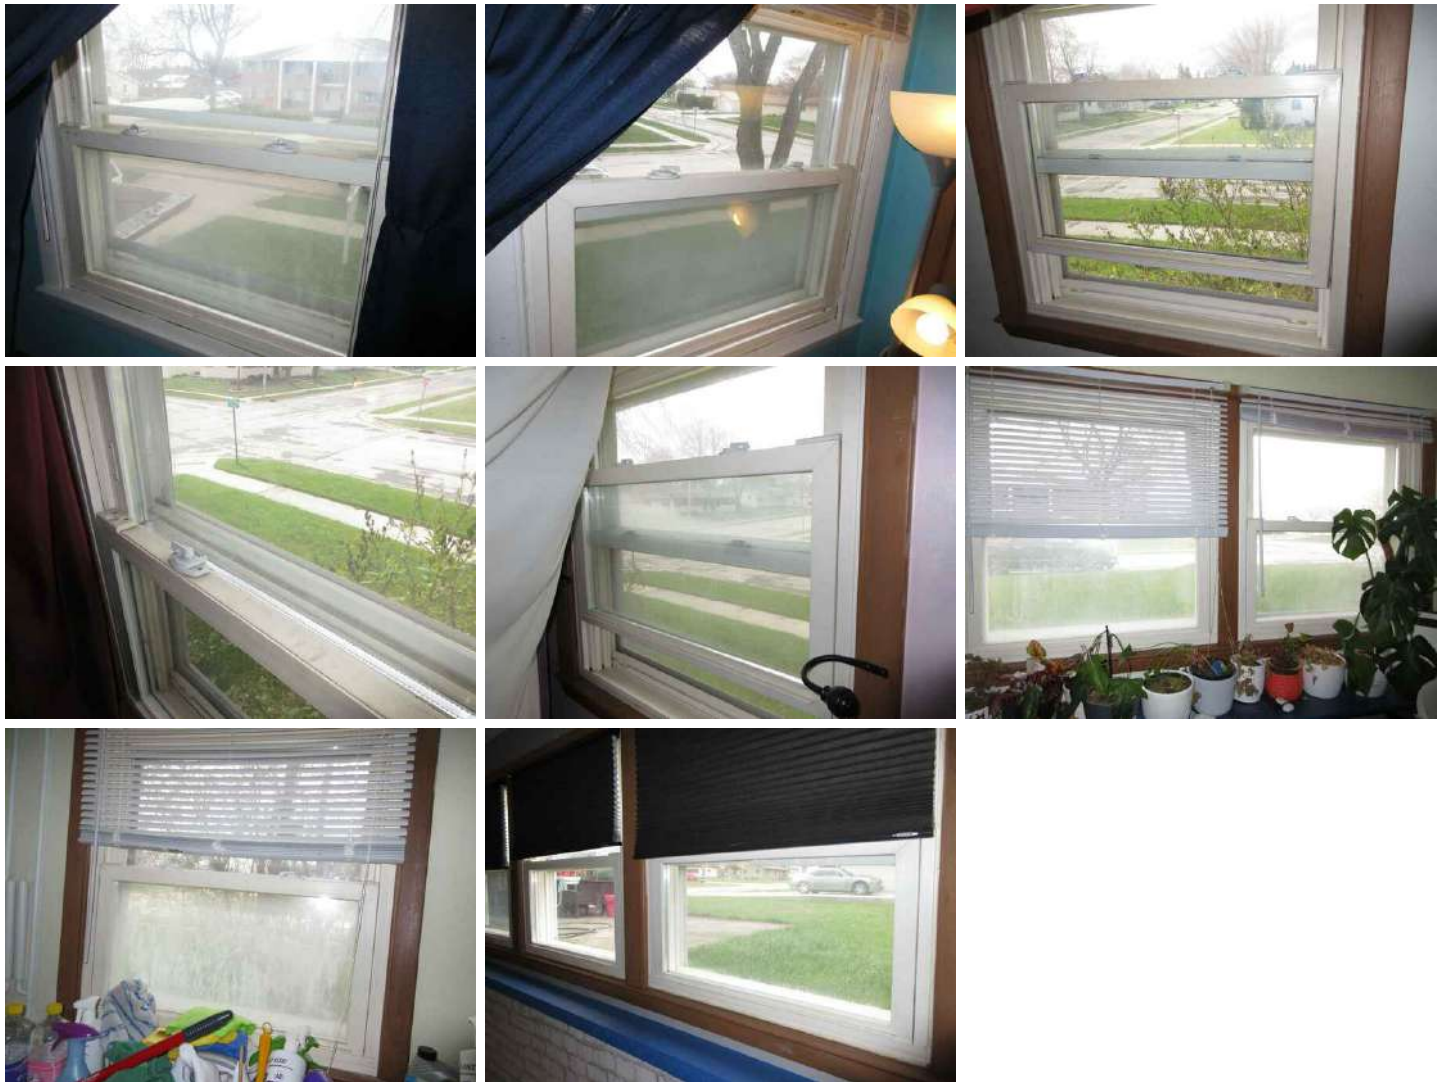
9.3.1 Windows (representative number)

The windows appeared to be difficult to lock/operate There were also many windows in the home with potential insulated glass leaks (foggy glass). A window with a an insulated glass leak still operates as intended, but it loses insulation value and may fog up. Signs of lost seals in thermal pane windows may appear and disappear as temperature and humidity changes. Some windows with lost seals may not have been visible at the time of the inspection. Contact a window professional to evaluate all windows and repair/replace as needed.

Contact a qualified window repair/installation contractor.

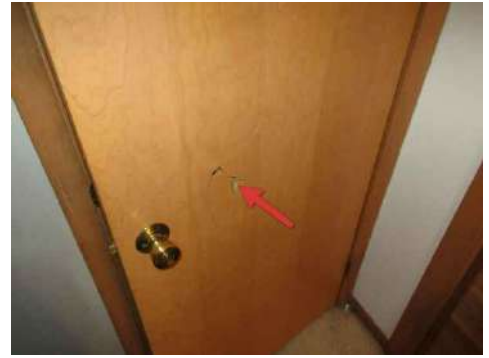
9.4.1 Interior Doors  
(representative number)

**DAMAGED DOOR(S)**

Damaged bedroom door observed today. If not corrected the door may not operate as intended. Consult professional for corrective action.

Contact a qualified door repair/installation contractor.

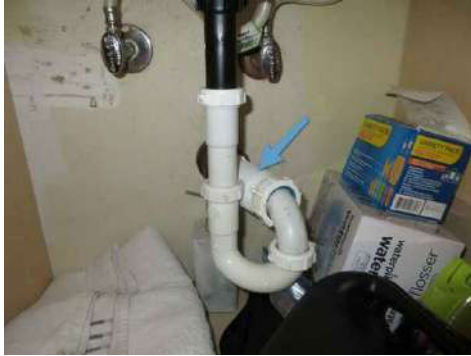
Sub-Standard plumbing observed in the home today. Although this plumbing may operate today flex type plumbing (commonly found) usually indicates a DIY installation and may not be installed per professional recommendations. Recommend professional evaluate further and repair as needed.

Lower bath

Contact a qualified plumbing contractor.

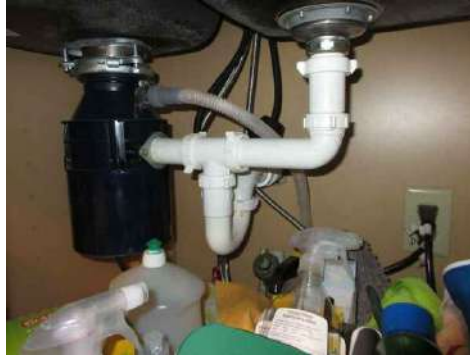
Kitchen - recommend disposal have its own trap

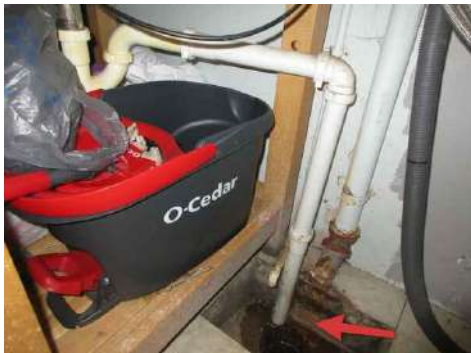
**IMPROPER DRAIN ASSEMBLY**

The drain at the laundry sink appears to be improper. If not corrected moisture damage may result. Consult professional for evaluation and corrective action.

Open drain

Contact a qualified plumbing contractor.

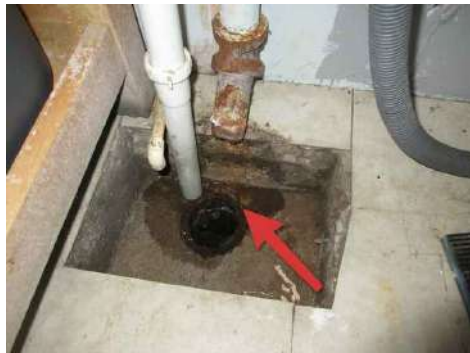
Open drain for laundry sink and washer drain - not recommended

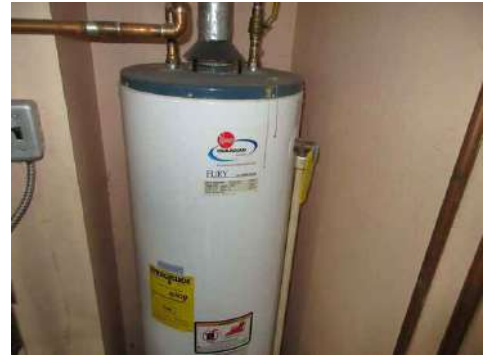
## 12.10.1 Water Heater(s)

The national average life expectancy of a water heater is 12-15 years. It is difficult to determine how long a water heater will last, but this unit is nearing its life cycle. Recommend budgeting for replacement.

Contact a qualified plumbing contractor.

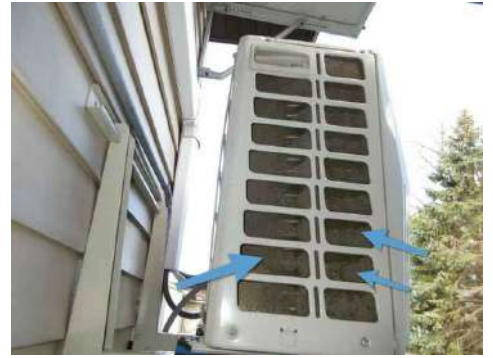
Unit has dirty cooling fins. If not properly cleaned/combed the unit may not operate as intended. Recommend professional evaluate/clean as needed.

Contact a qualified professional.
