WIC-SE-2025-60-03344

RE: Wetland Identification Report for Project Review Area, located in SE 1/4, NE 1/4, Section 20, Township 15 North, Range 21 E, Town of Plymouth, Sheboygan County

Site Photographs

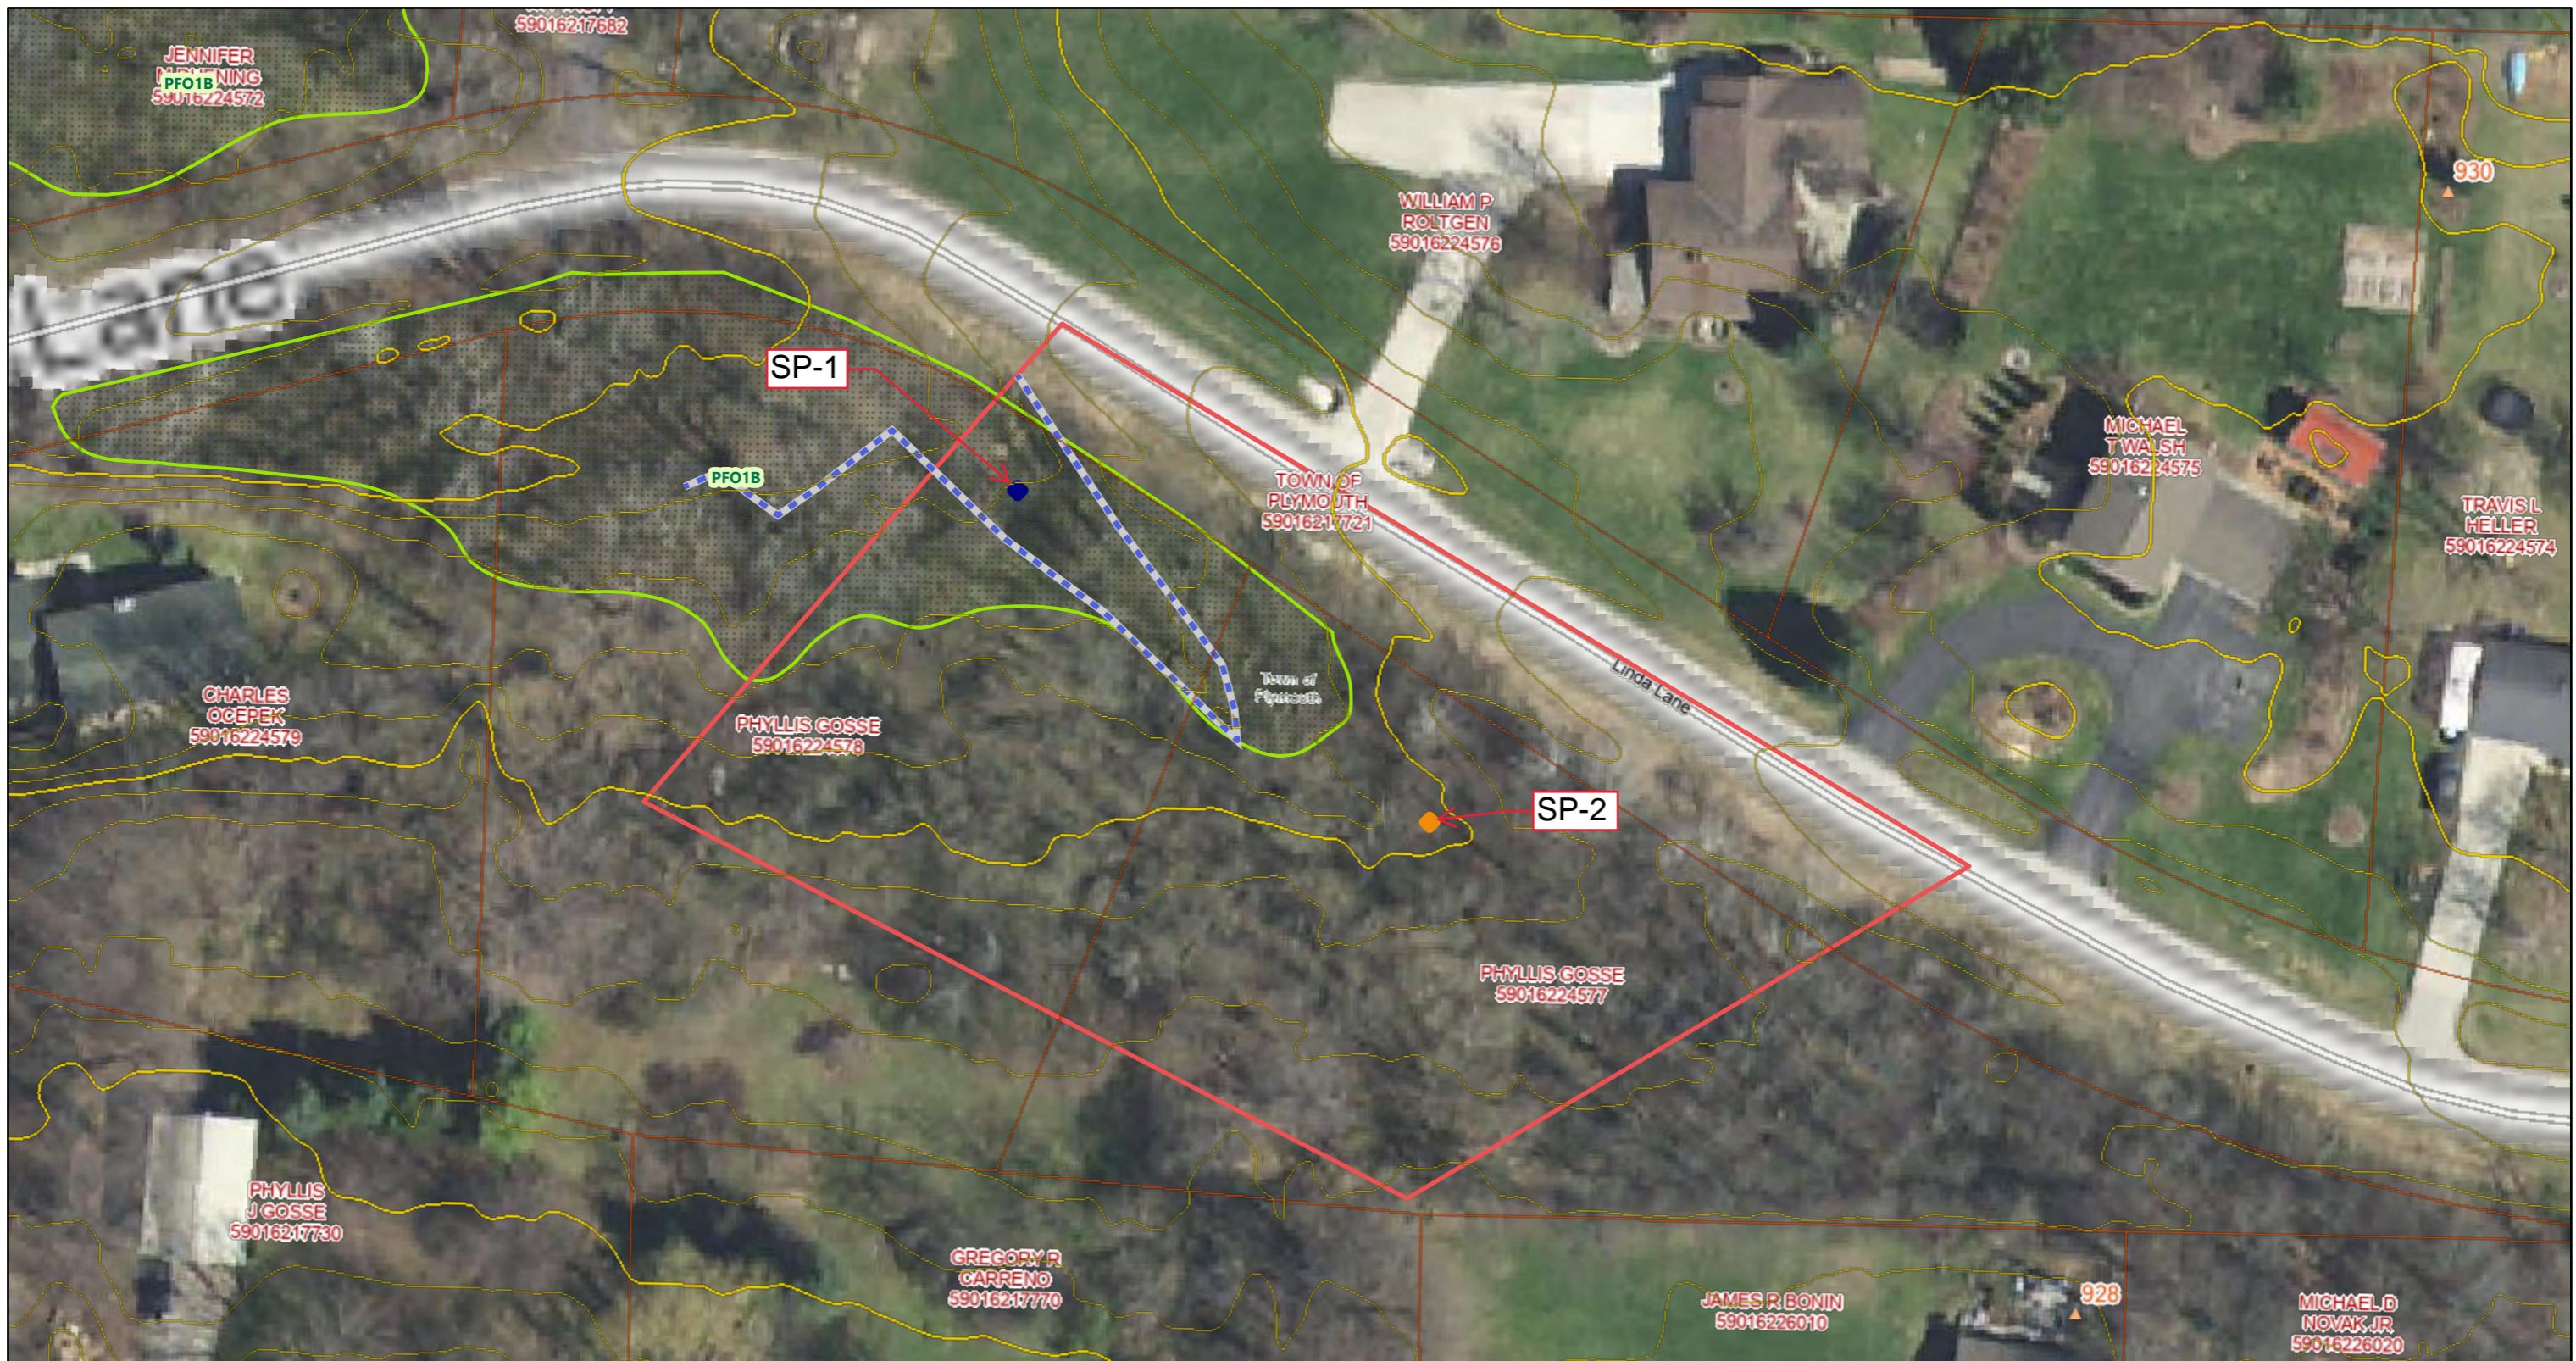
Approximate wetland boundaries were identified following 1987 Wetland Delineation Manual and applicable regional supplement guidelines. Wetlands are defined by the 1987 Wetland Delineation Manual as areas that are inundated or saturated by surface or ground water at a frequency and duration sufficient to support, and that under normal circumstances do support, a prevalence of vegetation typically adapted for life in saturated soil conditions. If any wetland areas were detected, their approximate boundaries were sketched onto an aerial photograph (see attached map).

Based on the data analyzed for the off-site review, as well as the field conditions observed during the field review, **wetlands are located in the project review area**.

The boundaries depicted on the associated field sketch are approximate only and may not be suitable for design purposes, set-back, or permit requirements. Flagging marking the exact wetland boundary was left in the field. Prior to conducting any activities in or around wetlands, we recommend you contact the appropriate staff from DNR Waterways Program, the U.S. Army Corps of Engineers, which may require a federal permit to work in wetlands, and relevant local government zoning authorities to ensure your project meets local floodplain and shoreland zoning ordinance requirements.

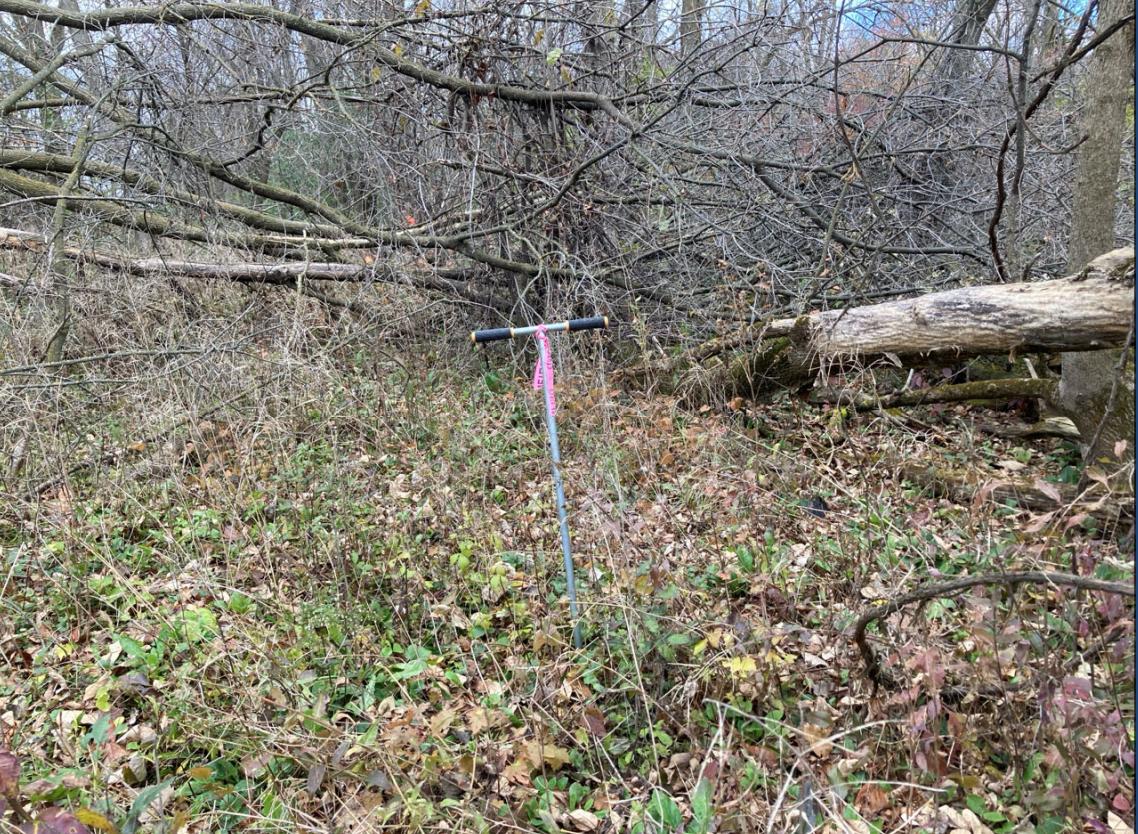
Project Name		Site Location	Project No.	
Lot 4 Linda Lane, Wetland ID		Plymouth, Sheboygan County	2025-03344	
Photo No.	Date			
1	11/5/2025

Description		Wetland Sample Point #1. Photo facing west.

Remarks: water stained leaves present intermittantly in lowest topographic positions

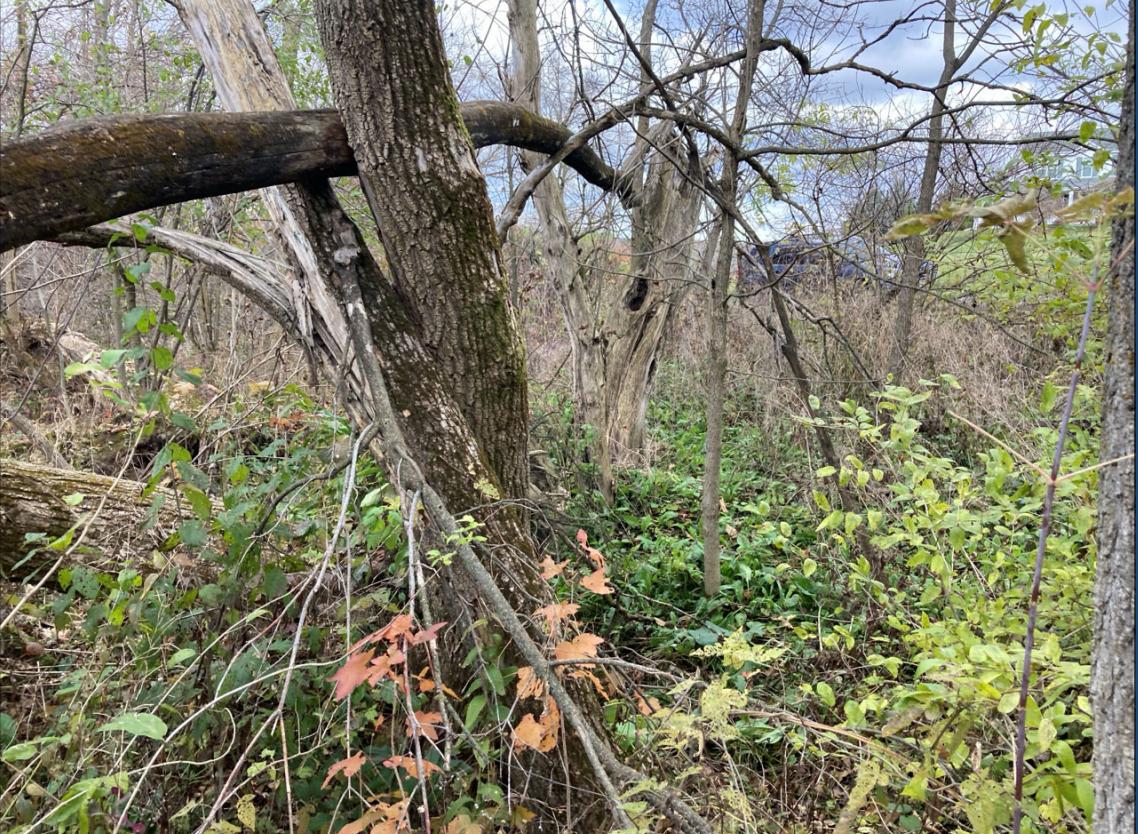
Photo No.	Date	
2	11/5/25	
Description		
Wetland Boundary. Photo facing west.

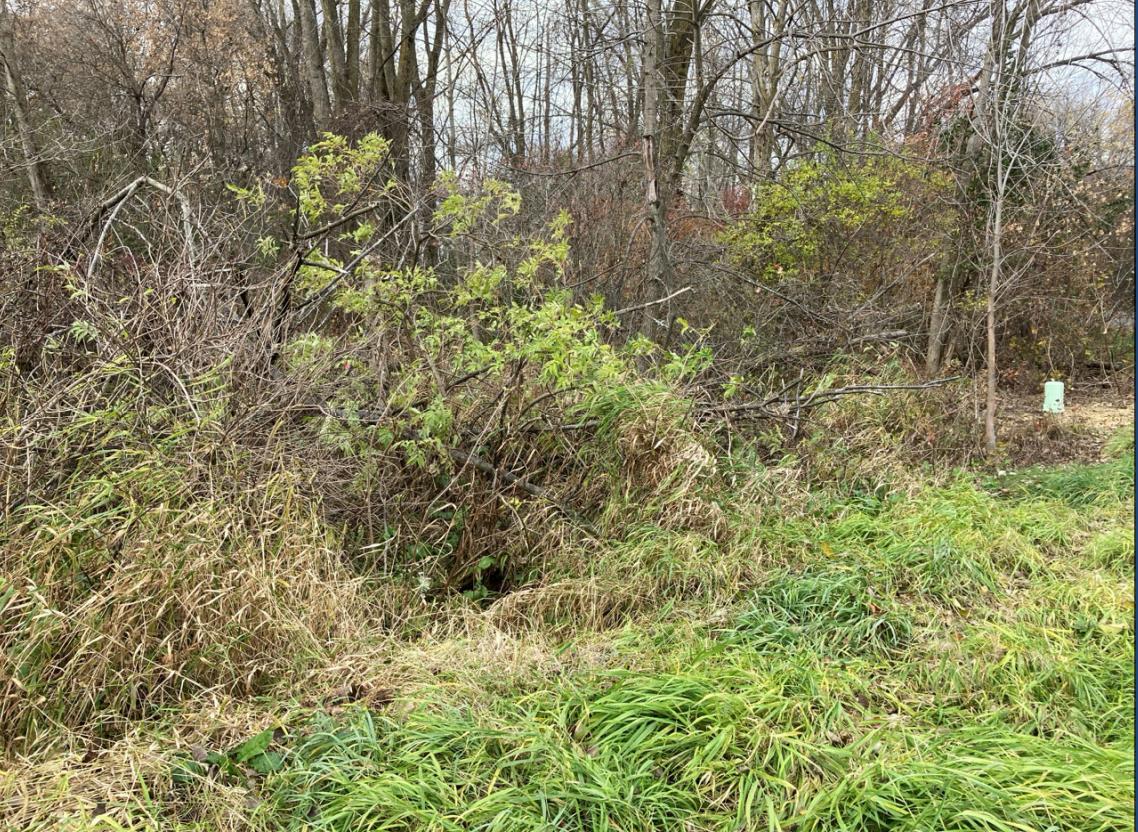
Project Name		Site Location	Project No.
Lot 4 Linda Lane, Wetland ID		Plymouth, Sheboygan County	2025-03344
Photo No.	Date		
3	11/5/2025		
Description Wetland Boundary. Photo facing north from road.

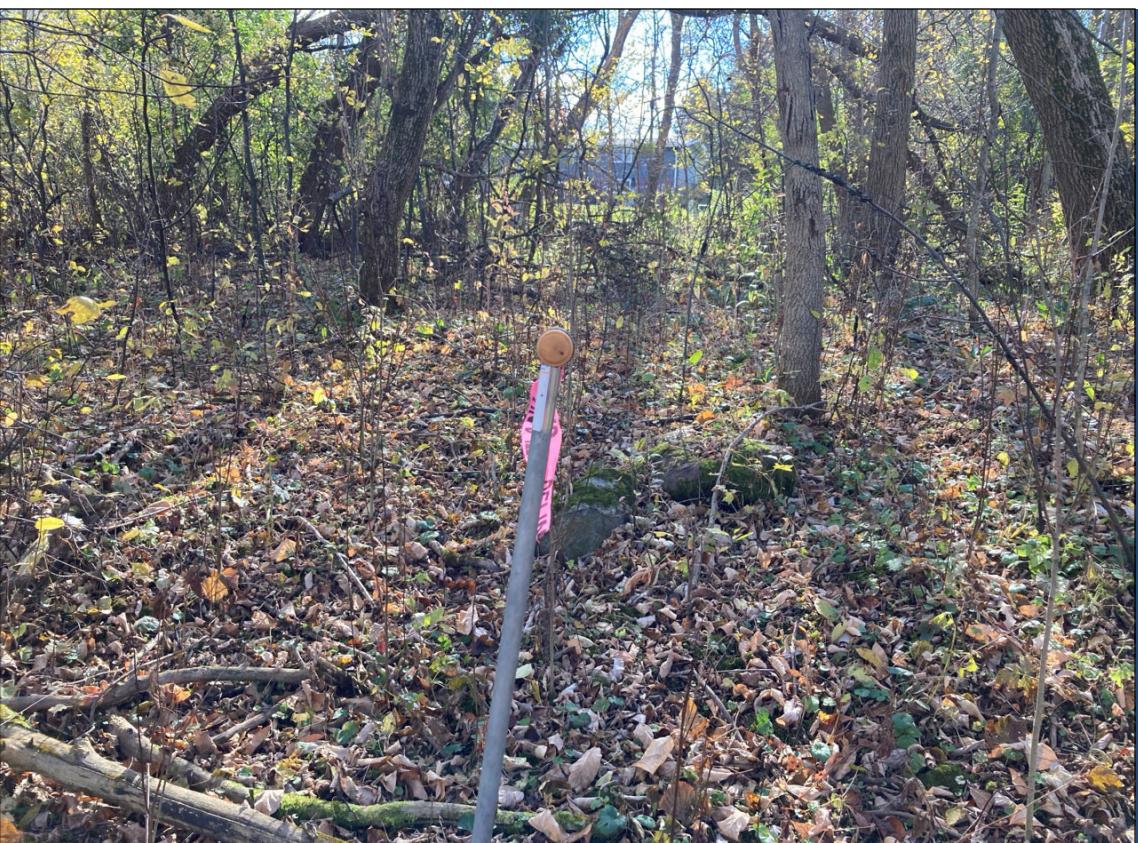
Photo No.	Date		
4	11/5/25		
Description Upland Sample Point #2. Photo facing southeast up swale.

Remarks:	
convergent slope drains water into wetland area. Slope percentage and missing vegetation parameter make it clear that this area is not subject to flooding or ponding.

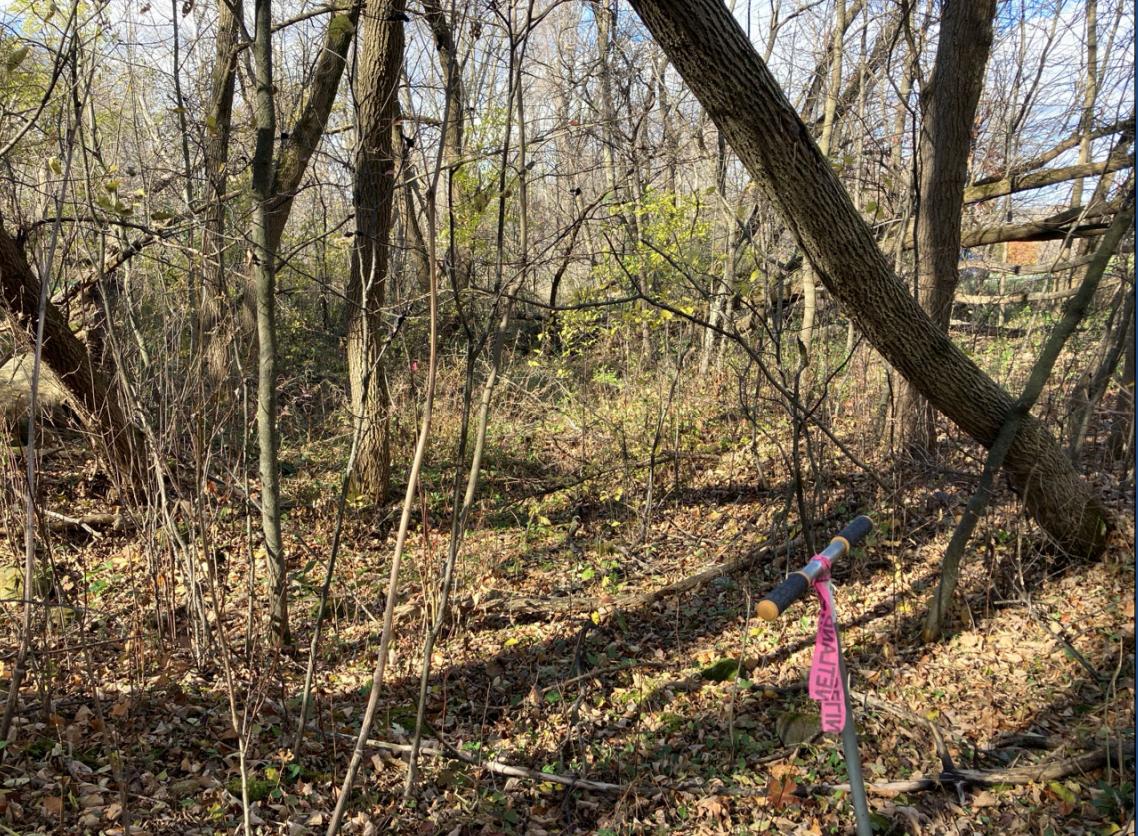
Project Name		Site Location	Project No.
Lot 4 Linda Lane, Wetland ID		Plymouth, Sheboygan County	2025-03344
Photo No.	Date		
5	11/5/2025		
Description			
Upland Sample Point #2. Photo facing east.

A photograph of a forested area. In the foreground, a survey rod is positioned vertically, with a pink flag attached to its top. The ground is covered with fallen leaves and some green vegetation. The background consists of a dense stand of trees, mostly bare, suggesting it is autumn or winter. The lighting indicates a sunny day.
