# Home Inspection Report

807, 809 Detroit St.  
Sheboygan Falls, WI 53085

Inspected by:  
Ryan Eigenfeld  
National Property Inspections  
Inspection Date: 5/5/2025

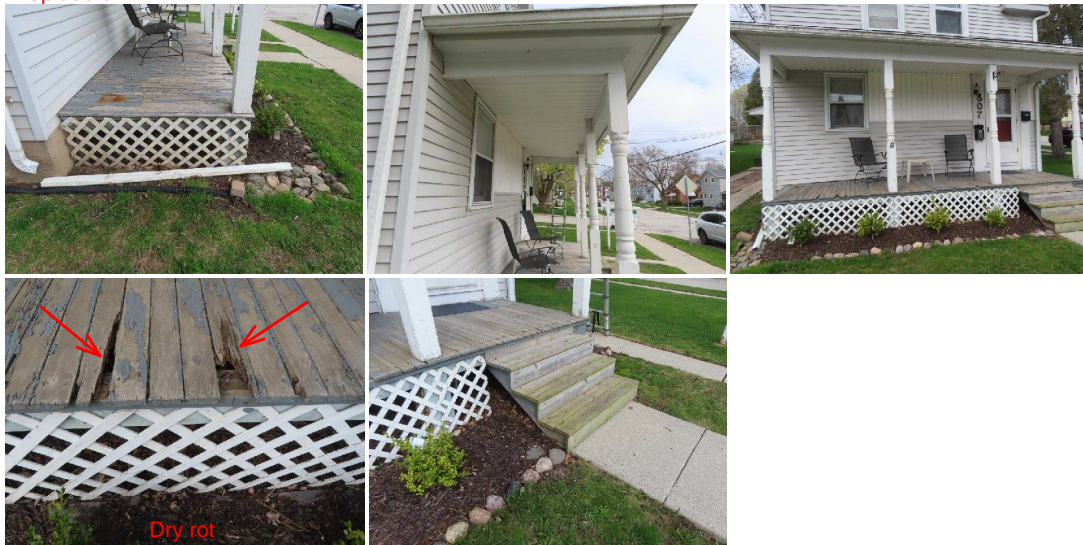
5. Needs Repair

South Porch: Wood, Wood columns      The wood Porch post connection to the concrete footing is missing a proper bracket. There are typical cracks. Recommend a qualified contractor inspect and repair/ replace as needed.

South Porch: Wood, Wood columns

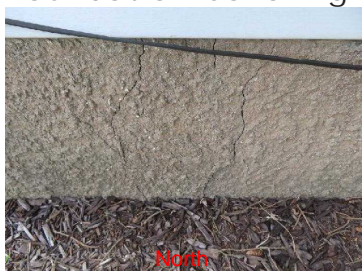
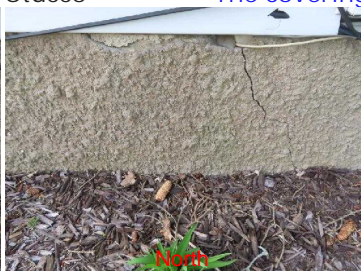
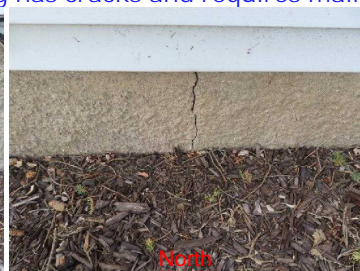
3. Functional Soffit/ Fascia: Aluminum, Vinyl
4. Needs Repair Entry/Patio Doors: Wood, Metal  
East laundry room door.
5. Not Present Basement Windows: Not present
6. Functional Exterior Lighting: Surface mount
7. Maintenance Hose Bibs: Gate Recommend shutting off exterior hose bibs during the winter months to avoid pipe supply damage and allow interior leaking.
8. Needs Repair Foundation Covering: Stucco The covering has cracks and requires maintenance.

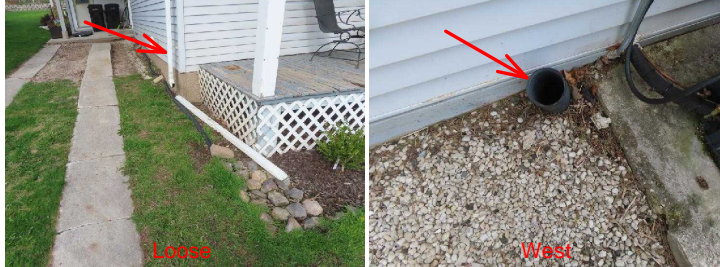
The SE down spout should be secured.

Note: The West corrugated pipe drain location is unknown.

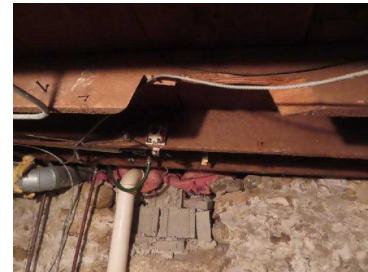
Joists/Trusses: Wood joists where visible  
There is a notched joist near the furnace. See Beam note.

There is a

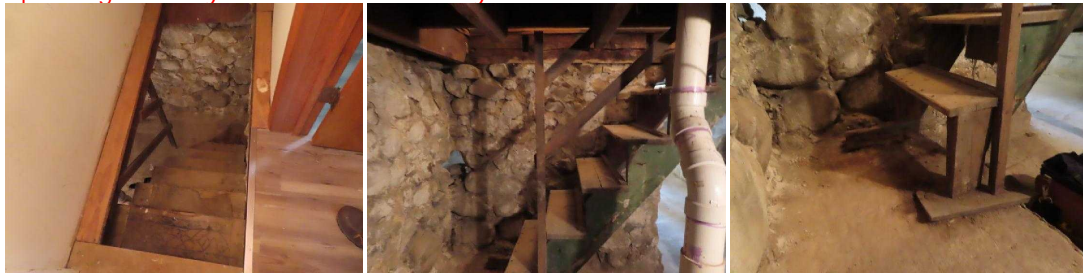
4. Defective

Basement Stairs/Railings: Wood stairs with wood handrails  
Note: Building standards have changed throughout the years. It is common in older homes to not have railing systems with multiple steps present, and does not meet today's standards. There are large riser heights. Consider updating to today's standards for safety reasons.

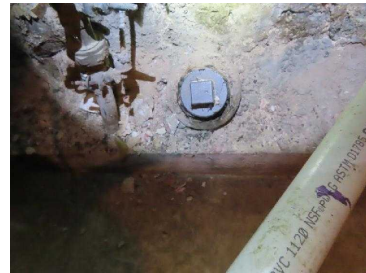
13. Further Evaluation Lateral/ Clean-Out: Accessible  
 Note: The drain-line lateral to the street is not visible for inspection. Mature tree roots can damage the drain system and cause water to back up into the home. Recommend a qualified, licensed plumbing contractor inspect and repair/ replace as needed.

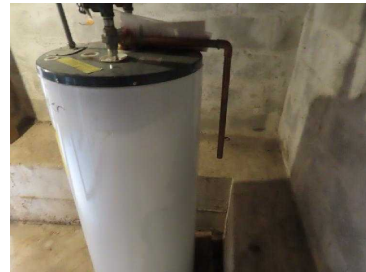
19. Needs Repair TPRV and Drain Tube: Copper  
 Recommend add proper TPR pipe for safety.

Recommend add proper

Basement - Lower Unit Water Heater TPRV and Drain Tube: Copper      Recommend add proper TPR pipe for safety.

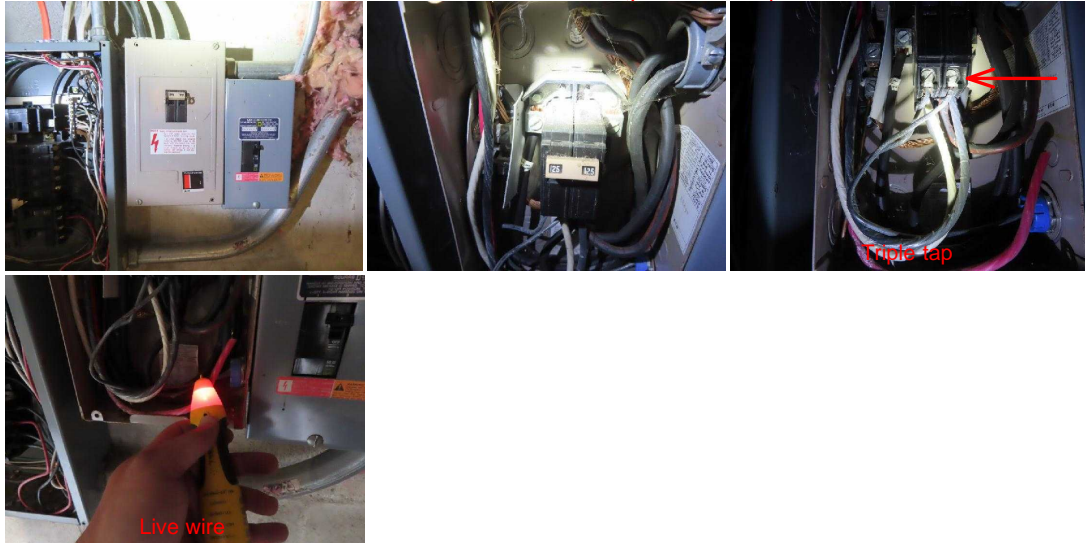
There appears to be triple taps present on the Main breaker. There is a live wire missing a wire nut. Recommend a qualified, licensed electrical contractor inspect and repair/ replace as needed.

Note: This panel was not labeled. Recommend verify what this panel services.

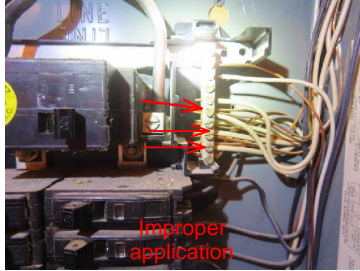
37. Defective Manufacturer: Square D There are neutral conductor(s) sharing a common screw on the bus bar with ground wire(s). This application is improper. Recommend a qualified, licensed electrical contractor inspect and repair/ replace as needed.

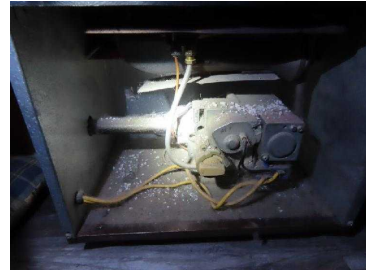
Heating System Operation: Functioning  
dirty. Monitor due to age.

The cabinet is

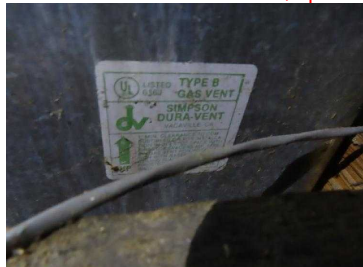
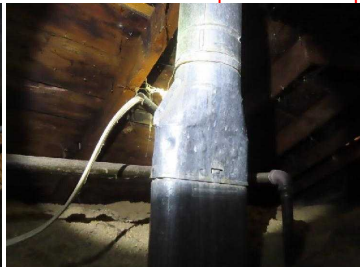
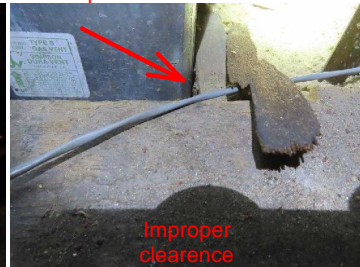
Class B Vent requires a 1" clearance to combustibles per UL listing. There was no evidence of heat marks at the time of inspection.

Recommend a licensed, qualified contractor inspect and repair/ replace as needed.

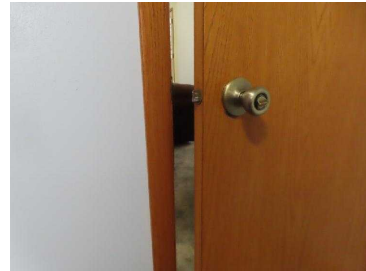
| 3. Maintenance | Doors: Wood | The East door needs adjustment to open/latch properly. |

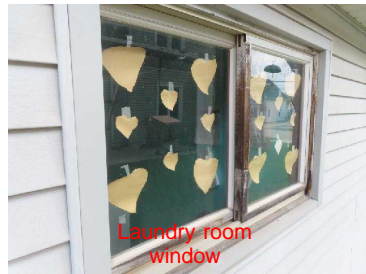
| 4. Maintenance | Windows: Wood double hung, Wood slider | The Laundry room window requires prime/ paint maintenance. |

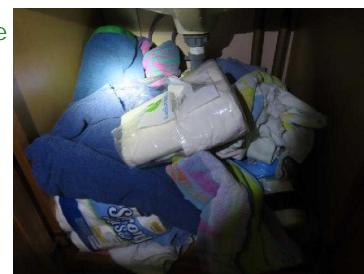
| 3. Not Inspected | Fixtures/Plumbing: PVC, Chrome faucet | Not inspected due to contents present. |
