# Your Inspection Report

117 Judge Dr  
Saukville, WI 53080

INSPECTION DATE:  
Friday, September 12, 2025

Report No. 7402

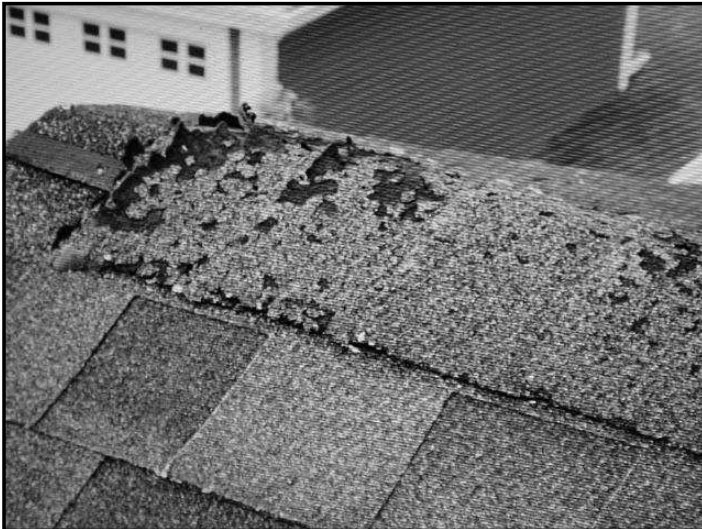
**Condition:** • Cupping, curling, clawing

**DEFECT** - There are a number of roof repairs that need to be made. There was no visible evidence of active leaking at the time of the inspection. The roof needs to be evaluated and repaired/replaced as deemed necessary by a qualified roofing contractor.

3. Cupping, curling, clawing

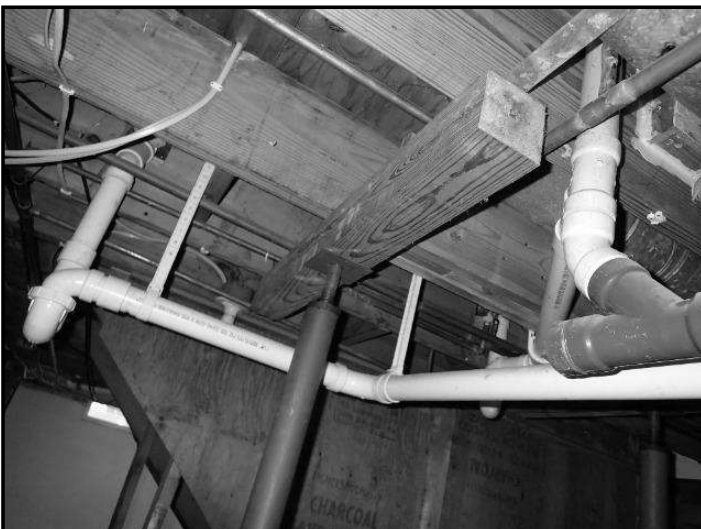
**Condition:** • Poorly secured at top or bottom

**DEFECT** - The temporary supports used in the basement are not proper permanent structural columns and need to be improved/corrected. There also needs to be a proper footing under each. The columns also need to be secured at the top and bottom.

7. Poorly secured at top or bottom

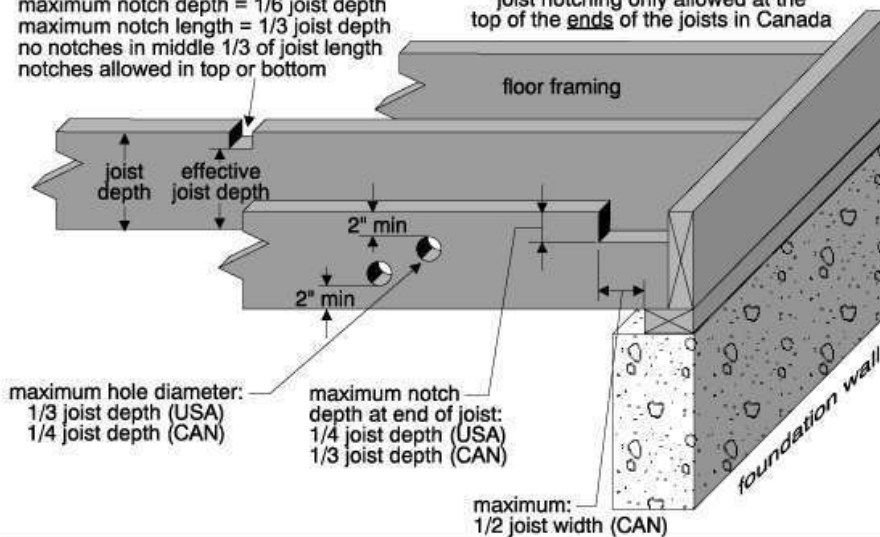
**Condition:** • Notches or holes

**DEFECT** - There are some damaged joists in the basement that need to be repaired/replaced.

14. Notches or holes

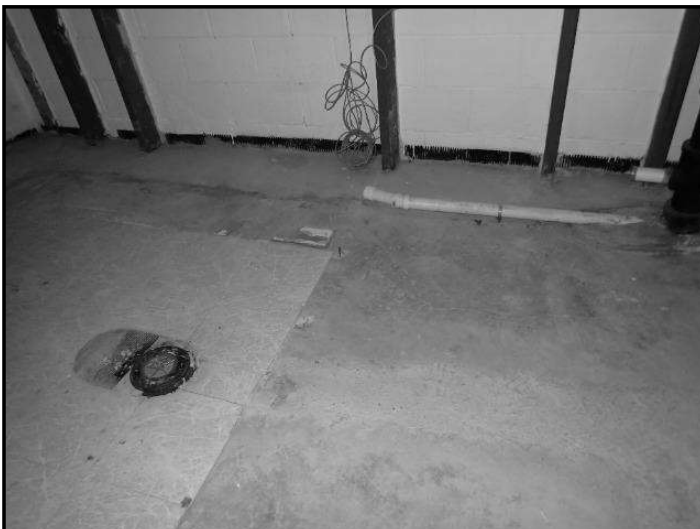
**Condition:** • Nonstandard materials and patches

**Implication(s):** Chance of water damage to structure, finishes and contents | Sewage entering the building

43. Nonstandard materials and patches

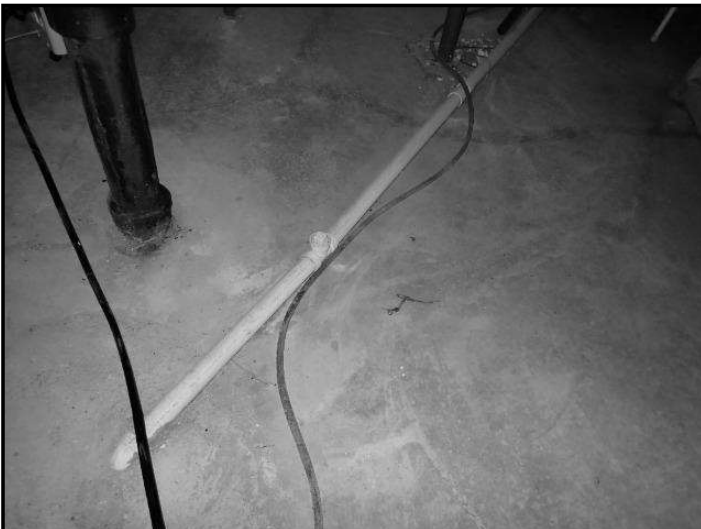
47. Nonstandard materials and patches

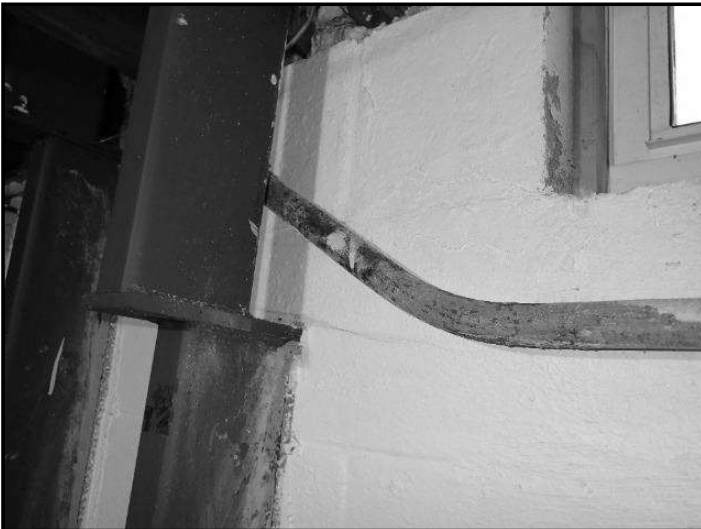
**Condition:** • Efflorescence

51. Efflorescence

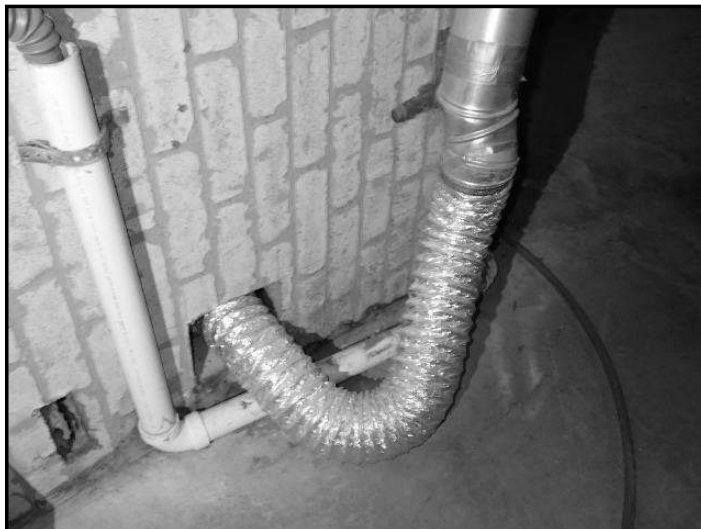
**53.** *Plastic dryer vent*
