117 Judge Dr, Saukville, WI September 12, 2025

Report No. 7402

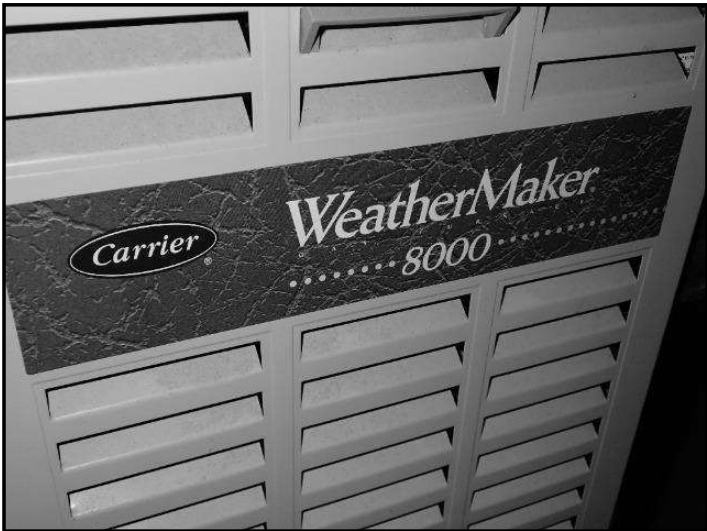
205. Cracks, holes or rust

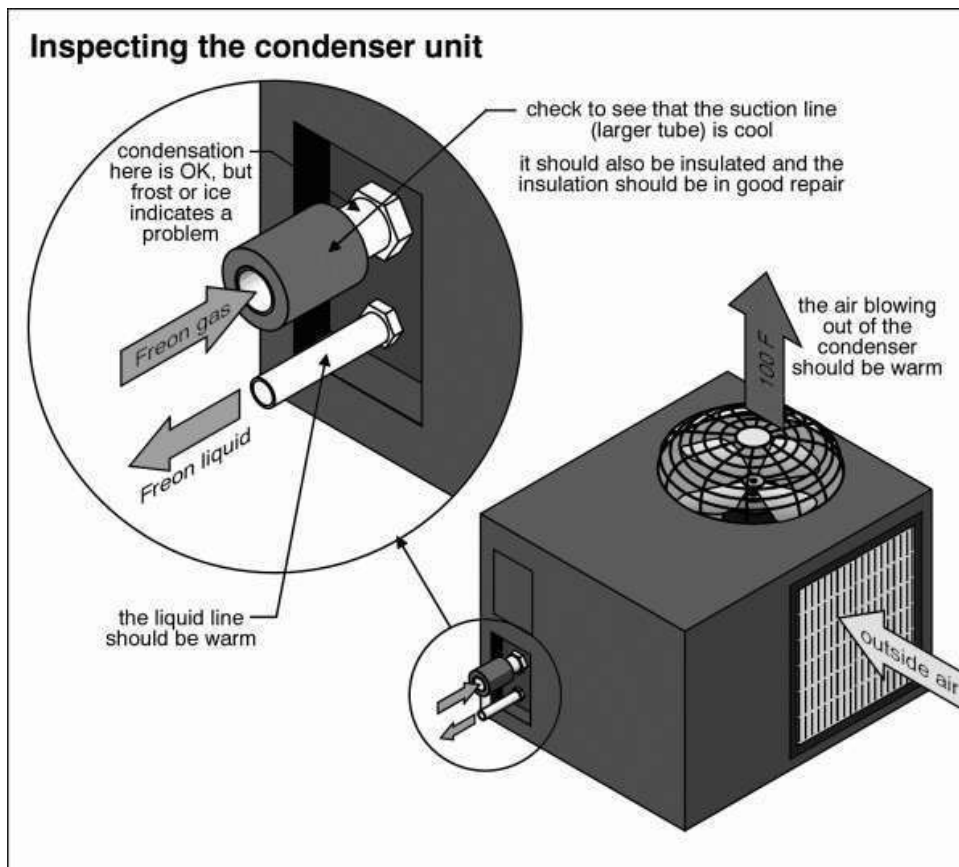
36. Condition: • Insulation - missing

The insulation on the refrigerant line to the A/C unit should be replaced. It should be continuous from the exterior unit to the furnace.

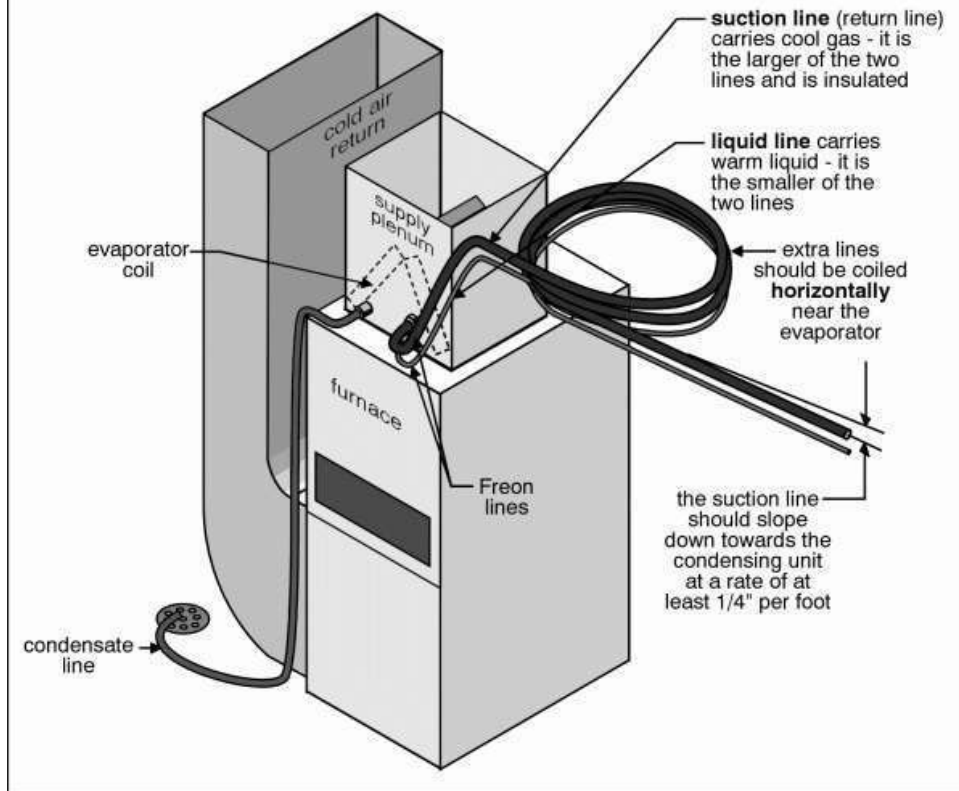
214. Insulation - missing

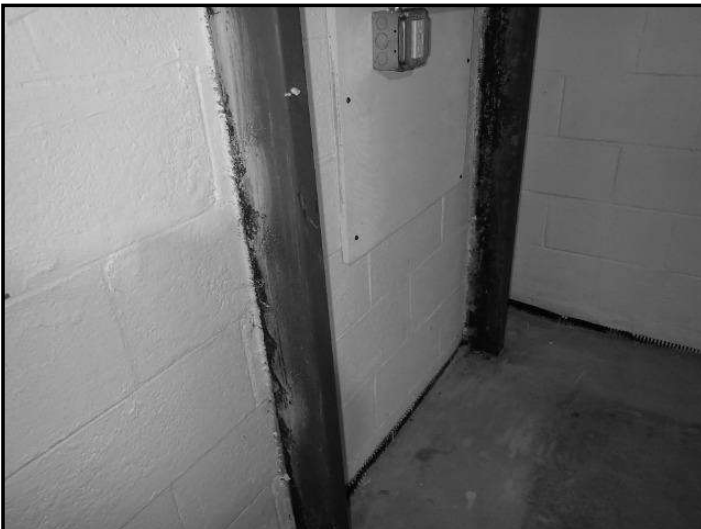
42. Condition: • Efflorescence

DEFECT - The basement is showing signs of efflorescence and moisture intrusion. The walls and floor were dry at the time of the inspection. These conditions are usually addressed by improving your grading, gutters, and downspouts. If the moisture persists there may be a need for a drain tile improvement/system. The moisture appears to be a continuing issue.

260. *Efflorescence*

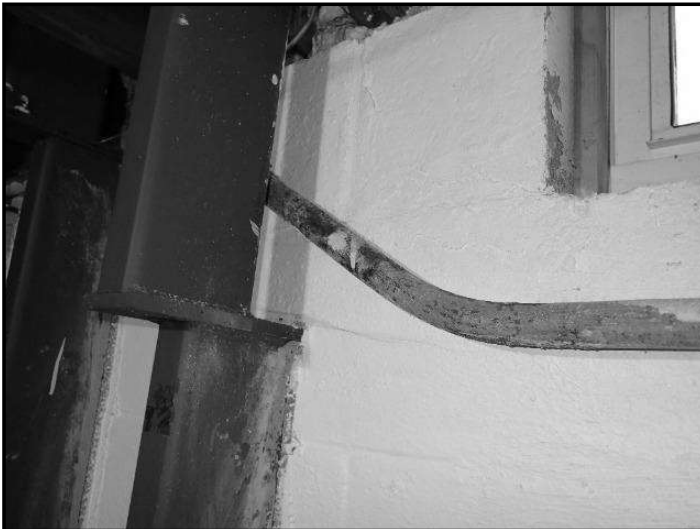
262. Efflorescence

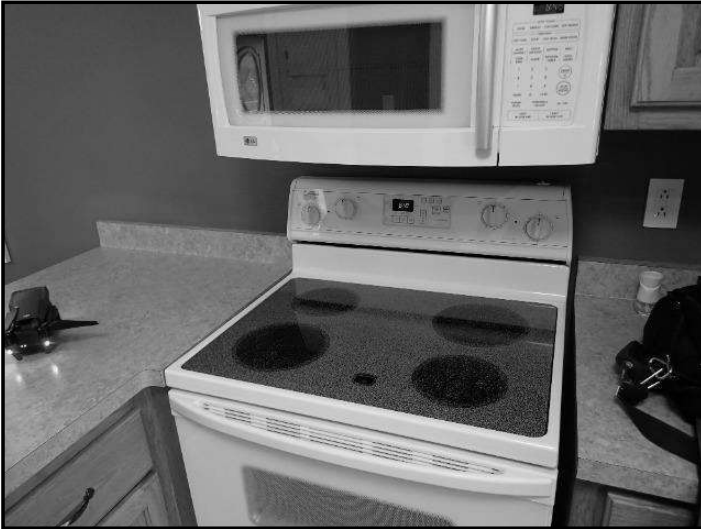
50. Condition: • Microwave is too close to the cooktop and could be damaged due to excessive heat. The unit should be raised or consider a low profile Microwave that will have all the same features.

280. Microwave is to close to the cooktop and...
