EXTERIOR

117 Judge Dr, Saukville, WI September 12, 2025

Report No. 7402

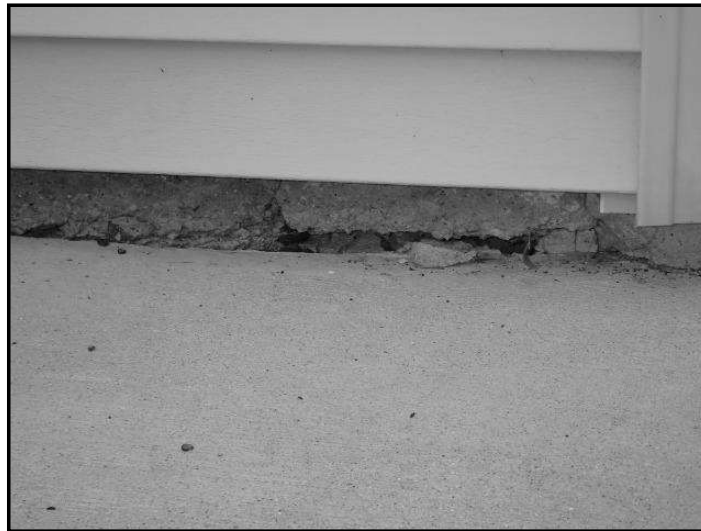
108.

19. Condition: • The garage foundation was added onto at some point is damaged at the point of the additional section.

The foundation should be repaired to ensure long-term structural stability.

Task: Repair Further evaluation Improve Correct

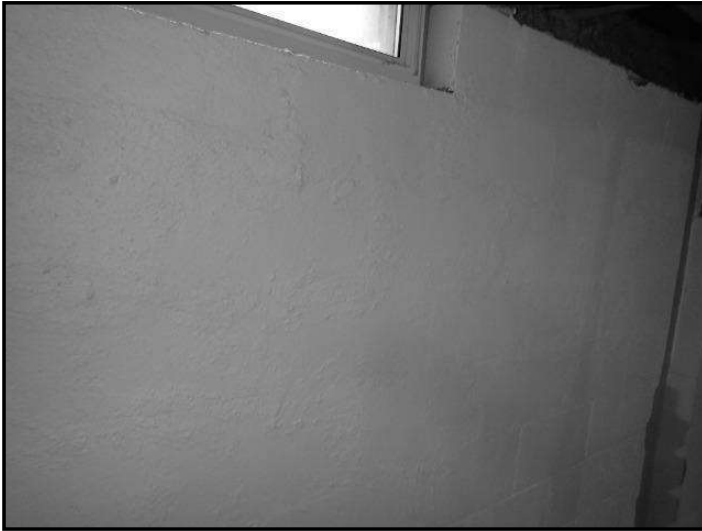
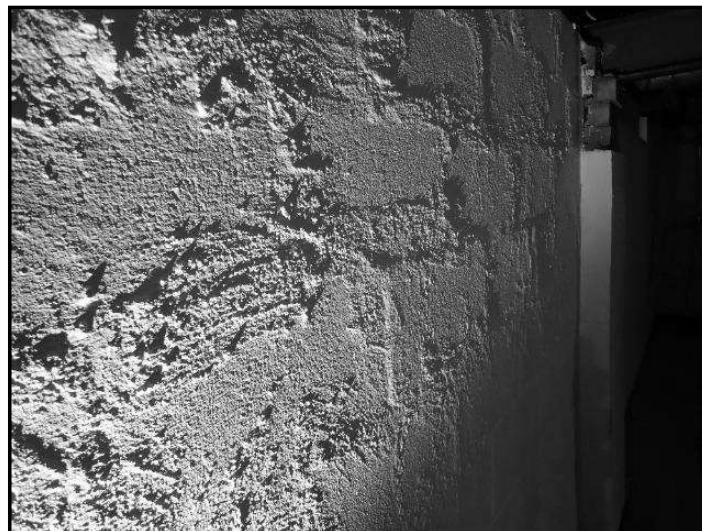
132. Bowed, bulging or leaning

134. Bowed, bulging or leaning
